# Experimental PVC Rocket XR-1

Nicklas Johnson & Miles DeWaele

11/23/19

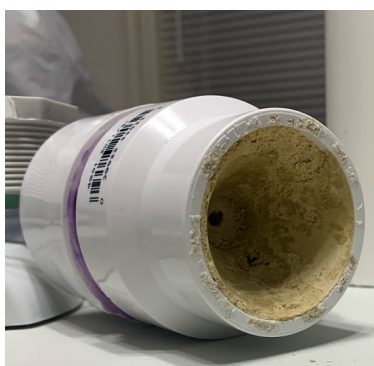
**Figure 1: Nozzle**

Note that the throat of the nozzle does not flow smoothly into the diffuser. This was not how the nozzle was at the time of launch. Unfortunately, there is no documentation of the nozzle at the time of launch, but a pocket knife was used to carve out the throat from both ends such that the contour flowed smoothly into the converging and diverging section.

The angle for the converging section is estimated at 80 degrees with the surface of the fairing. This was essentially a wall, and did not allow for a smooth flow of fluid to and through

the throat. Regarding the throat, it is also possible that it was too constrictive. A sort of “bottlenecking” could have occurred, drastically increasing the internal pressure of the system. We also observed that the throat expanded during the burn. The throat started at roughly  $\frac{1}{4}$ ” and finished at  $\frac{3}{8}$ ”. While we highly doubt the problem stemmed from the diffuser, we acknowledge that the diffuser we created was short and may have led to an increase in internal pressure. However, we believe this possibility is not as likely as those prior.

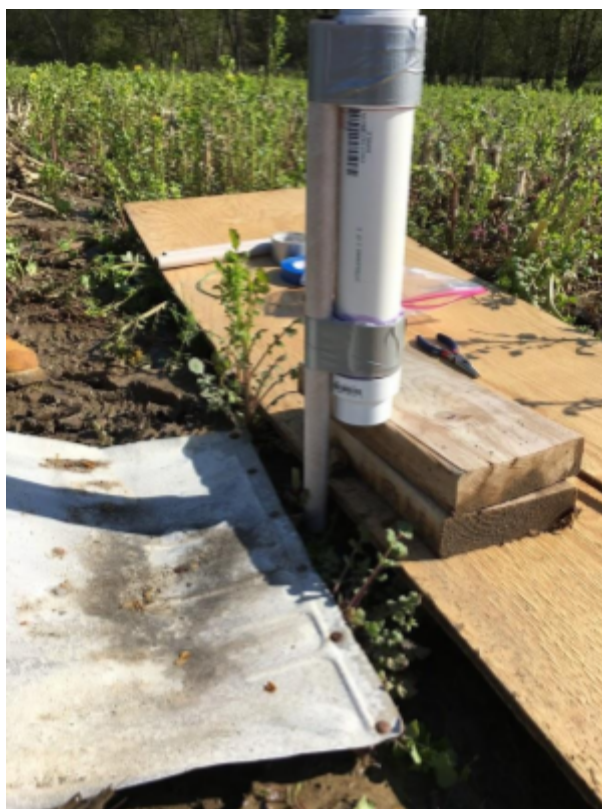
Figure 2 - Launch Apparatus

Preparations for the launch were not taken with much consideration. The time of launch was a cool and wet spring morning. The launching apparatus consisted of steel reinforcement bar embedded vertically into wet soil. The rocket was fastened to a cardboard tube that loosely enveloped the RE bar. A large sheet of plywood was set underneath to prevent significant erosion to the ground below the diffuser. Several inches of space were provided by 2 planks of wood. A firework fuse was inserted through the nozzle touching the surface of the bottom (first) fuel grain. The apparatus can be seen in Figure 1. Lit with a barbeque lighter, we had ample time to evacuate the area and begin recording a video as well as observing visually.

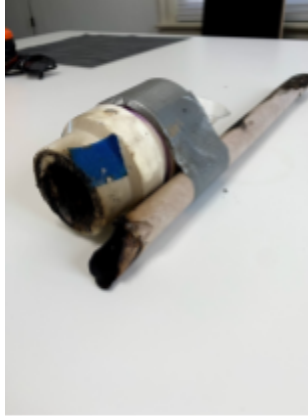
**Figure 3: Nozzle**

It can be seen in the photos above that the fuel grains in particular were greatly deformed and blackened. All the inside surface of the other pieces also reflect the same coloration, implying that extreme temperatures were experienced.
