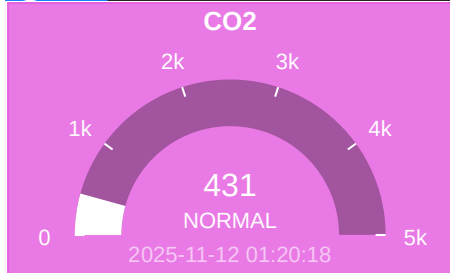
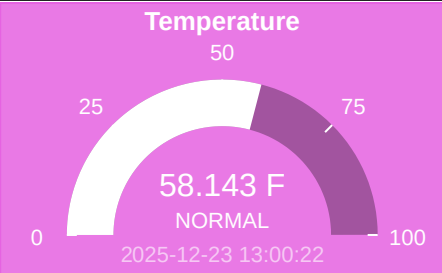
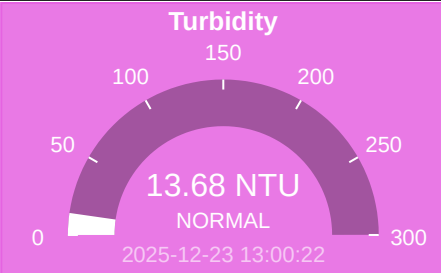
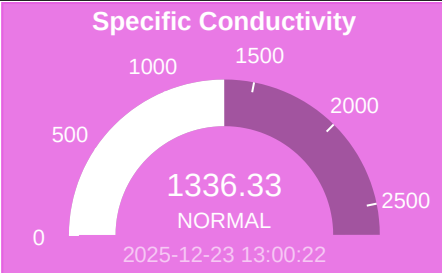
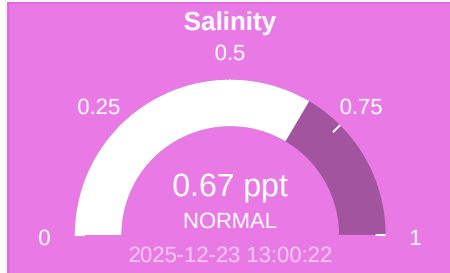
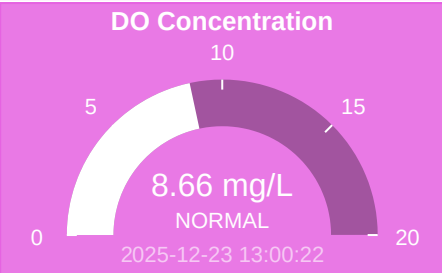
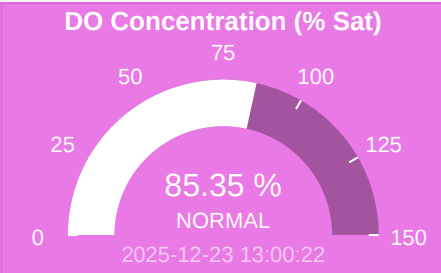
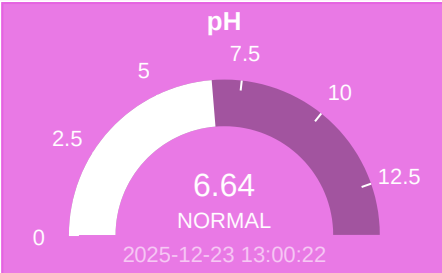
Tickfaw Buoy Water Quality Data

The figure displays eight water quality gauges arranged in a 2x4 grid. Each gauge has a semi-circular scale with a white needle and a grey background. The data is as follows:

Parameter	Value	Status	Timestamp
CO2	564.37	NORMAL	2025-11-12 07:20:38
Temperature	59.182 F	NORMAL	2025-12-23 12:45:20
Turbidity	27.38 NTU	NORMAL	2025-12-23 12:45:20
Specific Conductivity	631.48	NORMAL	2025-12-23 12:45:20
Salinity	0.31 ppt	NORMAL	2025-12-23 12:45:20
DO Concentration	9.72 mg/L	NORMAL	2025-12-23 12:45:20
DO Concentration (% Sat)	96.73 %	NORMAL	2025-12-23 12:45:20
pH	6.88	NORMAL	2025-12-23 12:45:20
