Blind Buoy Weather Station Data

Maurepas Buoy Water Quality Data

Tickfaw Buoy Water Quality Data

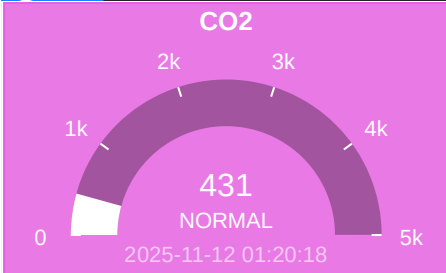
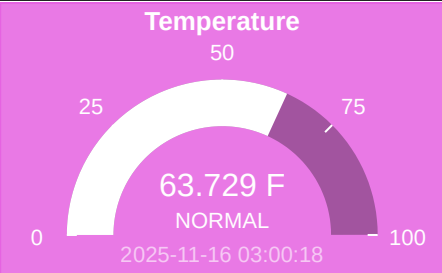
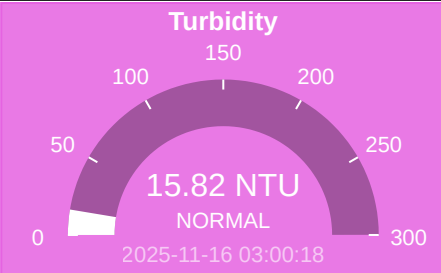
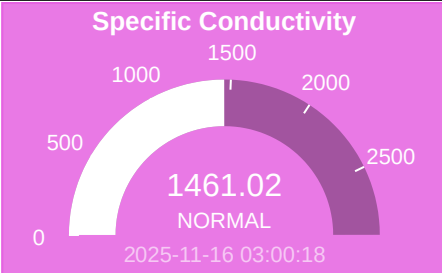
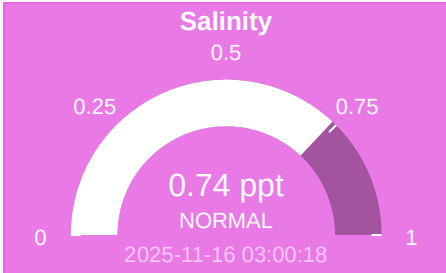
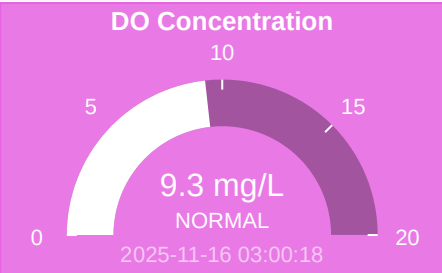
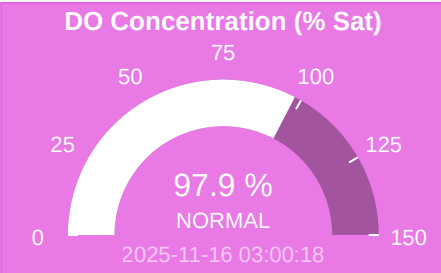
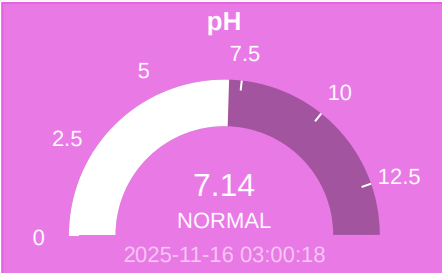
The figure displays eight water quality parameters in a 2x4 grid, each represented by a semi-circular gauge chart. The parameters and their values are as follows:

Parameter	Value	Status	Timestamp
CO2	564.37	NORMAL	2025-11-12 07:20:38
Temperature	64.375 F	NORMAL	2025-11-16 02:45:20
Turbidity	12.09 NTU	NORMAL	2025-11-16 02:45:20
Specific Conductivity	1231.81	NORMAL	2025-11-16 02:45:20
Salinity	0.62 ppt	NORMAL	2025-11-16 02:45:20
DO Concentration	10.81 mg/L	NORMAL	2025-11-16 02:45:20
DO Concentration (% Sat)	114.59 %	NORMAL	2025-11-16 02:45:20
pH	7.75	NORMAL	2025-11-16 02:45:20
