Blind Buoy Weather Station Data

Maurepas Buoy Water Quality Data

Tickfaw Buoy Water Quality Data

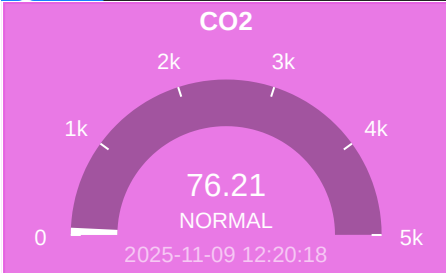
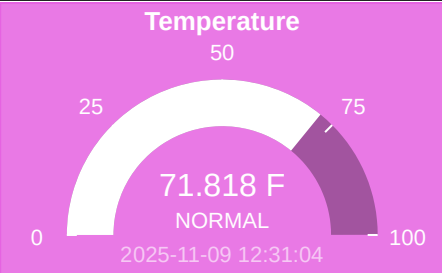
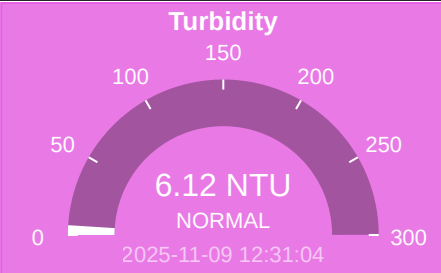
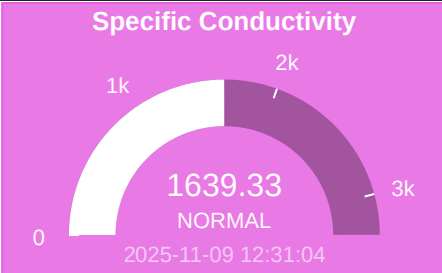
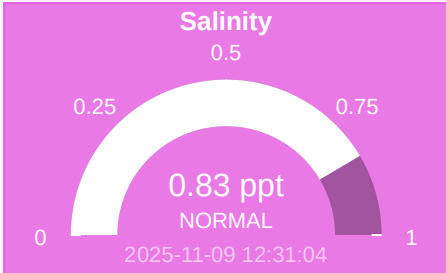
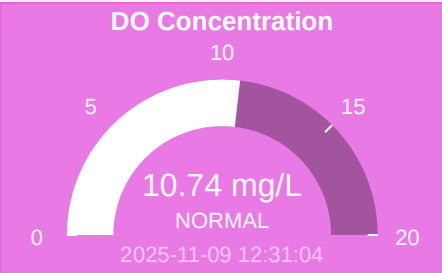
The figure displays eight water quality parameters in a 2x4 grid, each represented by a semi-circular gauge chart. The parameters and their current values are:

- CO2:** 1039.42 (NORMAL). Scale: 0 to 5k. Timestamp: 2025-11-09 12:50:38.
- Temperature:** 69.309 F (NORMAL). Scale: 0 to 100. Timestamp: 2025-11-09 13:00:24.
- Turbidity:** 6.91 NTU (NORMAL). Scale: 0 to 300. Timestamp: 2025-11-09 13:00:24.
- Specific Conductivity:** 1140.64 (NORMAL). Scale: 0 to 2000. Timestamp: 2025-11-09 13:00:24.
- Salinity:** 0.57 ppt (NORMAL). Scale: 0 to 1. Timestamp: 2025-11-09 13:00:24.
- DO Concentration:** 9.37 mg/L (NORMAL). Scale: 0 to 20. Timestamp: 2025-11-09 13:00:24.
- DO Concentration (% Sat):** 104.92 % (NORMAL). Scale: 0 to 150. Timestamp: 2025-11-09 13:00:24.
- pH:** 7.2 (NORMAL). Scale: 0 to 12.5. Timestamp: 2025-11-09 13:00:24.
