Blind Buoy Weather Station Data

Maurepas Buoy Water Quality Data

Tickfaw Buoy Water Quality Data

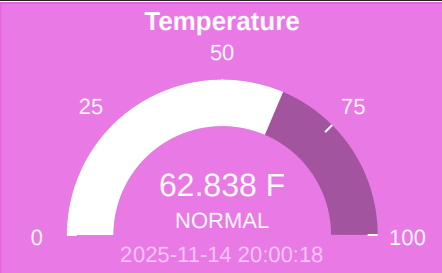
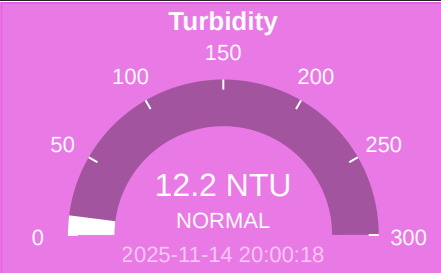
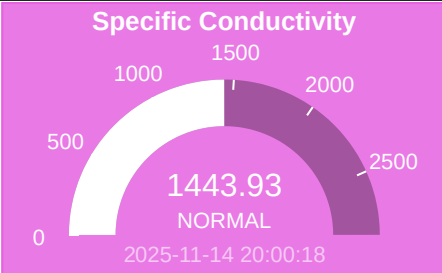
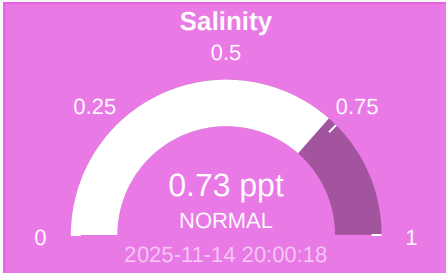
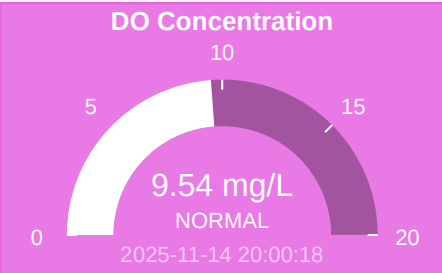
The figure displays eight water quality parameters in a 2x4 grid. Each parameter is represented by a semi-circular gauge with a white needle and a white value. The status 'NORMAL' is displayed below the value, and a timestamp is shown at the bottom of each gauge.

Parameter	Value	Status	Timestamp
CO2	564.37	NORMAL	2025-11-12 07:20:38
Temperature	63.082 F	NORMAL	2025-11-14 20:00:24
Turbidity	14.53 NTU	NORMAL	2025-11-14 20:00:24
Specific Conductivity	1243.21	NORMAL	2025-11-14 20:00:24
Salinity	0.62 ppt	NORMAL	2025-11-14 20:00:24
DO Concentration	10.34 mg/L	NORMAL	2025-11-14 20:00:24
DO Concentration (% Sat)	107.94 %	NORMAL	2025-11-14 20:00:24
pH	7.38	NORMAL	2025-11-14 20:00:24
