## Blind Buoy Weather Station Data

Maurepas Buoy Water Quality Data

Tickfaw Buoy Water Quality Data

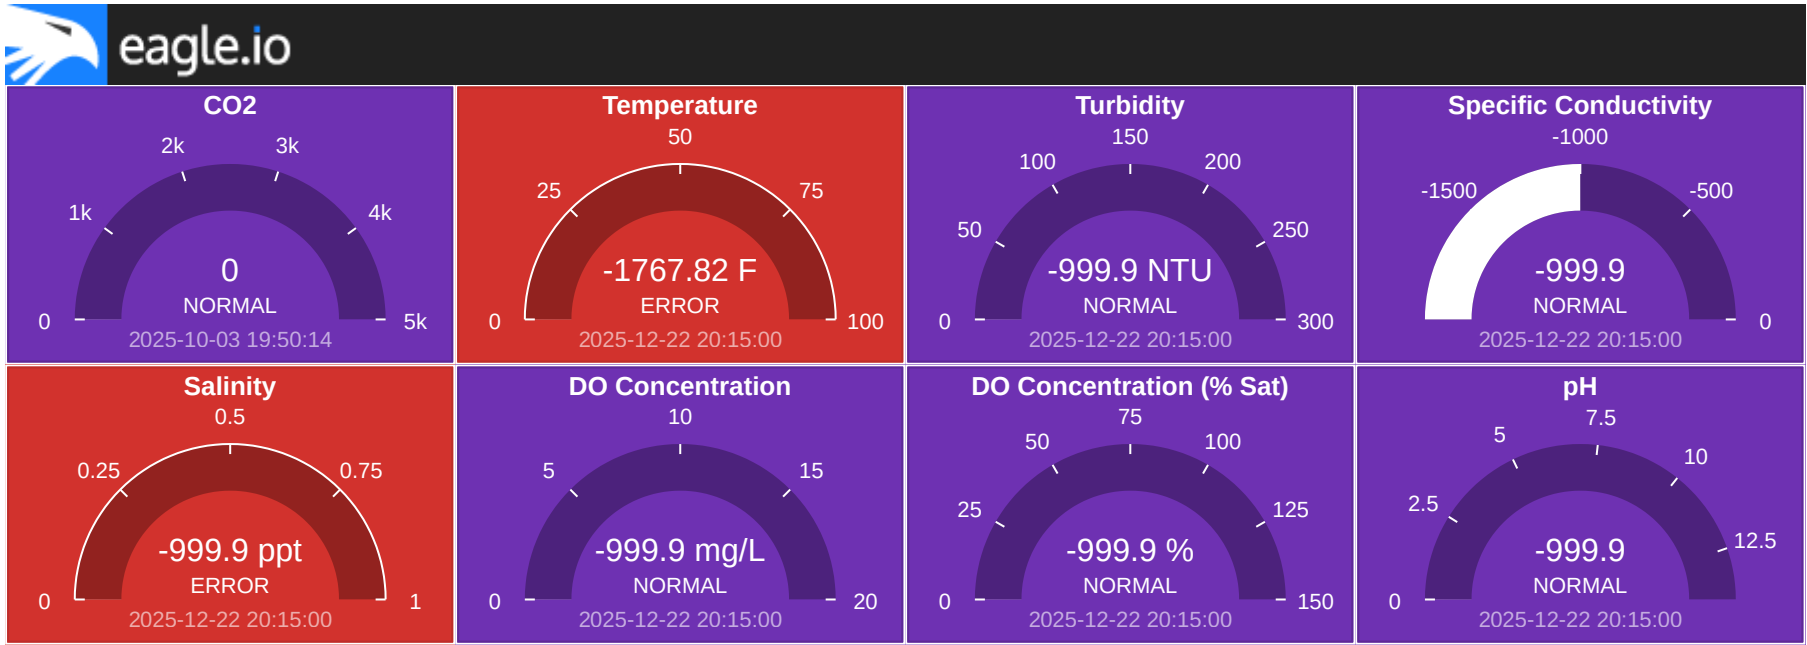
The figure displays eight water quality parameters in a 2x4 grid, each represented by a gauge chart. The gauges are blue with white scales and needles. The current values and status are displayed in the center of each gauge, and the timestamp is shown at the bottom.

Parameter	Value	Status	Timestamp
CO2	116.73	NORMAL	2025-11-12 06:50:16
Temperature	58.689 F	NORMAL	2025-12-22 19:46:04
Turbidity	8.67 NTU	NORMAL	2025-12-22 19:46:04
Specific Conductivity	1239.14	NORMAL	2025-12-22 19:46:04
Salinity	0.62 ppt	NORMAL	2025-12-22 19:46:04
DO Concentration	10.43 mg/L	NORMAL	2025-12-22 19:46:04
DO Concentration (% Sat)	103.44 %	NORMAL	2025-12-22 19:46:04
pH	6.92	NORMAL	2025-12-22 19:46:04

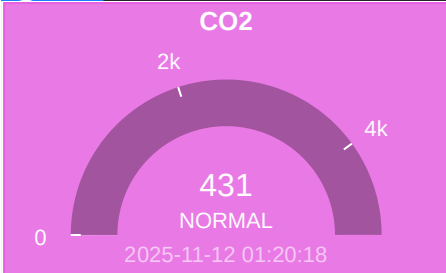
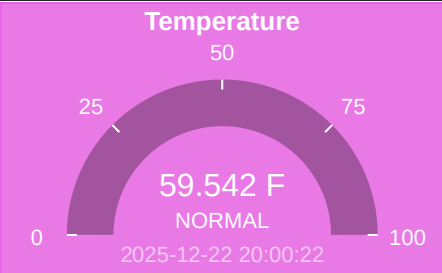
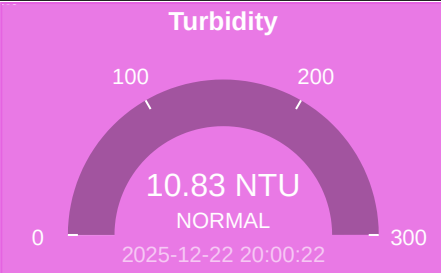
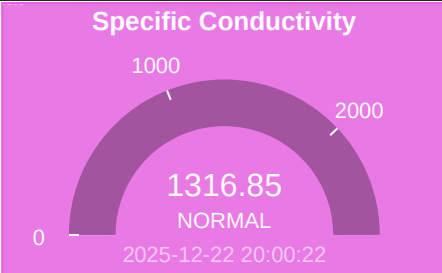
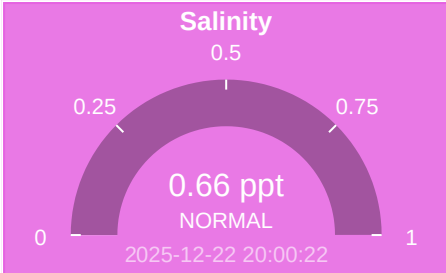
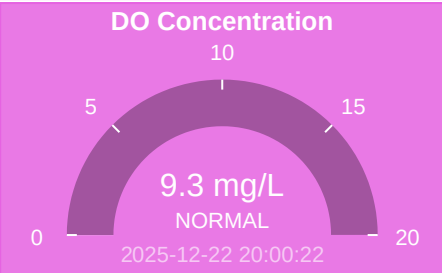
The figure displays eight water quality parameters in a 2x4 grid. Each parameter is represented by a semi-circular gauge with a needle, a central numerical value, a status label, and a timestamp.

Parameter	Value	Status	Timestamp
CO2	564.37	NORMAL	2025-11-12 07:20:38
Temperature	58.991 F	NORMAL	2025-12-22 19:45:20
Turbidity	25.44 NTU	NORMAL	2025-12-22 19:45:20
Specific Conductivity	626.15	NORMAL	2025-12-22 19:45:20
Salinity	0.31 ppt	NORMAL	2025-12-22 19:45:20
DO Concentration	9.82 mg/L	NORMAL	2025-12-22 19:45:20
DO Concentration (% Sat)	97.54 %	NORMAL	2025-12-22 19:45:20
pH	6.91	NORMAL	2025-12-22 19:45:20
