Blind Buoy Weather Station Data

Maurepas Buoy Water Quality Data

Tickfaw Buoy Water Quality Data

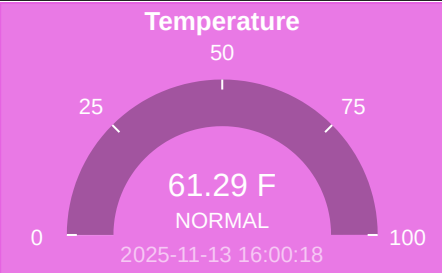
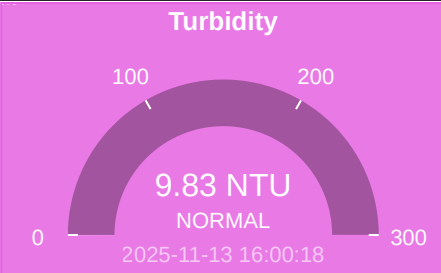
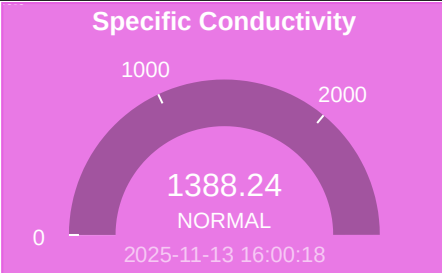
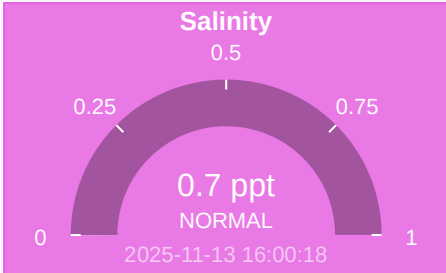
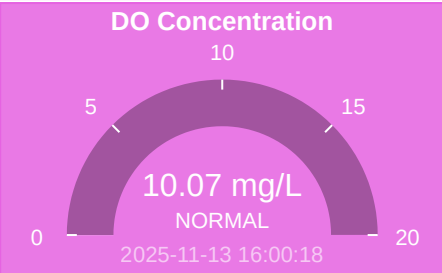
The figure displays eight water quality parameters in a 2x4 grid. Each parameter is represented by a semi-circular gauge with a needle, a current value, a status (NORMAL), and a timestamp.

Parameter	Value	Status	Timestamp
CO2	564.37	NORMAL	2025-11-12 07:20:38
Temperature	61.102 F	NORMAL	2025-11-13 15:45:20
Turbidity	16.14 NTU	NORMAL	2025-11-13 15:45:20
Specific Conductivity	1286.37	NORMAL	2025-11-13 15:45:20
Salinity	0.65 ppt	NORMAL	2025-11-13 15:45:20
DO Concentration	10.18 mg/L	NORMAL	2025-11-13 15:45:20
DO Concentration (% Sat)	103.94 %	NORMAL	2025-11-13 15:45:20
pH	7.27	NORMAL	2025-11-13 15:45:20

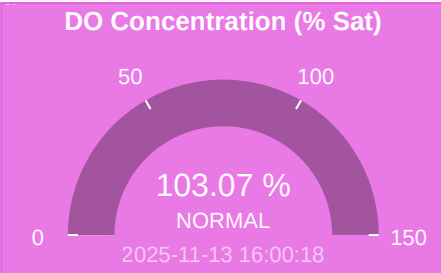
The figure displays eight water quality parameters, each represented by a semi-circular gauge chart. The gauges are arranged in a 2x4 grid. Each gauge shows a current value, a status (NORMAL), and a timestamp.

Parameter	Value	Status	Timestamp
CO2	116.73	NORMAL	2025-11-12 06:50:16
Temperature	61.353 F	NORMAL	2025-11-13 15:46:04
Turbidity	9.5 NTU	NORMAL	2025-11-13 15:46:04
Specific Conductivity	1726.04	NORMAL	2025-11-13 15:46:04
Salinity	0.88 ppt	NORMAL	2025-11-13 15:46:04
DO Concentration	10.04 mg/L	NORMAL	2025-11-13 15:46:04
DO Concentration (% Sat)	102.87 %	NORMAL	2025-11-13 15:46:04
pH	7.06	NORMAL	2025-11-13 15:46:04
