Blind Buoy Weather Station Data

Maurepas Buoy Water Quality Data

Tickfaw Buoy Water Quality Data

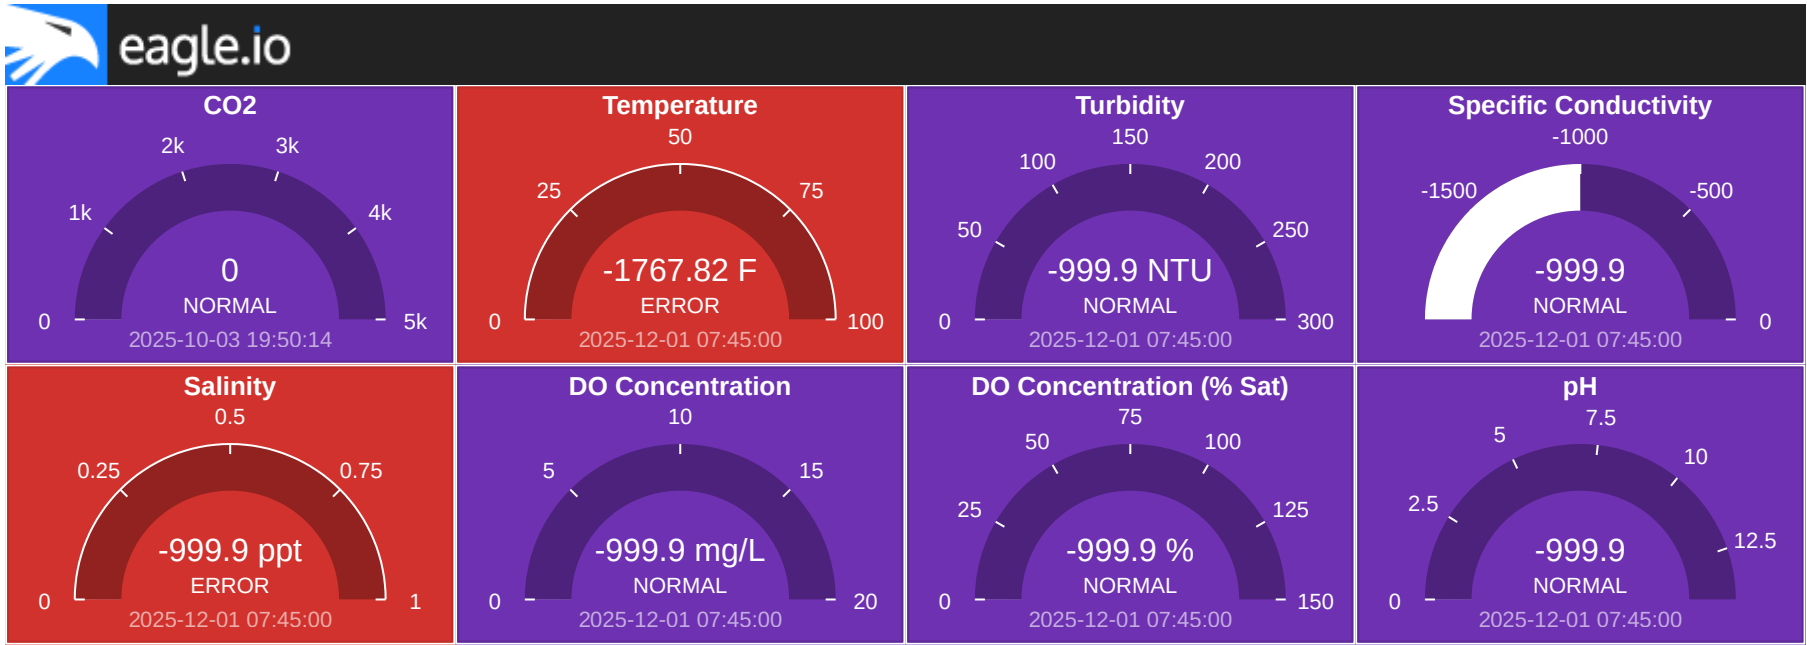
The figure displays eight water quality parameters in a 2x4 grid, each represented by a gauge chart. The gauges are blue with white scales and needles. The parameters and their values are:

- CO2:** 116.73 (NORMAL), timestamp: 2025-11-12 06:50:16
- Temperature:** 56.953 F (NORMAL), timestamp: 2025-12-03 22:46:04
- Turbidity:** 9.22 NTU (NORMAL), timestamp: 2025-12-03 22:46:04
- Specific Conductivity:** 2519.44 (NORMAL), timestamp: 2025-12-03 22:46:04
- Salinity:** 1.31 ppt (NORMAL), timestamp: 2025-12-03 22:46:04
- DO Concentration:** 9.63 mg/L (NORMAL), timestamp: 2025-12-03 22:46:04
- DO Concentration (% Sat):** 93.91 % (NORMAL), timestamp: 2025-12-03 22:46:04
- pH:** 7.09 (NORMAL), timestamp: 2025-12-03 22:46:04

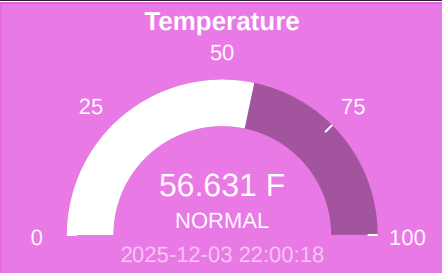
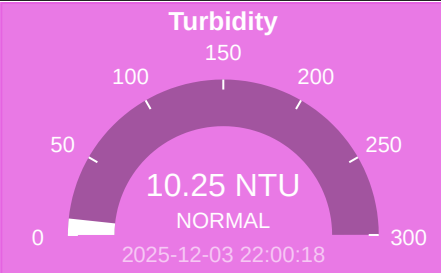
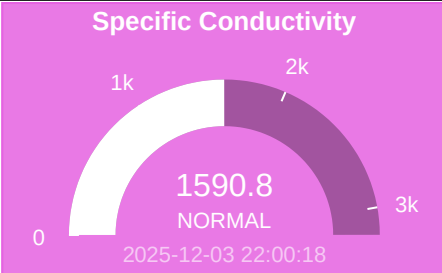
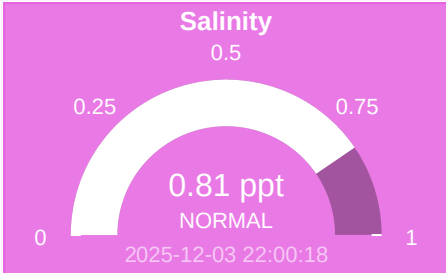
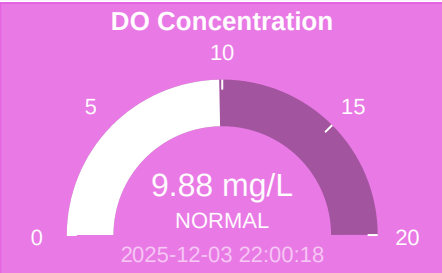
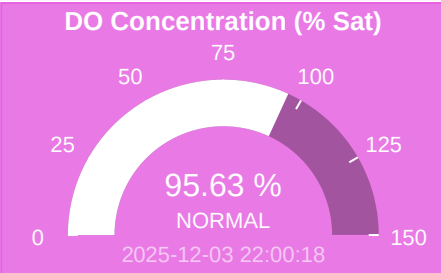
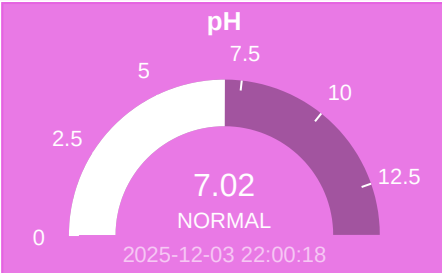
The figure displays eight water quality parameters, each represented by a semi-circular gauge chart. The gauges are arranged in a 2x4 grid. Each gauge shows a needle pointing to a value on a scale, with the current value and status (NORMAL) displayed in the center. The timestamp for each reading is shown at the bottom of the gauge.

Parameter	Value	Status	Timestamp
CO2	564.37	NORMAL	2025-11-12 07:20:38
Temperature	56.361 F	NORMAL	2025-12-03 22:45:20
Turbidity	18.22 NTU	NORMAL	2025-12-03 22:45:20
Specific Conductivity	1782.36	NORMAL	2025-12-03 22:45:20
Salinity	0.91 ppt	NORMAL	2025-12-03 22:45:20
DO Concentration	9.76 mg/L	NORMAL	2025-12-03 22:45:20
DO Concentration (% Sat)	94.29 %	NORMAL	2025-12-03 22:45:20
pH	6.8	NORMAL	2025-12-03 22:45:20
