Blind Buoy Weather Station Data

Maurepas Buoy Water Quality Data

Tickfaw Buoy Water Quality Data

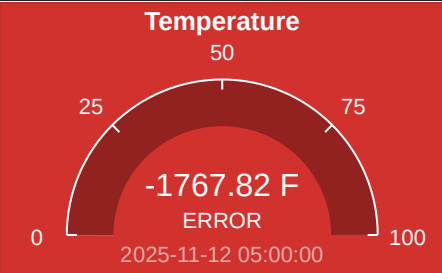
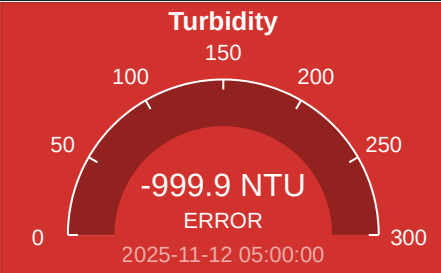
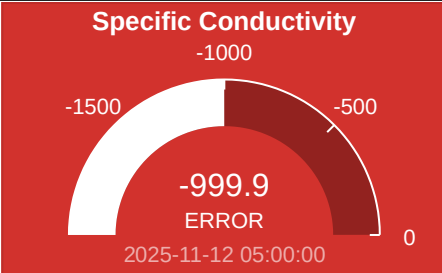
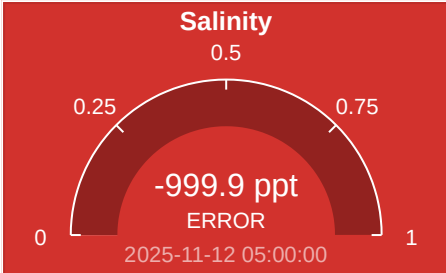
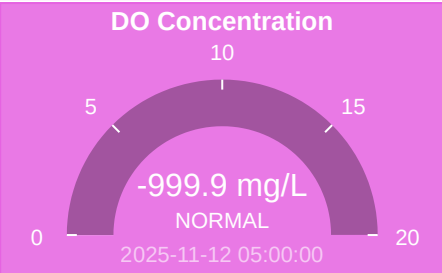
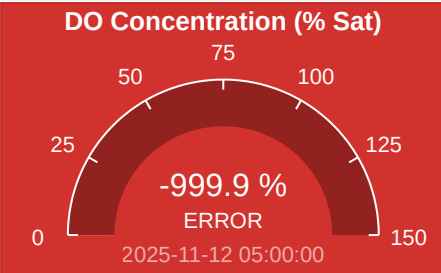
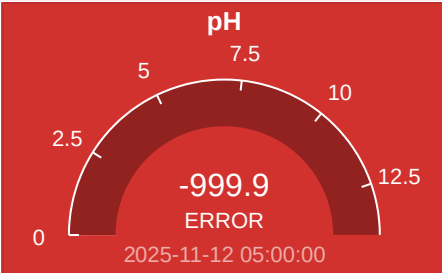
The figure displays eight water quality parameters in a 2x4 grid. Each parameter is represented by a semi-circular gauge with a needle, a numerical value, a status (NORMAL), and a timestamp.

Parameter	Value	Status	Timestamp
CO2	722.29	NORMAL	2025-11-12 04:50:38
Temperature	59.945 F	NORMAL	2025-11-12 04:45:20
Turbidity	26.21 NTU	NORMAL	2025-11-12 04:45:20
Specific Conductivity	1555.11	NORMAL	2025-11-12 04:45:20
Salinity	0.79 ppt	NORMAL	2025-11-12 04:45:20
DO Concentration	9.83 mg/L	NORMAL	2025-11-12 04:45:20
DO Concentration (% Sat)	99.08 %	NORMAL	2025-11-12 04:45:20
pH	6.91	NORMAL	2025-11-12 04:45:20
