Blind Buoy Weather Station Data

Maurepas Buoy Water Quality Data

Tickfaw Buoy Water Quality Data

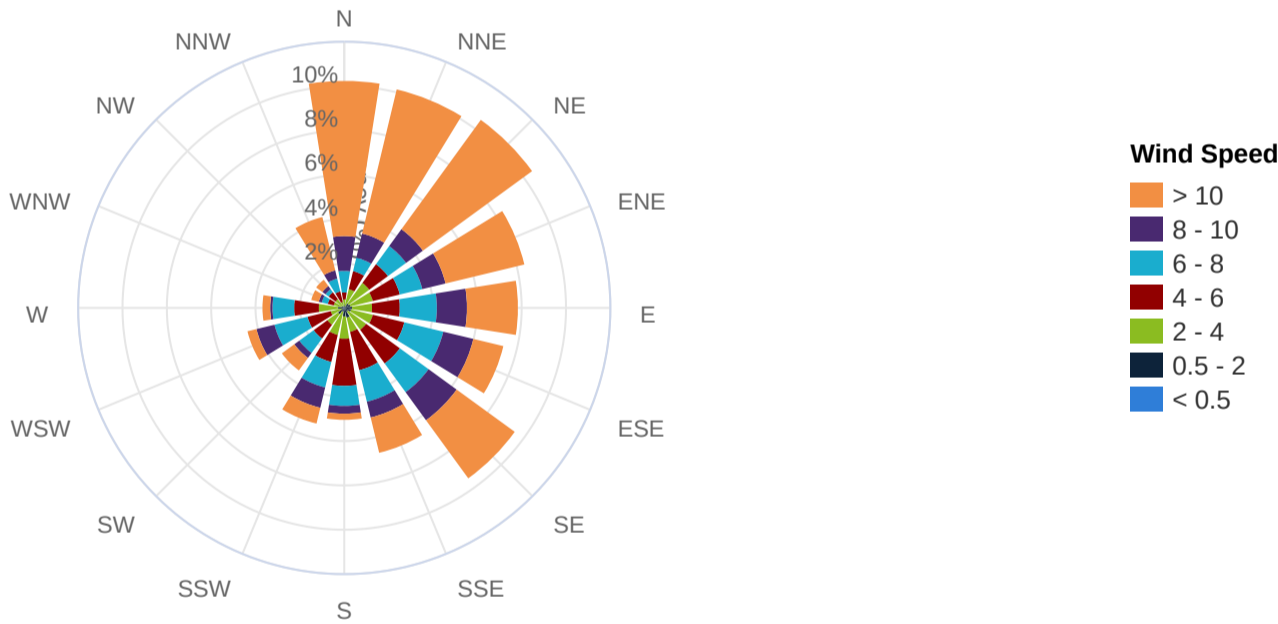
Wind Rose Chart: Historic Wind Speed and Direction

Historic wind speed and direction for the date range listed below. The frequency of winds over a time period is plotted by wind direction, with color bands showing wind speed ranges. Spoke length shows wind direction frequency.

[2025-11-16 04:29:23 - 2025-12-16 04:29:23]

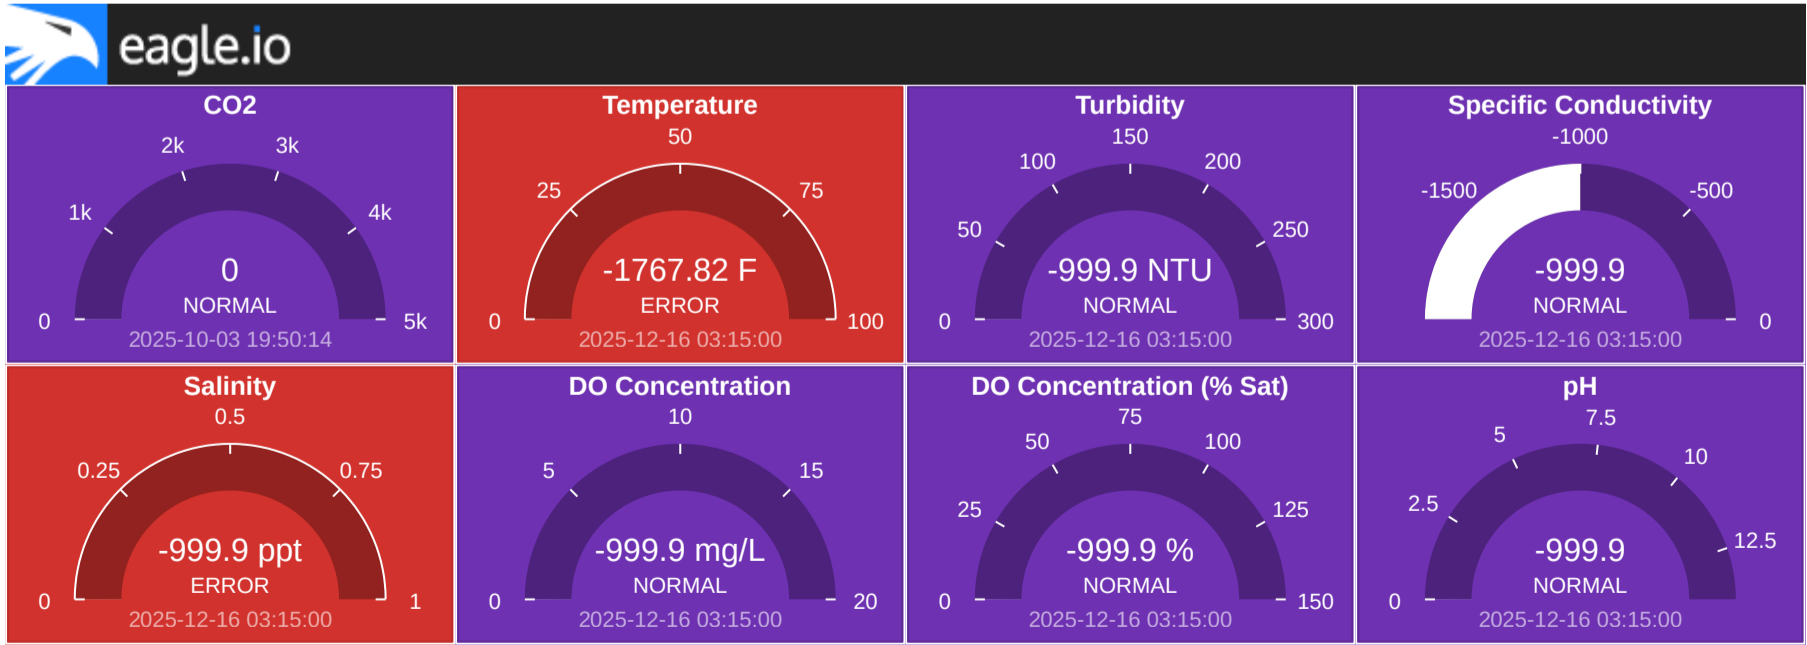
The figure displays eight water quality parameters in a 2x4 grid, each represented by a semi-circular gauge chart. The parameters and their values are as follows:

Parameter	Value	Status	Timestamp
CO2	116.73	NORMAL	2025-11-12 06:50:16
Temperature	53.019 F	NORMAL	2025-12-16 02:46:04
Turbidity	26.76 NTU	NORMAL	2025-12-16 02:46:04
Specific Conductivity	1451.65	NORMAL	2025-12-16 02:46:04
Salinity	0.73 ppt	NORMAL	2025-12-16 02:46:04
DO Concentration	10.24 mg/L	NORMAL	2025-12-16 02:46:04
DO Concentration (% Sat)	94.76 %	NORMAL	2025-12-16 02:46:04
pH	6.65	NORMAL	2025-12-16 02:46:04

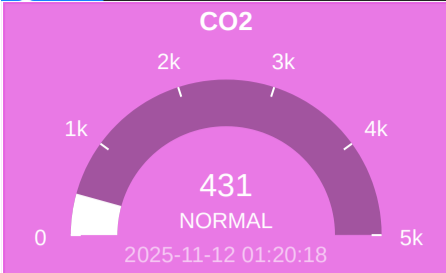
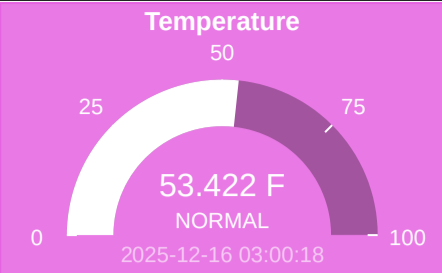
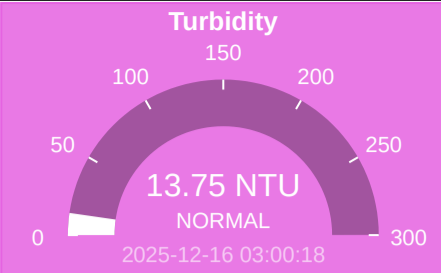
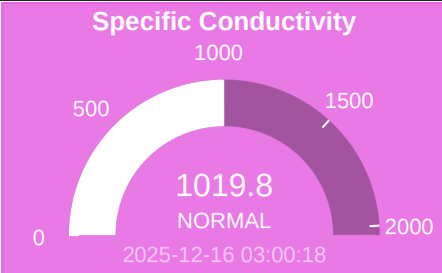
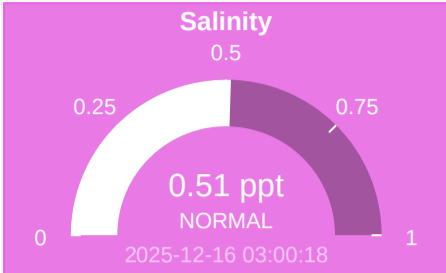
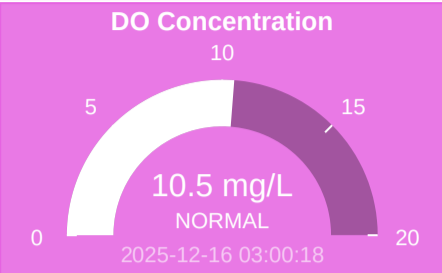
The figure displays eight water quality parameters in a 2x4 grid. Each parameter is represented by a semi-circular gauge with a needle, a current value, a status (NORMAL), and a timestamp (2025-12-16 02:45:20).

Parameter	Value	Status	Timestamp
CO2	564.37	NORMAL	2025-12-16 07:20:38
Temperature	52.196 F	NORMAL	2025-12-16 02:45:20
Turbidity	90 NTU	NORMAL	2025-12-16 02:45:20
Specific Conductivity	642.98	NORMAL	2025-12-16 02:45:20
Salinity	0.31 ppt	NORMAL	2025-12-16 02:45:20
DO Concentration	9.87 mg/L	NORMAL	2025-12-16 02:45:20
DO Concentration (% Sat)	90.16 %	NORMAL	2025-12-16 02:45:20
pH	6.88	NORMAL	2025-12-16 02:45:20
