Blind Buoy Weather Station Data

Maurepas Buoy Water Quality Data

Tickfaw Buoy Water Quality Data

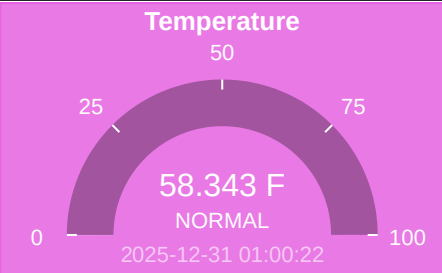
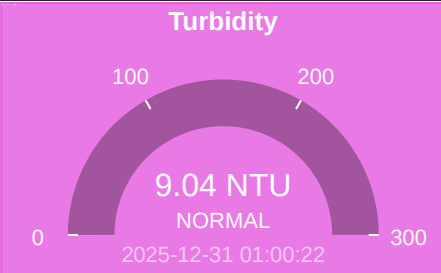
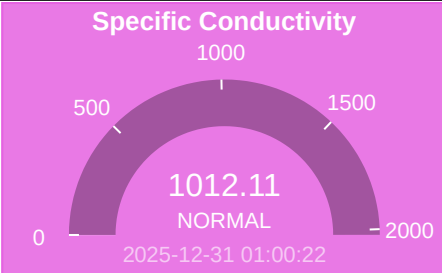
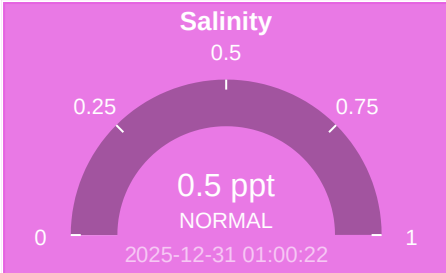
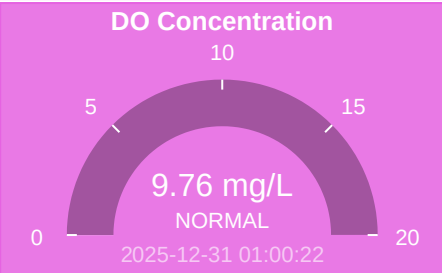
The figure displays eight water quality parameters in a 2x4 grid. Each parameter is represented by a semi-circular gauge with a needle, a scale, a current value, a status (NORMAL), and a timestamp.

Parameter	Value	Status	Timestamp
CO2	564.37	NORMAL	2025-11-12 07:20:38
Temperature	56.257 F	NORMAL	2025-12-31 00:45:20
Turbidity	55.74 NTU	NORMAL	2025-12-31 00:45:20
Specific Conductivity	867.41	NORMAL	2025-12-31 00:45:20
Salinity	0.43 ppt	NORMAL	2025-12-31 00:45:20
DO Concentration	9.21 mg/L	NORMAL	2025-12-31 00:45:20
DO Concentration (% Sat)	88.61 %	NORMAL	2025-12-31 00:45:20
pH	6.77	NORMAL	2025-12-31 00:45:20
