Blind Buoy Weather Station Data

Maurepas Buoy Water Quality Data

Tickfaw Buoy Water Quality Data

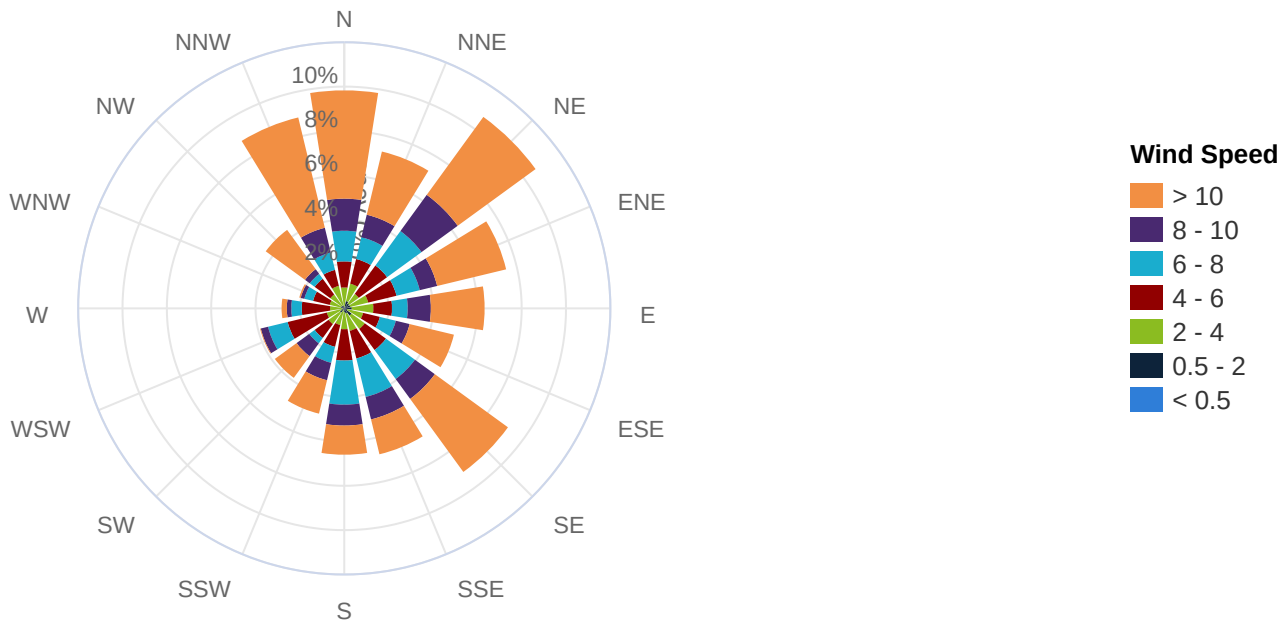
Wind Rose Chart: Historic Wind Speed and Direction

Historic wind speed and direction for the date range listed below. The frequency of winds over a time period is plotted by wind direction, with color bands showing wind speed ranges. Spoke length shows wind direction frequency.

[2025-10-11 01:25:24 - 2025-11-11 01:25:24]

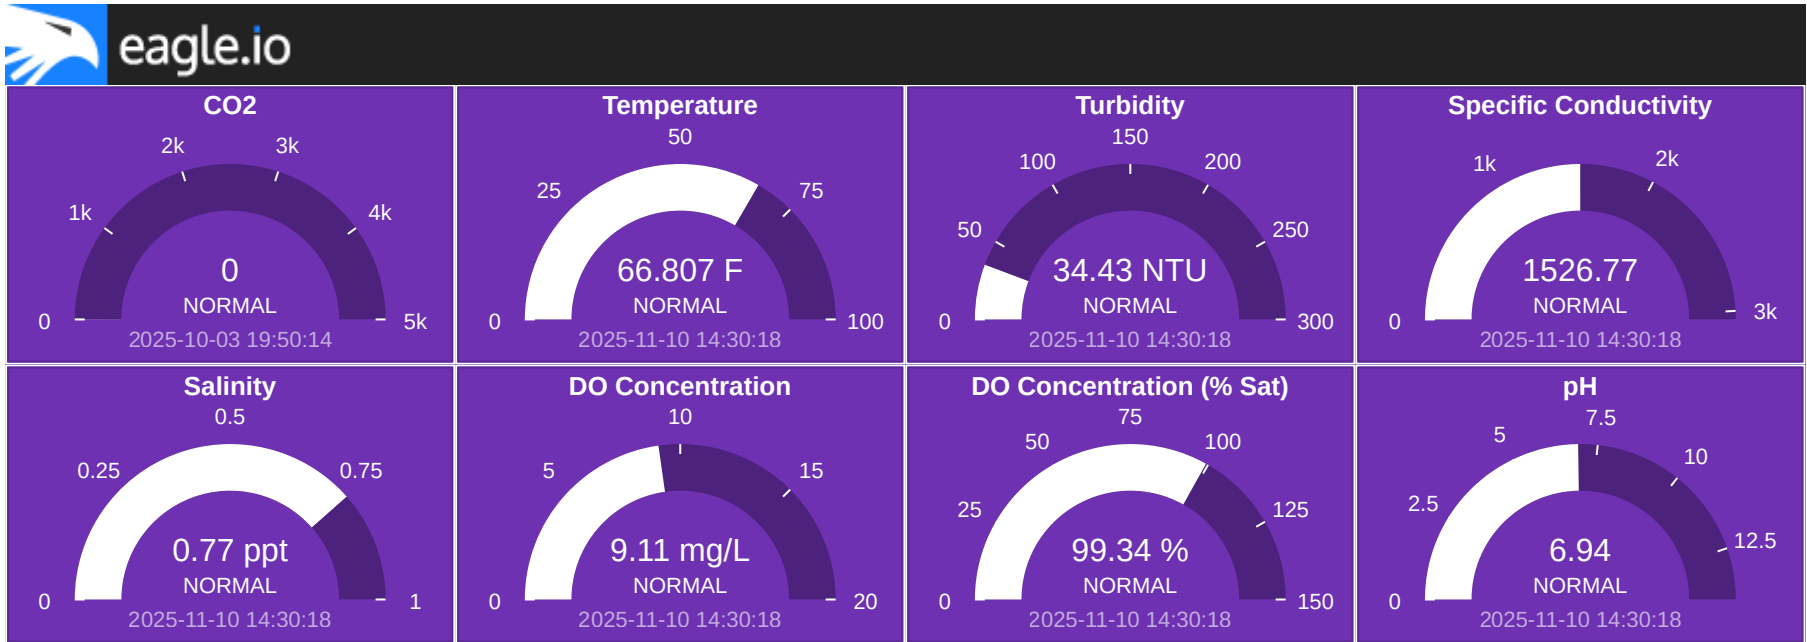
The figure displays eight water quality parameters in a 2x4 grid. Each parameter is represented by a semi-circular gauge with a needle, a current value, a status (NORMAL), and a timestamp (2025-11-11 00:16:04).

Parameter	Value	Status
CO2	675.16	NORMAL
Temperature	64.827 F	NORMAL
Turbidity	10.4 NTU	NORMAL
Specific Conductivity	1774.54	NORMAL
Salinity	0.9 ppt	NORMAL
DO Concentration	9.19 mg/L	NORMAL
DO Concentration (% Sat)	98.07 %	NORMAL
pH	6.78	NORMAL

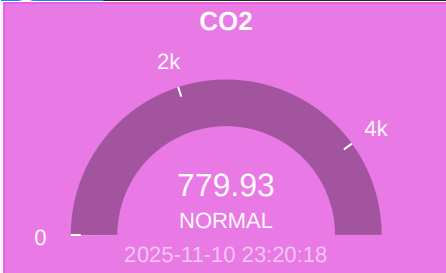
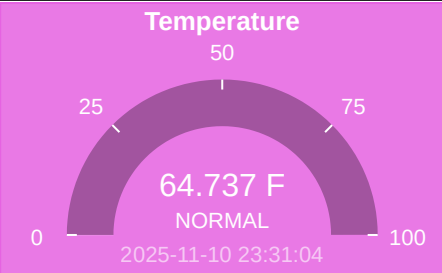
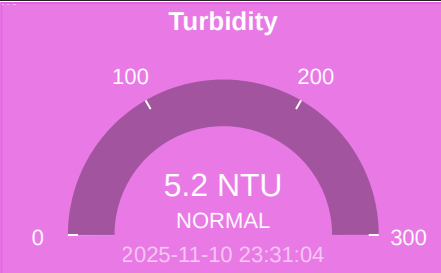
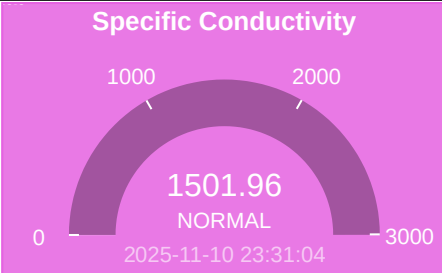
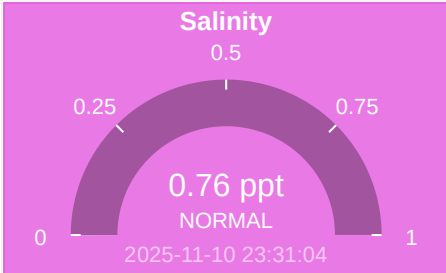
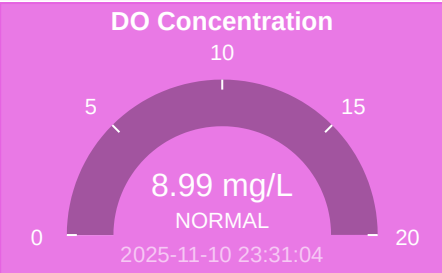
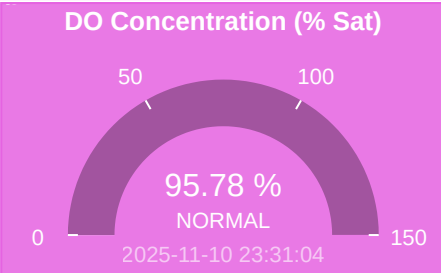
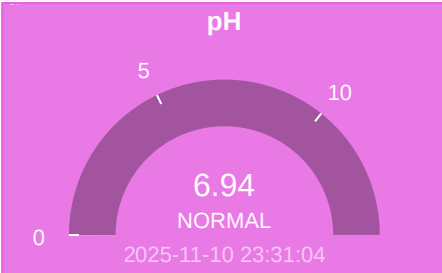
CO2

1293.69
NORMAL
2025-11-11 23:50:38

Temperature

63.095 F
NORMAL
2025-11-11 00:00:24

Turbidity

40.48 NTU
NORMAL
2025-11-11 00:00:24

Specific Conductivity

1697.41
NORMAL
2025-11-11 00:00:24

Salinity

0.86 ppt
NORMAL
2025-11-11 00:00:24

DO Concentration

8.48 mg/L
NORMAL
2025-11-11 00:00:24

DO Concentration (% Sat)

88.71 %
NORMAL
2025-11-11 00:00:24

pH

6.49
NORMAL
2025-11-11 00:00:24
