## Blind Buoy Weather Station Data

Maurepas Buoy Water Quality Data

Tickfaw Buoy Water Quality Data

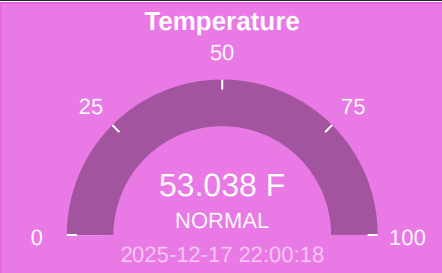
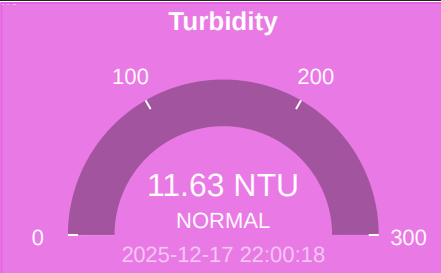
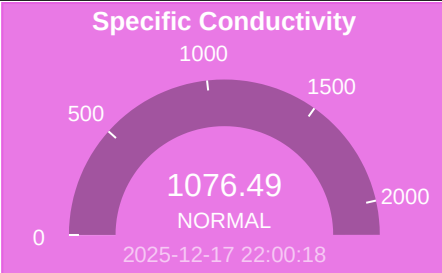
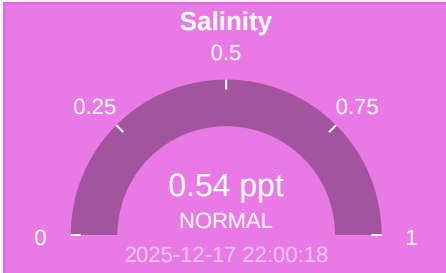
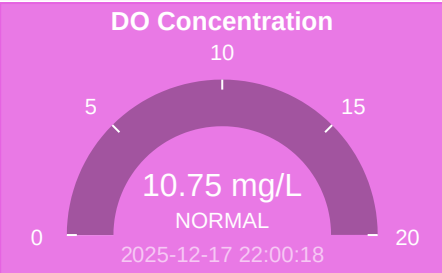
The figure displays eight water quality parameters in a 2x4 grid. Each parameter is represented by a semi-circular gauge with a scale, a needle, a numerical value, a status label (NORMAL), and a timestamp.

Parameter	Value	Status	Timestamp
CO2	564.37	NORMAL	2025-11-12 07:20:38
Temperature	51.931 F	NORMAL	2025-12-17 22:45:20
Turbidity	43.2 NTU	NORMAL	2025-12-17 22:45:20
Specific Conductivity	696.58	NORMAL	2025-12-17 22:45:20
Salinity	0.34 ppt	NORMAL	2025-12-17 22:45:20
DO Concentration	9.66 mg/L	NORMAL	2025-12-17 22:45:20
DO Concentration (% Sat)	87.96 %	NORMAL	2025-12-17 22:45:20
pH	6.77	NORMAL	2025-12-17 22:45:20
