## Blind Buoy Weather Station Data

Maurepas Buoy Water Quality Data

Tickfaw Buoy Water Quality Data

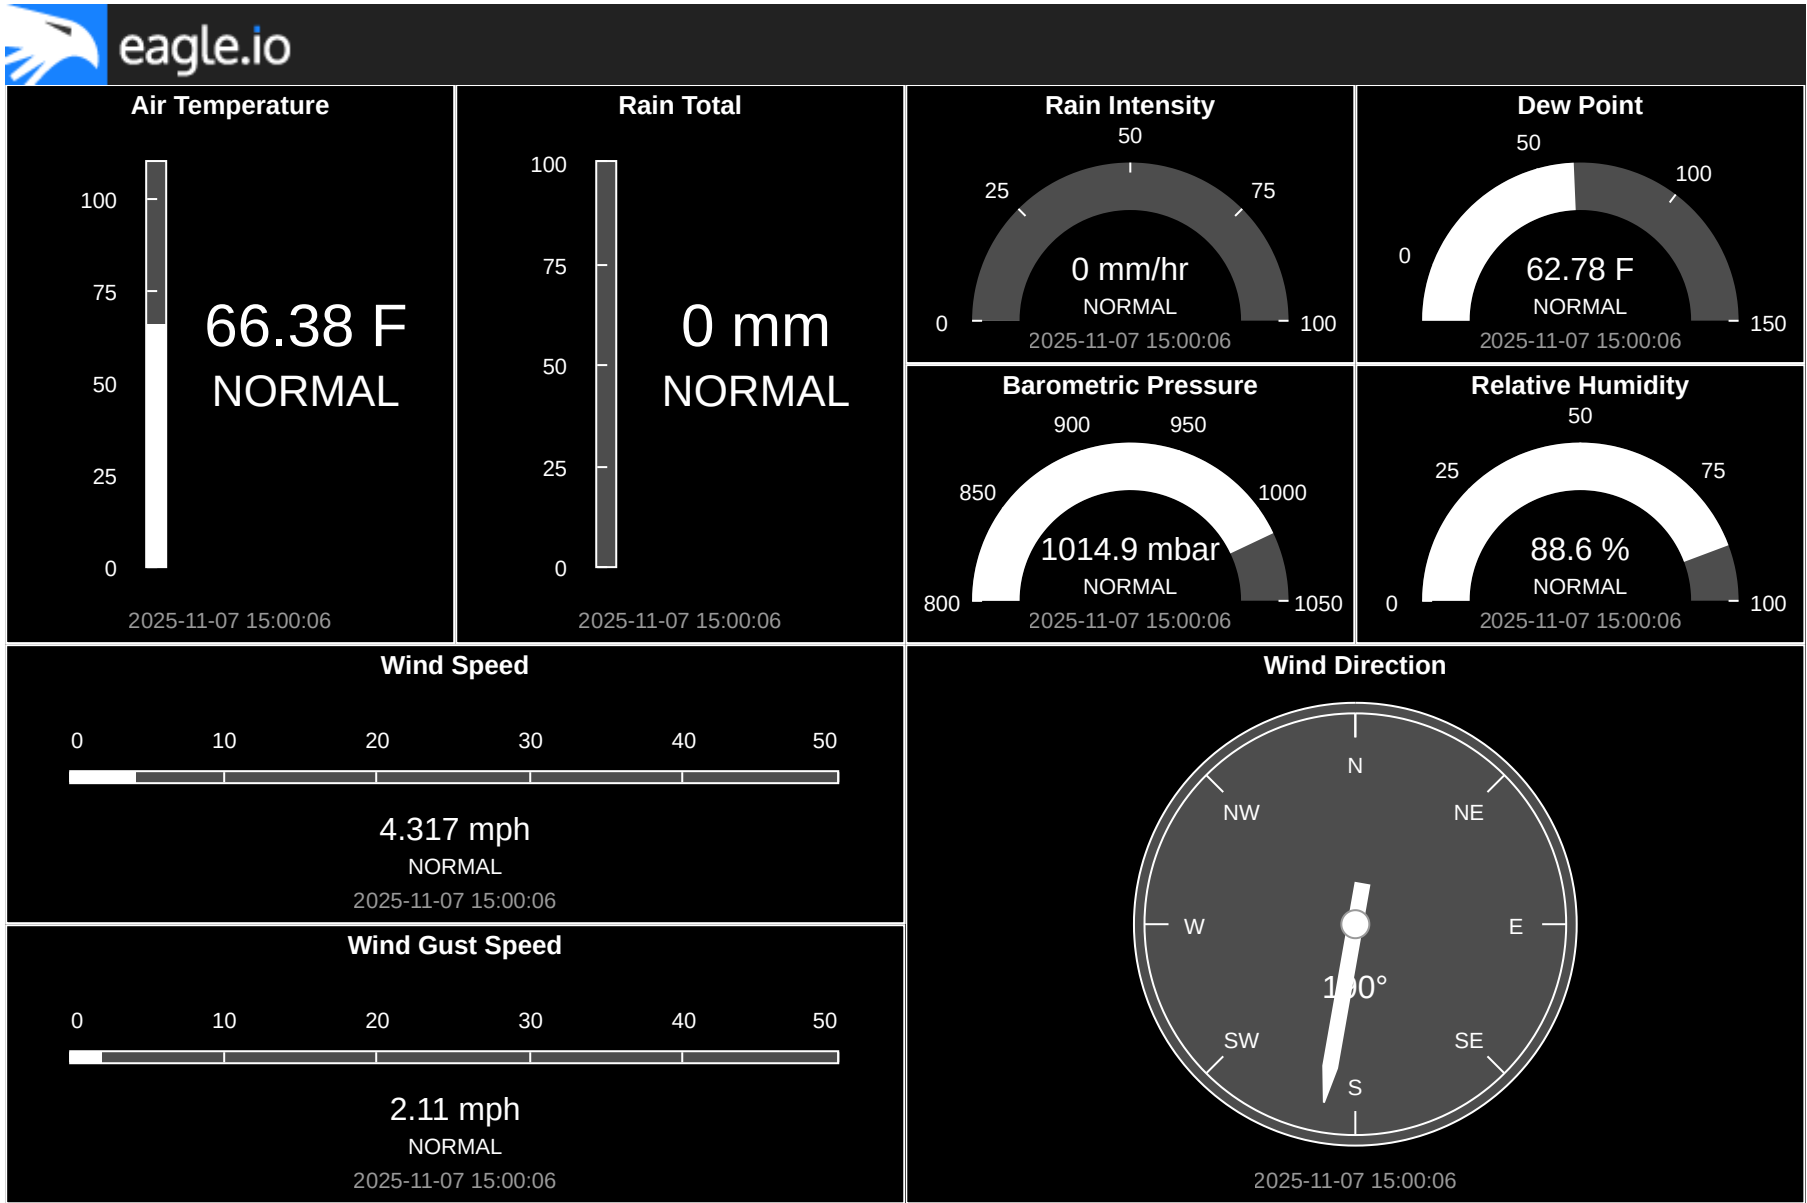
Wind Rose Chart: Historic Wind Speed and Direction

Historic wind speed and direction for the date range listed below. The frequency of winds over a time period is plotted by wind direction, with color bands showing wind speed ranges. Spoke length shows wind direction frequency.

[2025-10-07 16:25:25 - 2025-11-07 16:25:25]

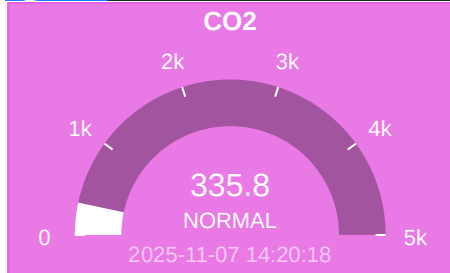
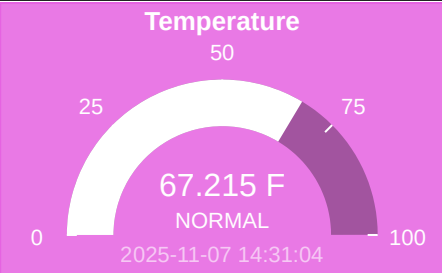
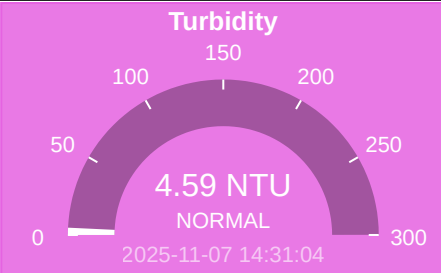
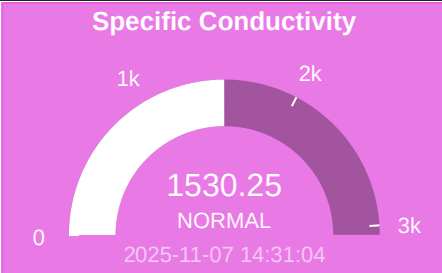
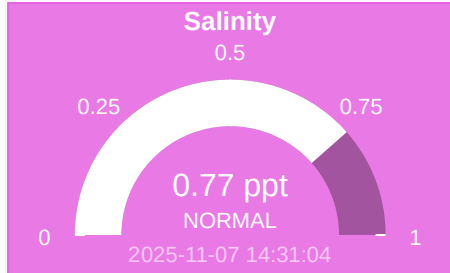
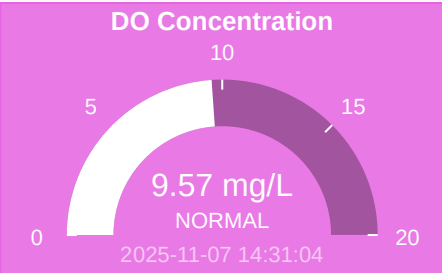
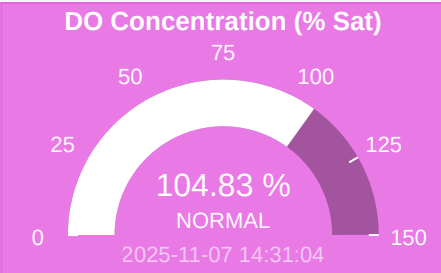
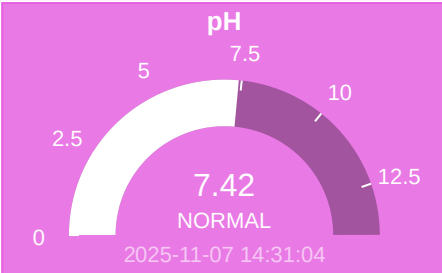
The figure displays eight water quality parameters in a 2x4 grid. Each parameter is represented by a semi-circular gauge with a needle, a numerical value, a status label (NORMAL), and a timestamp.

Parameter	Value	Status	Timestamp
CO2	213.97	NORMAL	2025-11-07 14:50:38
Temperature	67.667 F	NORMAL	2025-11-07 15:00:24
Turbidity	5.73 NTU	NORMAL	2025-11-07 15:00:24
Specific Conductivity	1245.54	NORMAL	2025-11-07 15:00:24
Salinity	0.62 ppt	NORMAL	2025-11-07 15:00:24
DO Concentration	10.27 mg/L	NORMAL	2025-11-07 15:00:24
DO Concentration (% Sat)	112.97 %	NORMAL	2025-11-07 15:00:24
pH	7.68	NORMAL	2025-11-07 15:00:24
