Blind Buoy Weather Station Data

Maurepas Buoy Water Quality Data

Tickfaw Buoy Water Quality Data

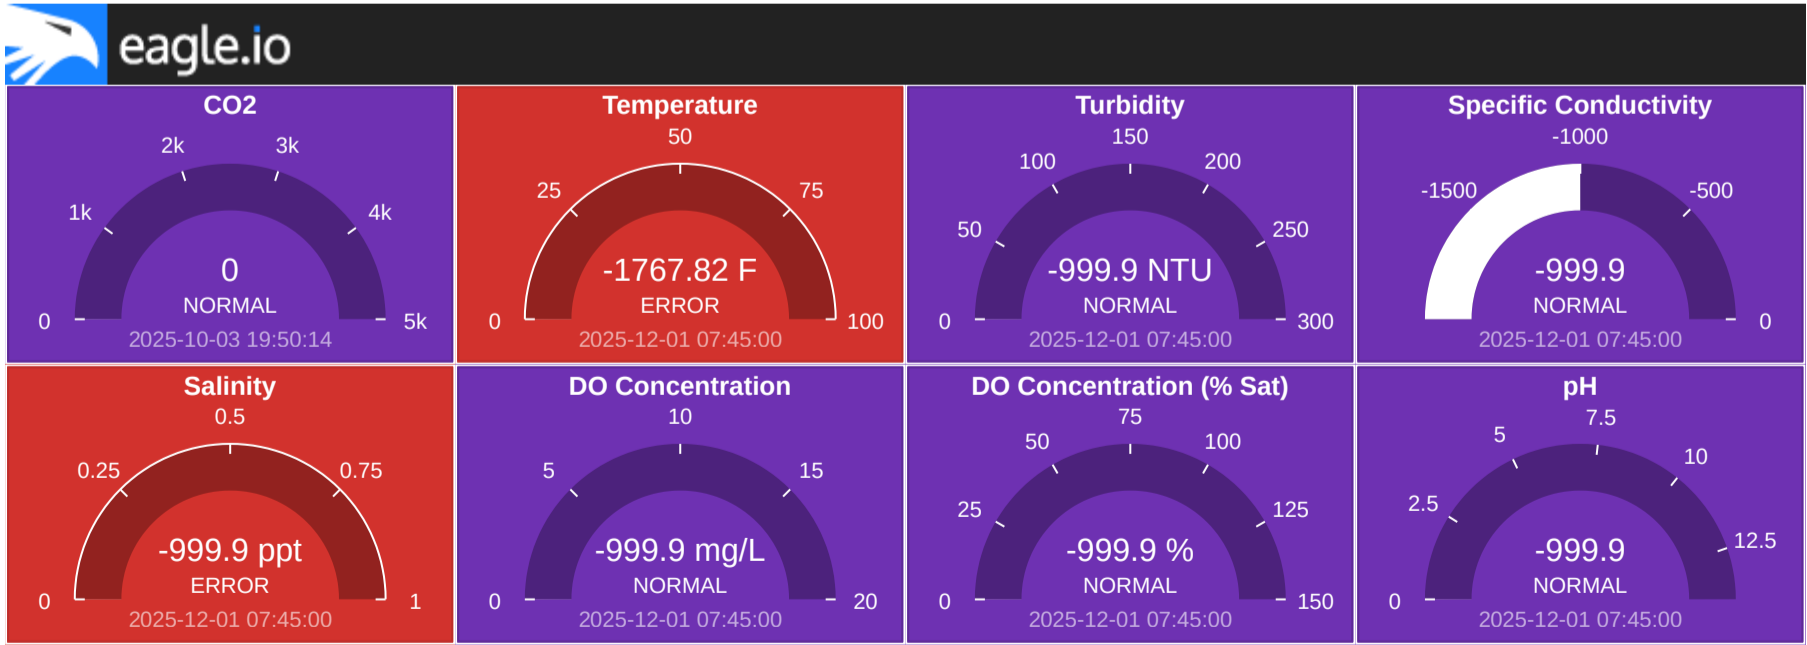
The figure displays eight water quality parameters, each represented by a gauge chart. The gauges are arranged in a 2x4 grid. Each gauge has a semi-circular scale with tick marks and a needle pointing to the current value. The parameters and their values are as follows:

Parameter	Value	Unit	Status	Timestamp
CO2	116.73		NORMAL	2025-11-12 06:50:16
Temperature	55.17	F	NORMAL	2025-12-07 01:46:04
Turbidity	10.45	NTU	NORMAL	2025-12-07 01:46:04
Specific Conductivity	1725.72		NORMAL	2025-12-07 01:46:04
Salinity	0.88	ppt	NORMAL	2025-12-07 01:46:04
DO Concentration	9.78	mg/L	NORMAL	2025-12-07 01:46:04
DO Concentration (% Sat)	93.07	%	NORMAL	2025-12-07 01:46:04
pH	6.69		NORMAL	2025-12-07 01:46:04

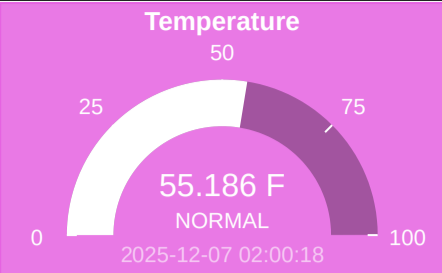
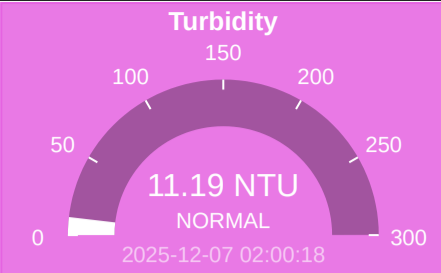
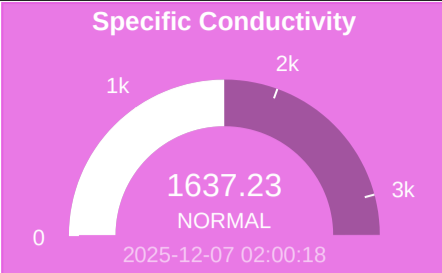
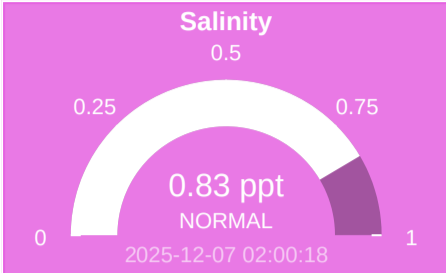
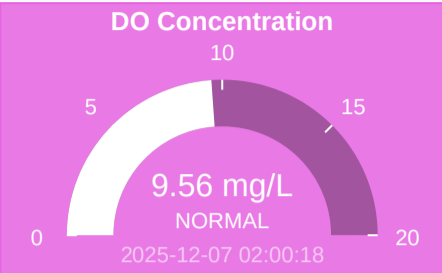
The figure displays eight water quality parameters in a 2x4 grid, each represented by a gauge chart. The gauges show the current value, a status (NORMAL), and a timestamp.

Parameter	Current Value	Status	Timestamp
CO2	564.37	NORMAL	2025-11-12 07:20:38
Temperature	54.849 F	NORMAL	2025-12-07 01:45:20
Turbidity	13.33 NTU	NORMAL	2025-12-07 01:45:20
Specific Conductivity	1746.99	NORMAL	2025-12-07 01:45:20
Salinity	0.89 ppt	NORMAL	2025-12-07 01:45:20
DO Concentration	9.92 mg/L	NORMAL	2025-12-07 01:45:20
DO Concentration (% Sat)	94.06 %	NORMAL	2025-12-07 01:45:20
pH	6.71	NORMAL	2025-12-07 01:45:20
