Blind Buoy Weather Station Data

Maurepas Buoy Water Quality Data

Tickfaw Buoy Water Quality Data

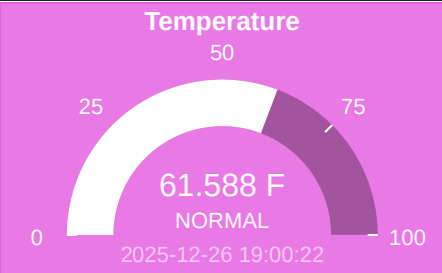
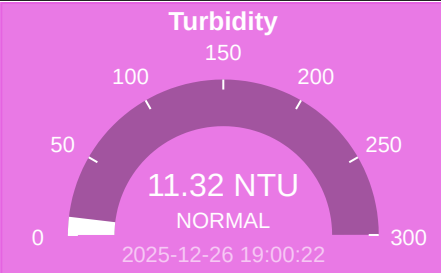
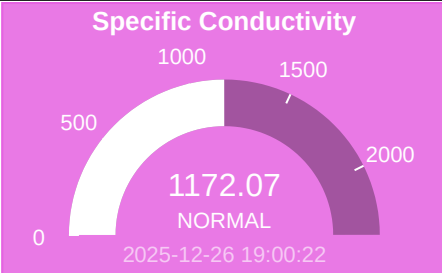
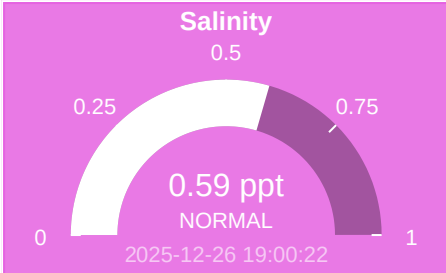
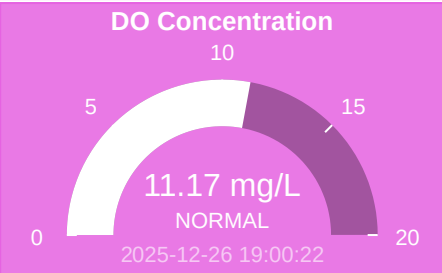
The figure displays eight water quality parameters in a 2x4 grid, each represented by a semi-circular gauge. The gauges show the current value, a status (NORMAL), and a timestamp.

Parameter	Value	Status	Timestamp
CO2	564.37	NORMAL	2025-11-12 07:20:38
Temperature	63.214 F	NORMAL	2025-12-26 18:45:20
Turbidity	11.82 NTU	NORMAL	2025-12-26 18:45:20
Specific Conductivity	792.58	NORMAL	2025-12-26 18:45:20
Salinity	0.39 ppt	NORMAL	2025-12-26 18:45:20
DO Concentration	10.62 mg/L	NORMAL	2025-12-26 18:45:20
DO Concentration (% Sat)	110.9 %	NORMAL	2025-12-26 18:45:20
pH	7.02	NORMAL	2025-12-26 18:45:20
