## Blind Buoy Weather Station Data

Maurepas Buoy Water Quality Data

Tickfaw Buoy Water Quality Data

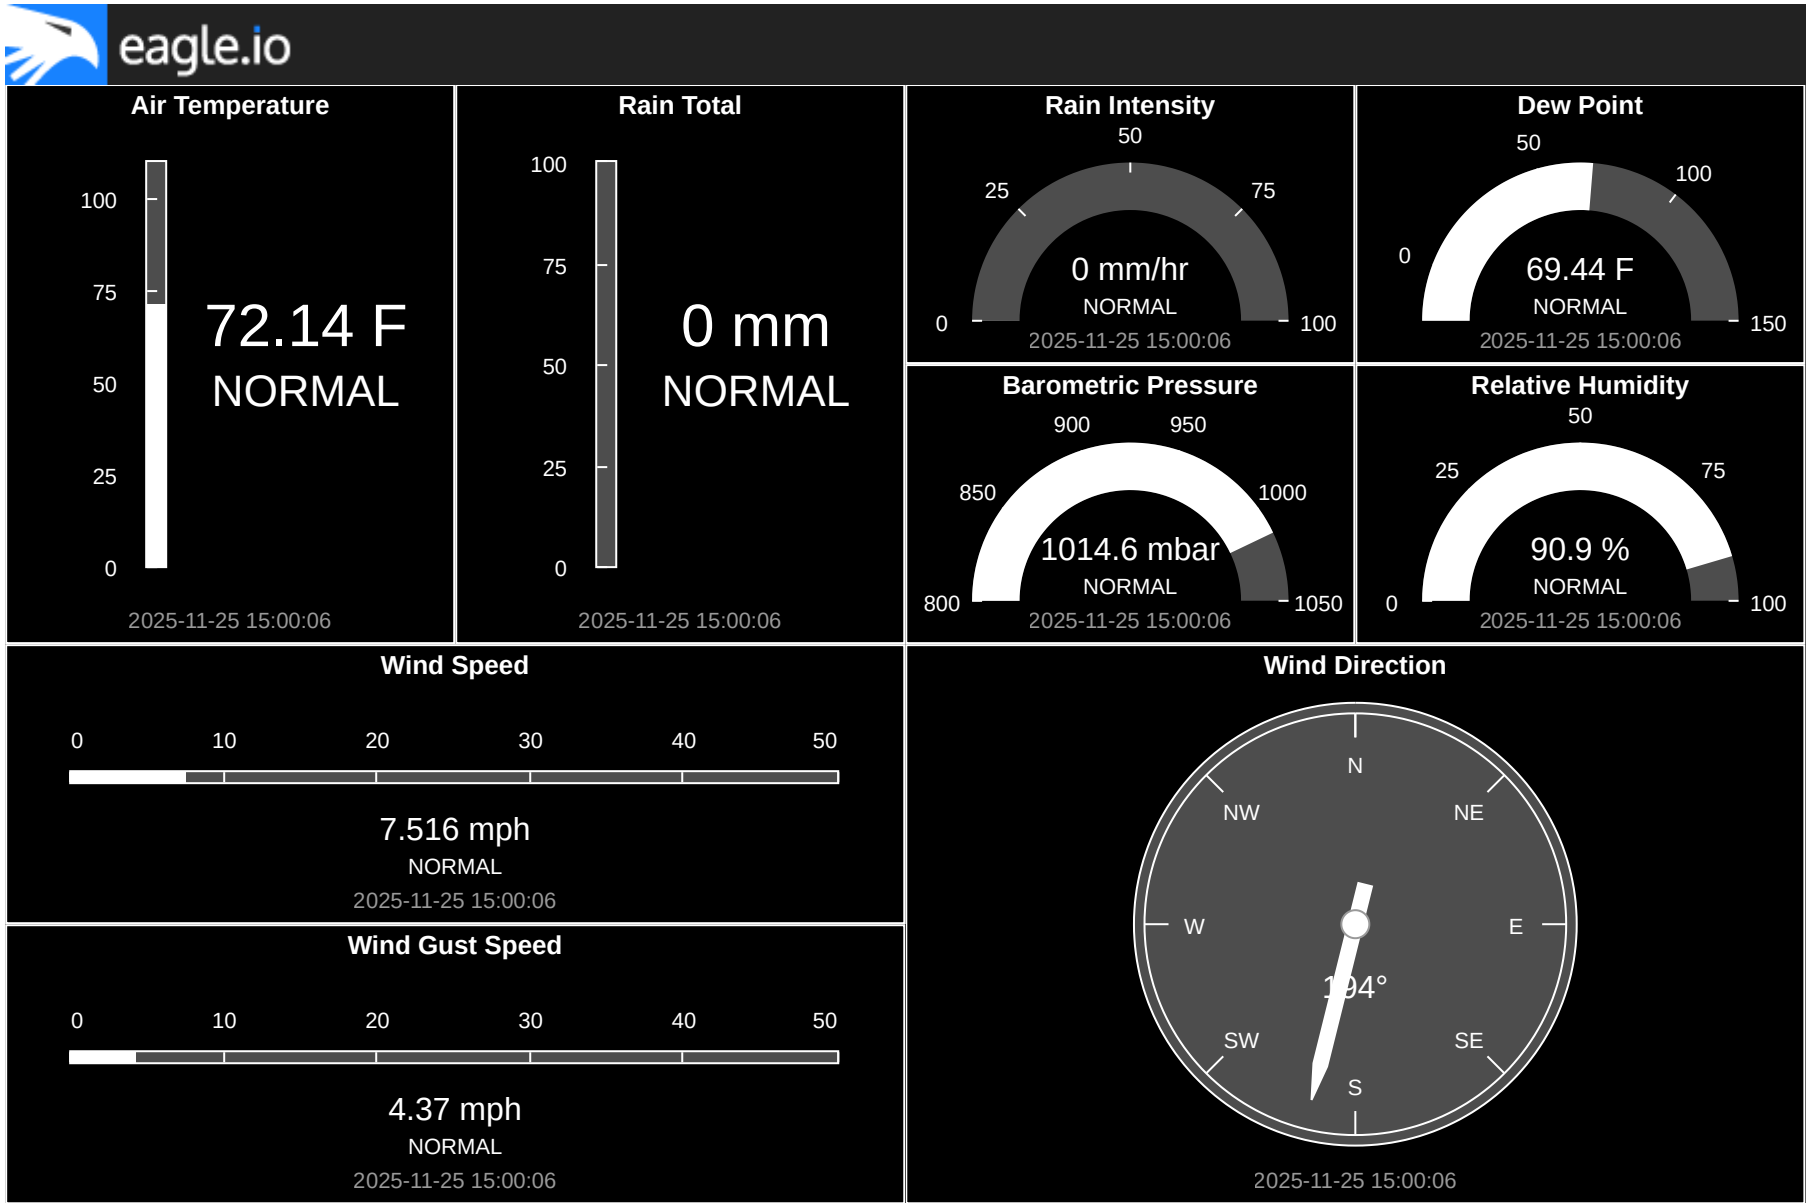
Wind Rose Chart: Historic Wind Speed and Direction

Historic wind speed and direction for the date range listed below. The frequency of winds over a time period is plotted by wind direction, with color bands showing wind speed ranges. Spoke length shows wind direction frequency.

[2025-10-25 16:26:15 - 2025-11-25 16:26:15]

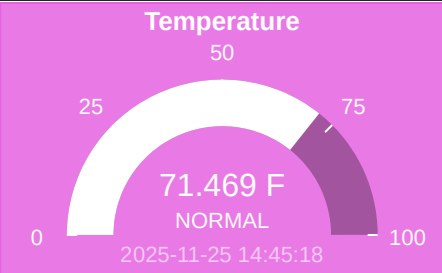
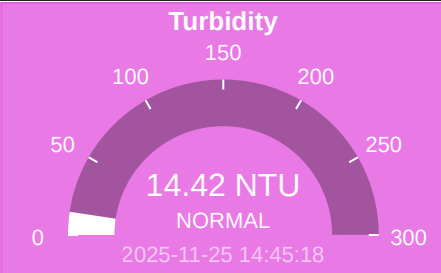
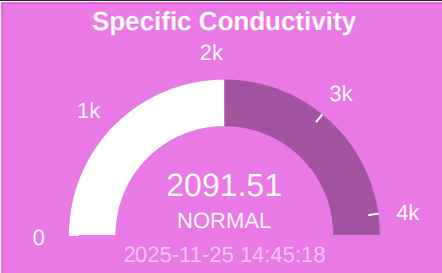
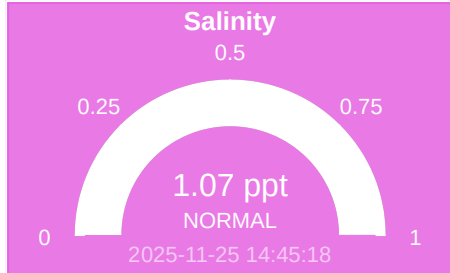
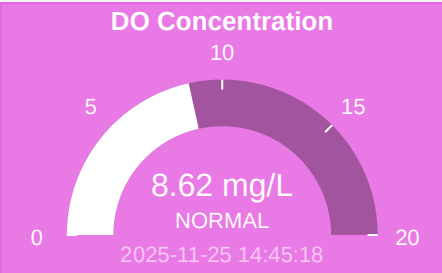
The figure displays eight water quality parameters in a 2x4 grid. Each parameter is represented by a semi-circular gauge with a title, a scale, a current value, a status (NORMAL), and a timestamp.

Parameter	Value	Status	Timestamp
CO2	564.37	NORMAL	2025-11-12 07:20:38
Temperature	69.627 F	NORMAL	2025-11-25 15:00:24
Turbidity	11.36 NTU	NORMAL	2025-11-25 15:00:24
Specific Conductivity	1288.71	NORMAL	2025-11-25 15:00:24
Salinity	0.64 ppt	NORMAL	2025-11-25 15:00:24
DO Concentration	8.39 mg/L	NORMAL	2025-11-25 15:00:24
DO Concentration (% Sat)	94.31 %	NORMAL	2025-11-25 15:00:24
pH	6.95	NORMAL	2025-11-25 15:00:24
