## Blind Buoy Weather Station Data

Maurepas Buoy Water Quality Data

Tickfaw Buoy Water Quality Data

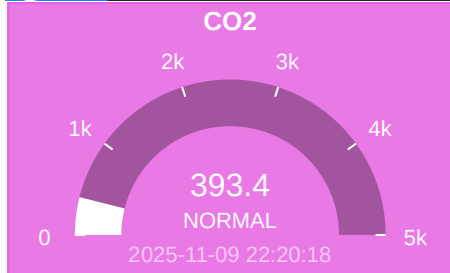
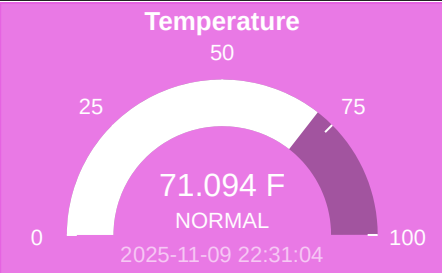
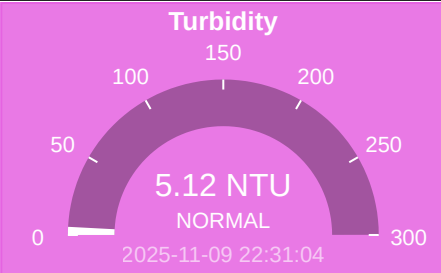
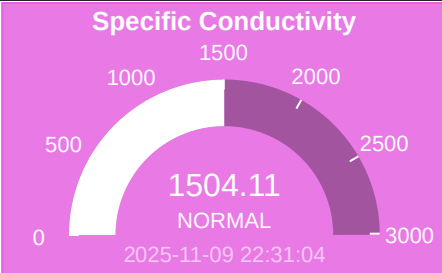
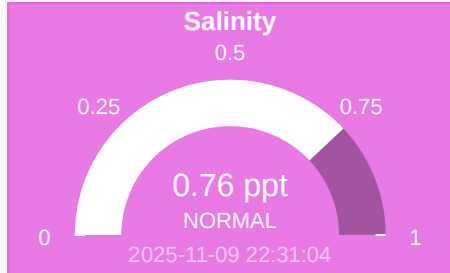
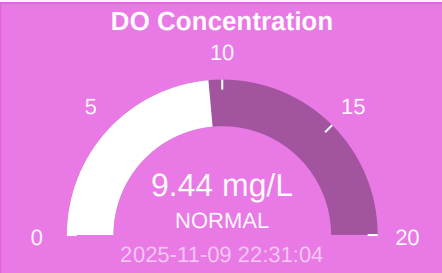
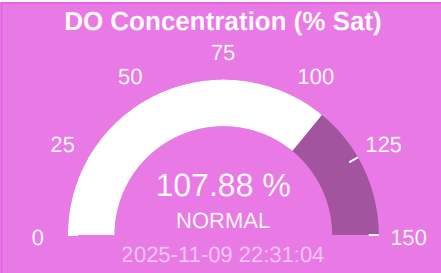
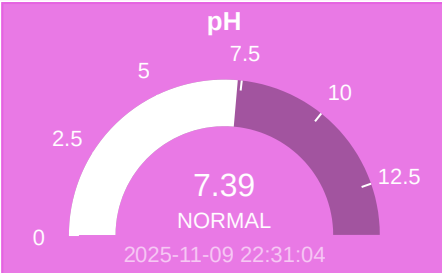
The figure displays eight water quality parameters, each represented by a semi-circular gauge. The gauges are arranged in a 2x4 grid. Each gauge shows a current value, a status (NORMAL), and a timestamp.

Parameter	Value	Status	Timestamp
CO2	2063.57	NORMAL	2025-11-09 22:50:38
Temperature	68.983 F	NORMAL	2025-11-09 23:00:24
Turbidity	6.74 NTU	NORMAL	2025-11-09 23:00:24
Specific Conductivity	1200.07	NORMAL	2025-11-09 23:00:24
Salinity	0.6 ppt	NORMAL	2025-11-09 23:00:24
DO Concentration	8.15 mg/L	NORMAL	2025-11-09 23:00:24
DO Concentration (% Sat)	90.9 %	NORMAL	2025-11-09 23:00:24
pH	6.96	NORMAL	2025-11-09 23:00:24
