### Blind Buoy Weather Station Data

Maurepas Buoy Water Quality Data

Tickfaw Buoy Water Quality Data

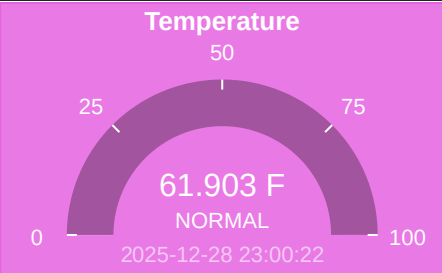
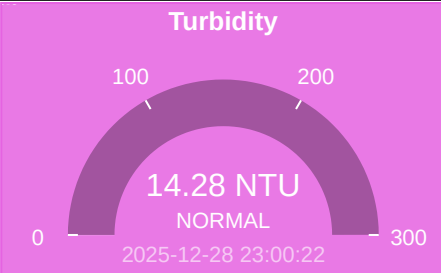
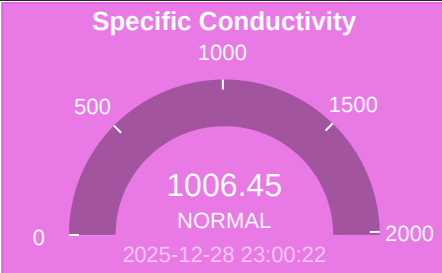
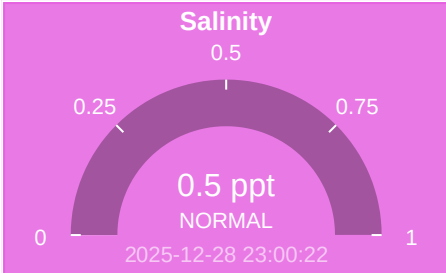
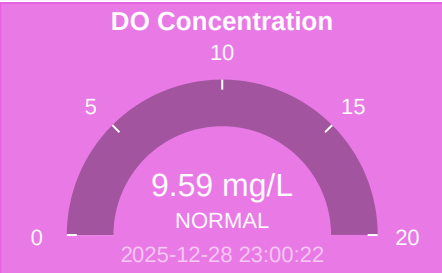
The figure displays eight water quality parameters in a 2x4 grid. Each parameter is represented by a semi-circular gauge with a title, a scale, a current value, a status (NORMAL), and a timestamp.

Parameter	Value	Status	Timestamp
CO2	564.37	NORMAL	2025-11-12 07:20:38
Temperature	63.964 F	NORMAL	2025-12-28 22:45:20
Turbidity	13.95 NTU	NORMAL	2025-12-28 22:45:20
Specific Conductivity	444.48	NORMAL	2025-12-28 22:45:20
Salinity	0.21 ppt	NORMAL	2025-12-28 22:45:20
DO Concentration	8.51 mg/L	NORMAL	2025-12-28 22:45:20
DO Concentration (% Sat)	89.52 %	NORMAL	2025-12-28 22:45:20
pH	6.89	NORMAL	2025-12-28 22:45:20
