### Blind Buoy Weather Station Data

Maurepas Buoy Water Quality Data

Tickfaw Buoy Water Quality Data

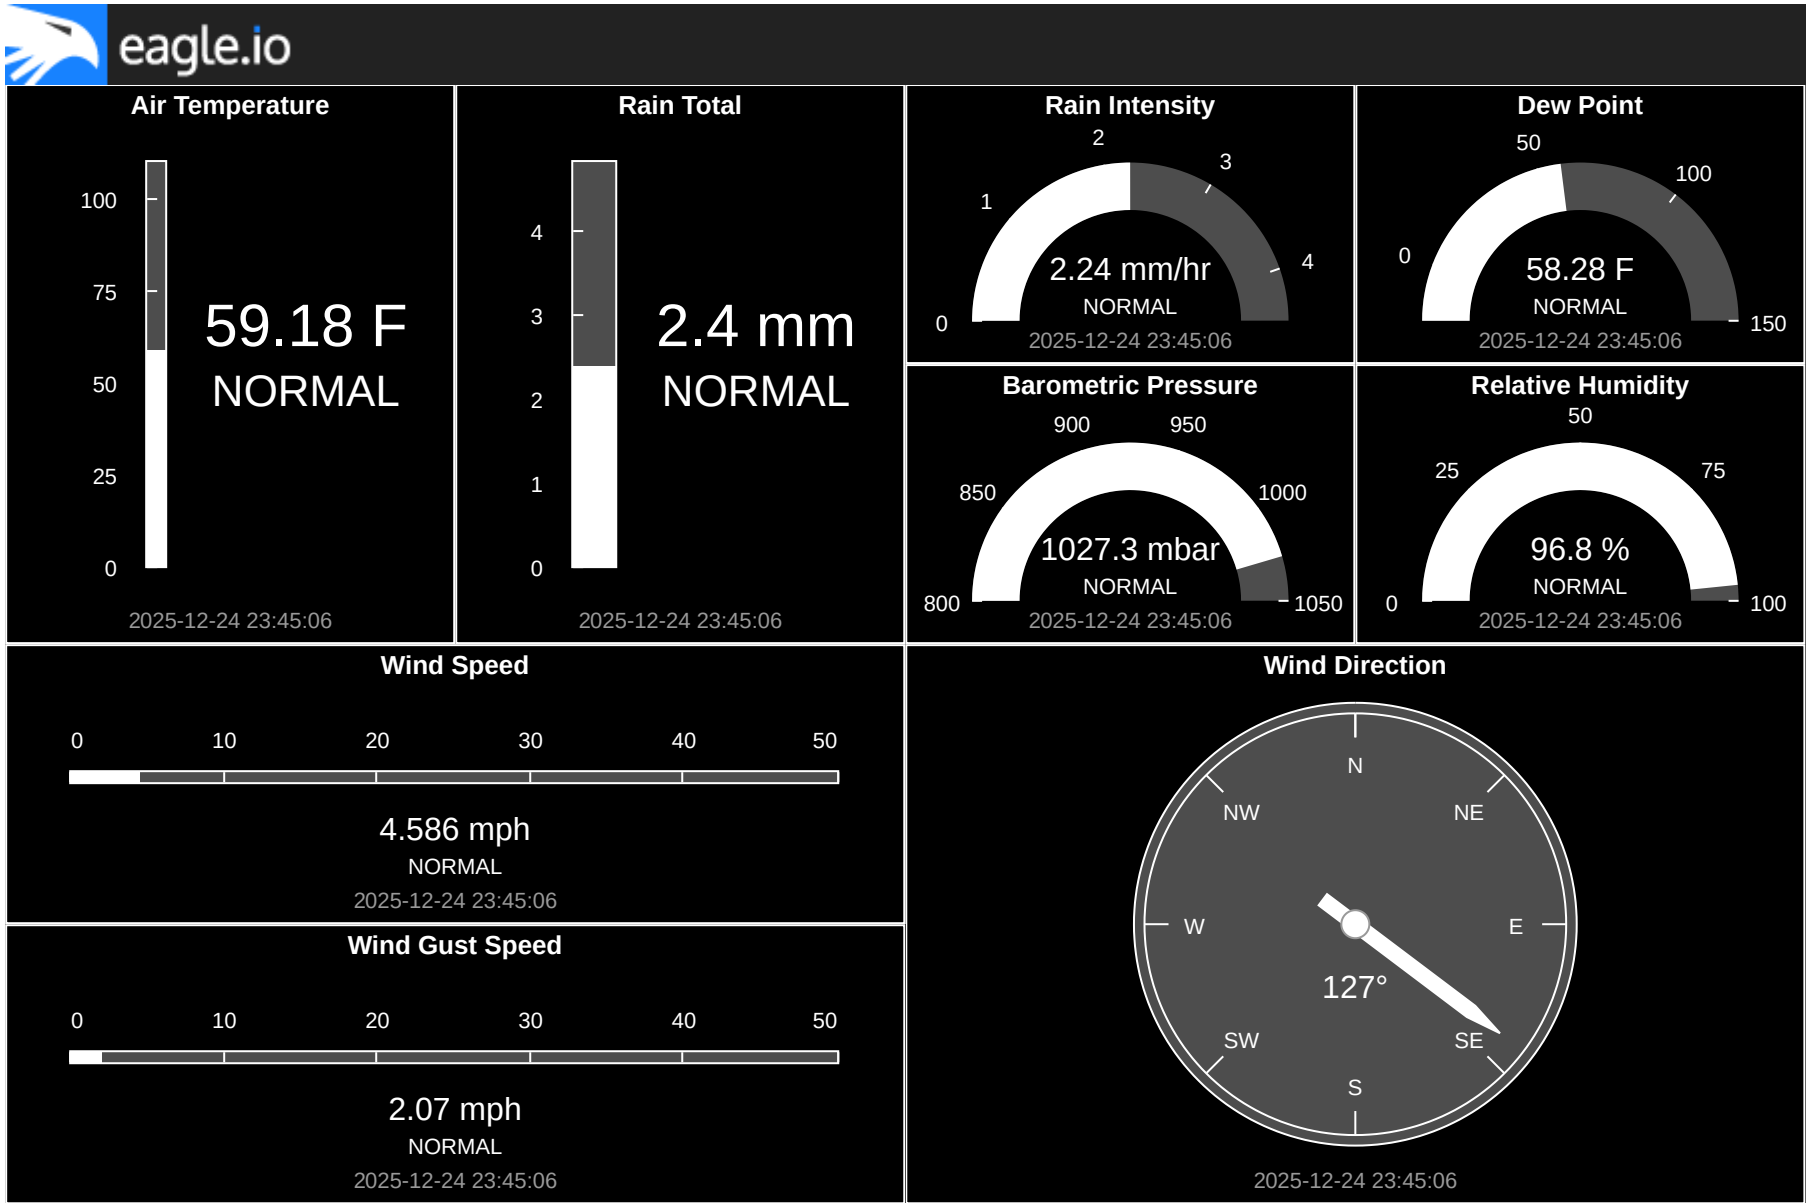
Wind Rose Chart: Historic Wind Speed and Direction

Historic wind speed and direction for the date range listed below. The frequency of winds over a time period is plotted by wind direction, with color bands showing wind speed ranges. Spoke length shows wind direction frequency.

[2025-11-25 01:24:45 - 2025-12-25 01:24:45]

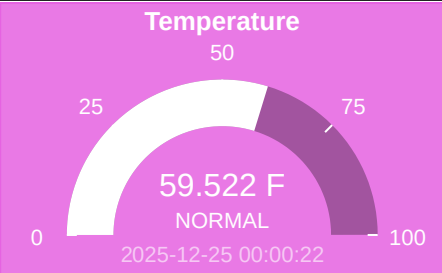
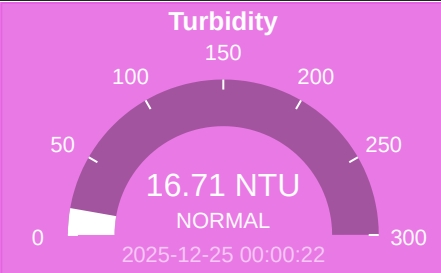
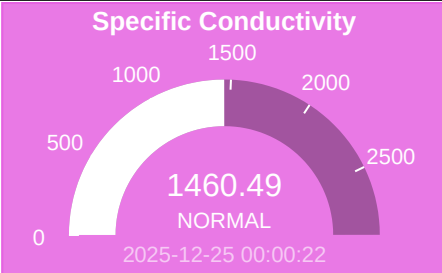
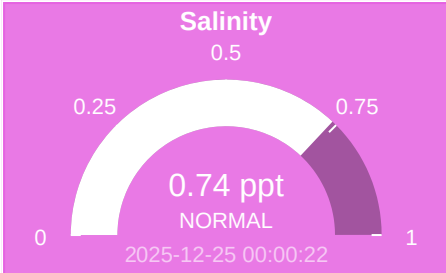
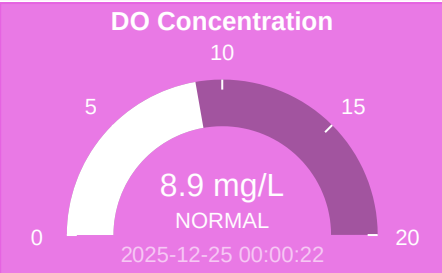
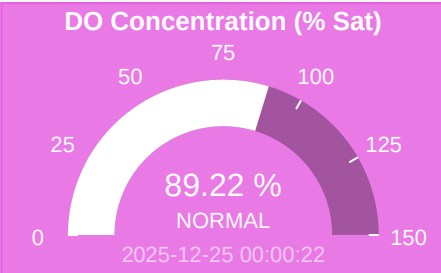
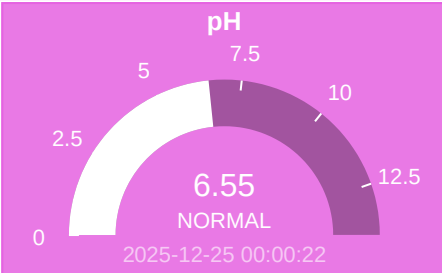
The figure displays eight water quality parameters in a 2x4 grid, each represented by a gauge chart. The parameters and their values are:

- CO2:** 564.37, NORMAL, 2025-11-12 07:20:38
- Temperature:** 60.886 F, NORMAL, 2025-12-24 23:45:20
- Turbidity:** 20.61 NTU, NORMAL, 2025-12-24 23:45:20
- Specific Conductivity:** 857.35, NORMAL, 2025-12-24 23:45:20
- Salinity:** 0.42 ppt, NORMAL, 2025-12-24 23:45:20
- DO Concentration:** 10.51 mg/L, NORMAL, 2025-12-24 23:45:20
- DO Concentration (% Sat):** 106.88 %, NORMAL, 2025-12-24 23:45:20
- pH:** 6.73, NORMAL, 2025-12-24 23:45:20
