## Blind Buoy Weather Station Data

Maurepas Buoy Water Quality Data

Tickfaw Buoy Water Quality Data

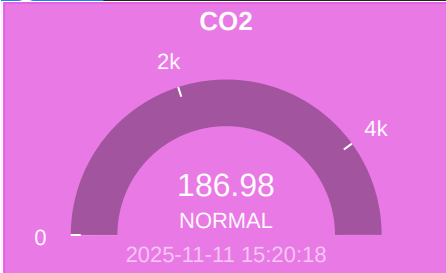
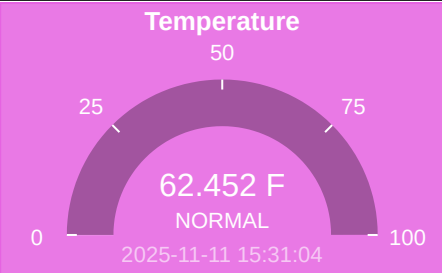
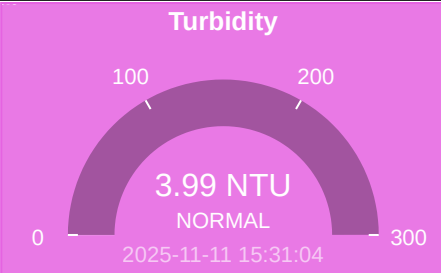
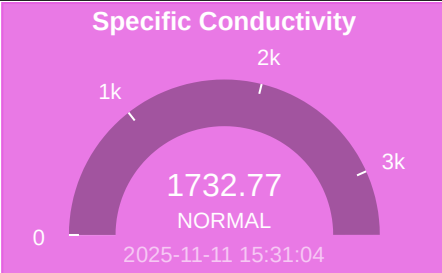
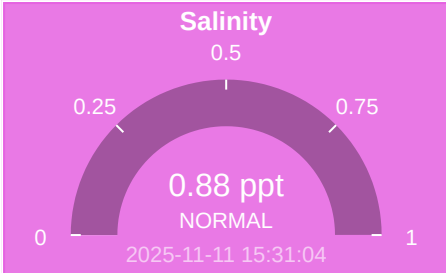
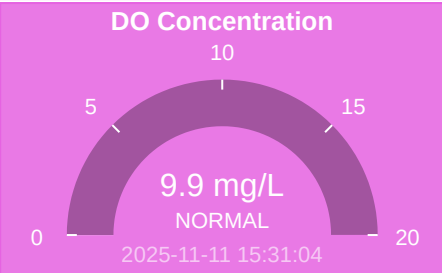
The figure displays eight water quality parameters in a 2x4 grid. Each parameter is represented by a semi-circular gauge with a needle, a numerical value, a status label, and a timestamp.

Parameter	Value	Status	Timestamp
CO2	1087.31	NORMAL	2025-11-11 15:50:38
Temperature	61.124 F	NORMAL	2025-11-11 16:00:24
Turbidity	34.81 NTU	NORMAL	2025-11-11 16:00:24
Specific Conductivity	1455.83	NORMAL	2025-11-11 16:00:24
Salinity	0.74 ppt	NORMAL	2025-11-11 16:00:24
DO Concentration	9.11 mg/L	NORMAL	2025-11-11 16:00:24
DO Concentration (% Sat)	93.04 %	NORMAL	2025-11-11 16:00:24
pH	6.88	NORMAL	2025-11-11 16:00:24
