## BUOY DATA

This page contains the real time water quality readings from our four continuous monitoring buoys in Lake Maurepas: the Amite (blue), Blind (black), Maurepas (purple), and Tickfaw (pink) buoys. By providing real-time data, our aim is to enhance the community's understanding of Lake Maurepas' current status and to elevate their awareness regarding water quality and atmospheric conditions in the area. Click on the buoys in the interactive map below to learn more details about each one.

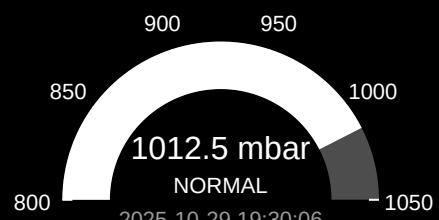
#### Barometric Pressure

1012.5 mbar
