BUOY DATA

Amite Buoy Water Quality Data

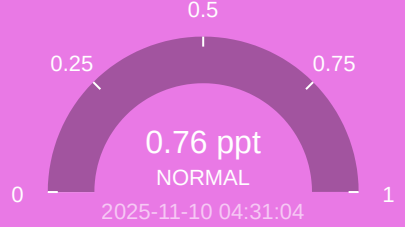
Salinity

2025-11-10 04:31:04

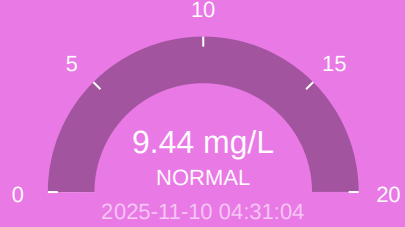
DO Concentration

2025-11-10 04:31:04
