Blind Buoy Weather Station Data

Maurepas Buoy Water Quality Data

Tickfaw Buoy Water Quality Data

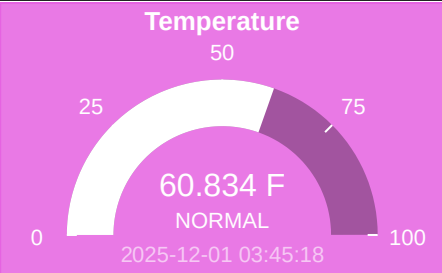
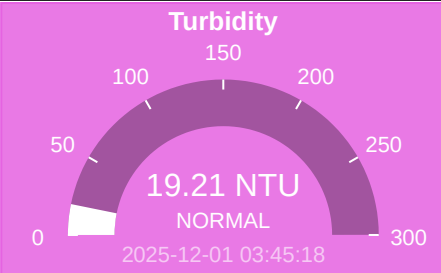
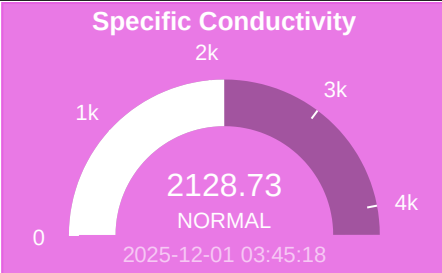
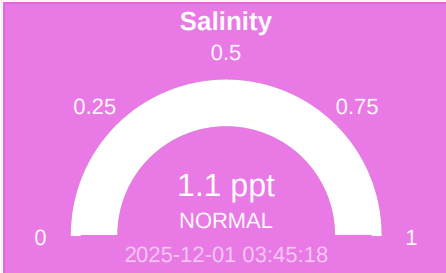
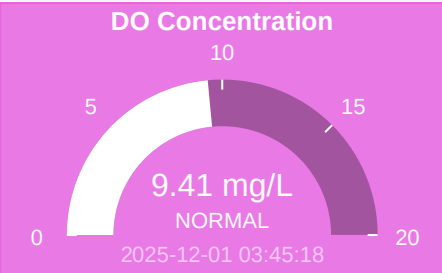
The figure displays eight water quality parameters, each represented by a semi-circular gauge. The gauges are arranged in a 2x4 grid. Each gauge shows a current value, a 'NORMAL' range, and a timestamp.

Parameter	Current Value	Normal Range	Timestamp
CO2	564.37	0 - 5k	2025-11-12 07:20:38
Temperature	60.033 F	25 - 100	2025-12-01 04:00:24
Turbidity	27.85 NTU	0 - 300	2025-12-01 04:00:24
Specific Conductivity	1664.99	0 - 3k	2025-12-01 04:00:24
Salinity	0.85 ppt	0 - 1	2025-12-01 04:00:24
DO Concentration	9.67 mg/L	0 - 20	2025-12-01 04:00:24
DO Concentration (% Sat)	97.53 %	0 - 150	2025-12-01 04:00:24
pH	6.66	0 - 12.5	2025-12-01 04:00:24
