Blind Buoy Weather Station Data

Maurepas Buoy Water Quality Data

Tickfaw Buoy Water Quality Data

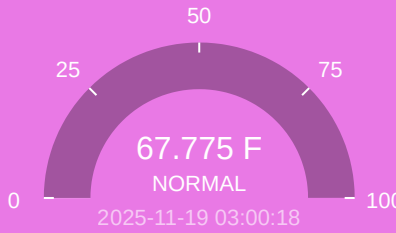
Temperature

2025-11-19 03:00:18

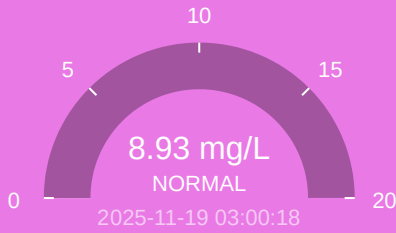
DO Concentration

2025-11-19 03:00:18
