## Blind Buoy Weather Station Data

Maurepas Buoy Water Quality Data

Tickfaw Buoy Water Quality Data

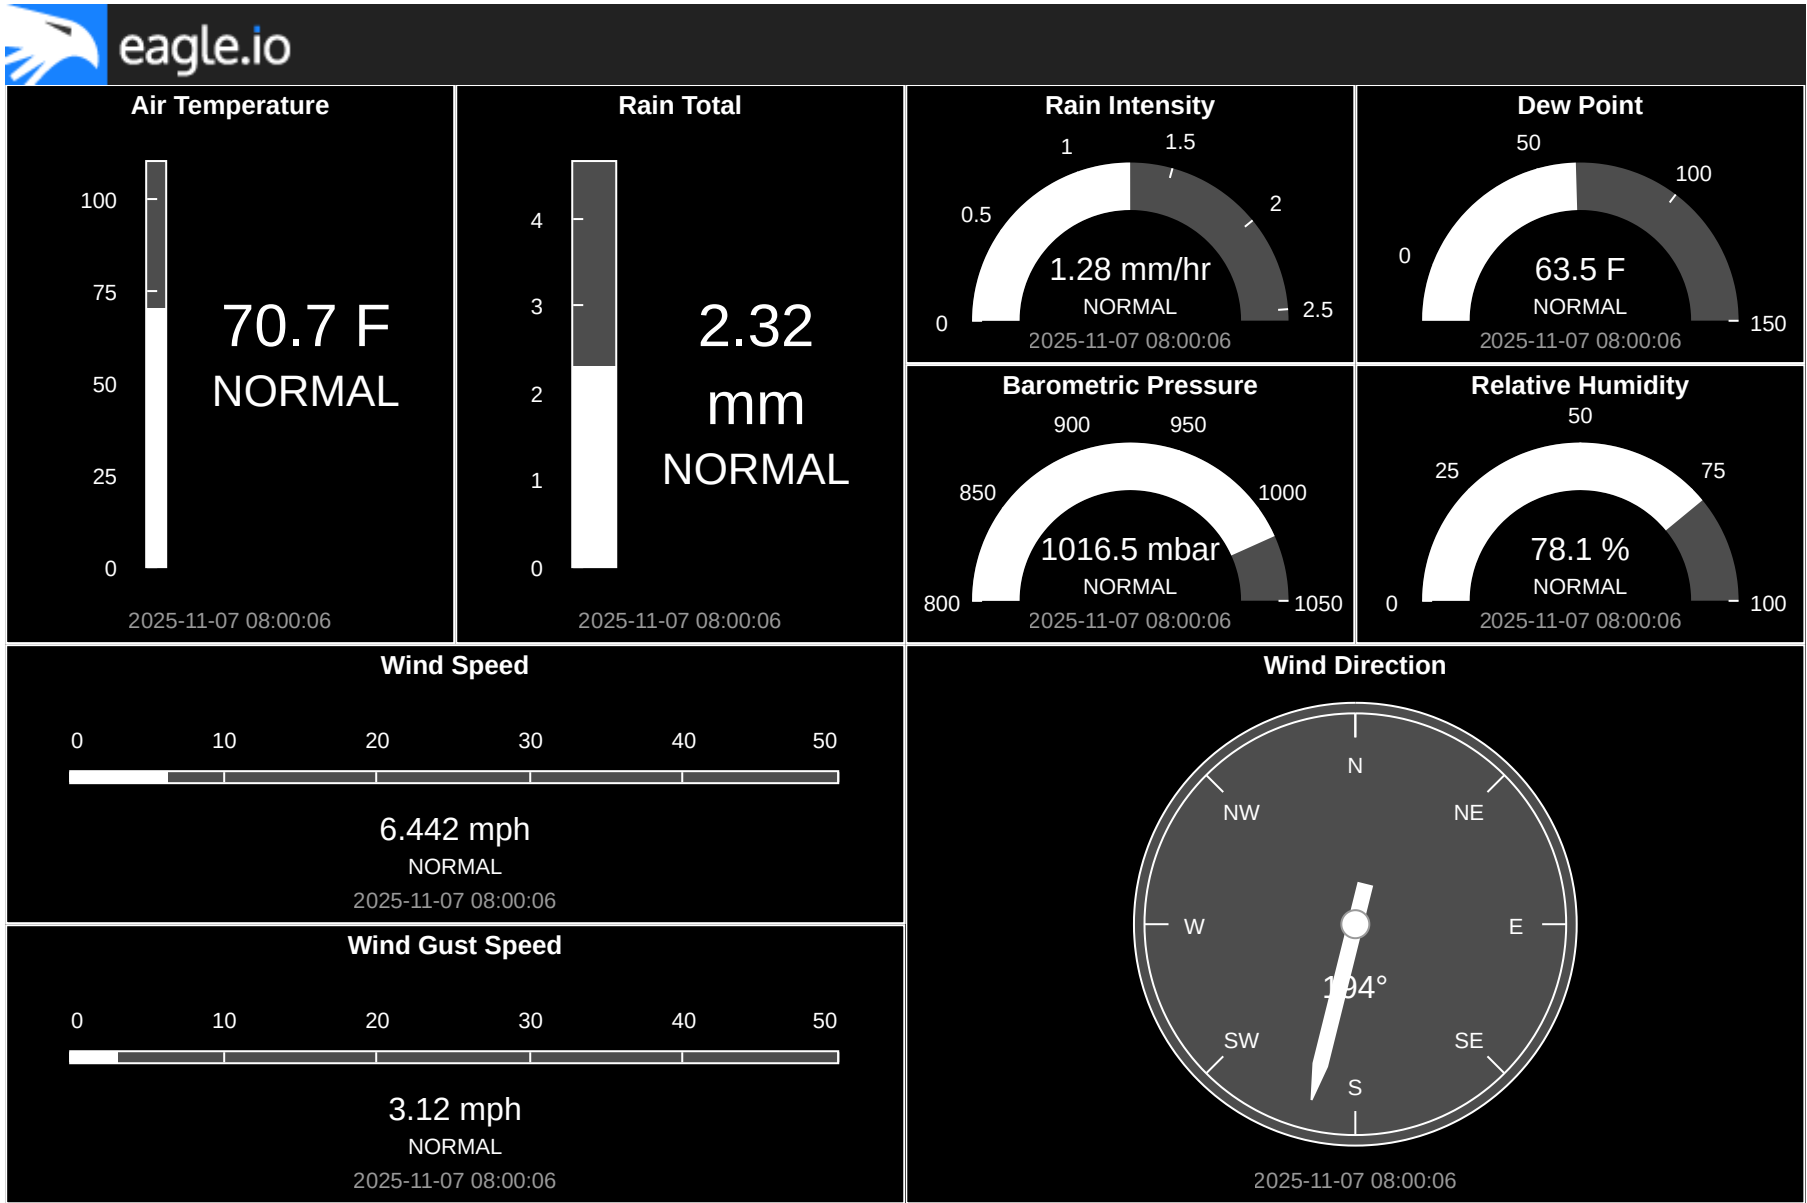
Wind Rose Chart: Historic Wind Speed and Direction

Historic wind speed and direction for the date range listed below. The frequency of winds over a time period is plotted by wind direction, with color bands showing wind speed ranges. Spoke length shows wind direction frequency.

[2025-10-07 09:14:19 - 2025-11-07 09:14:19]

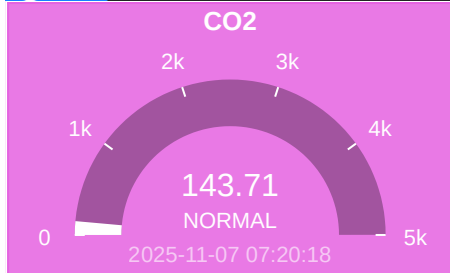
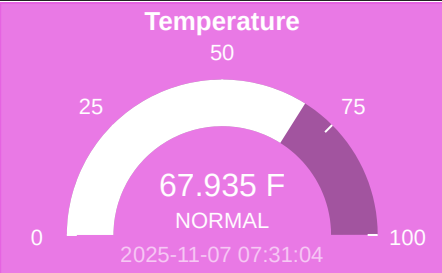
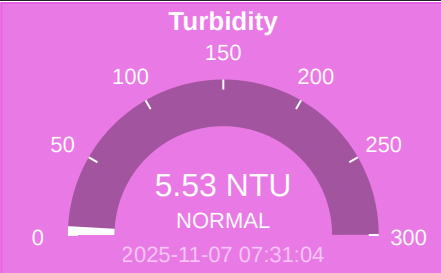
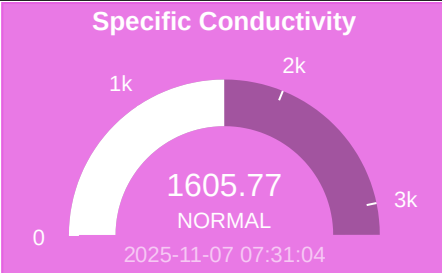
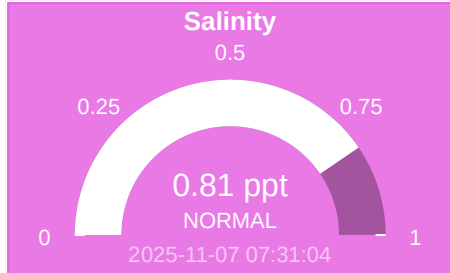
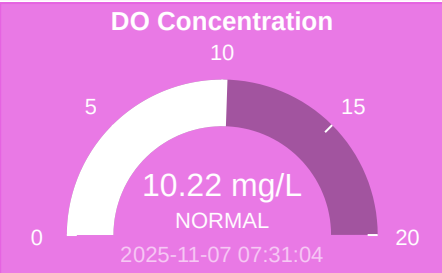
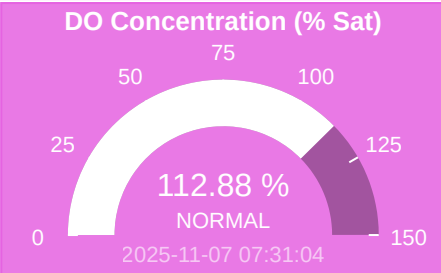
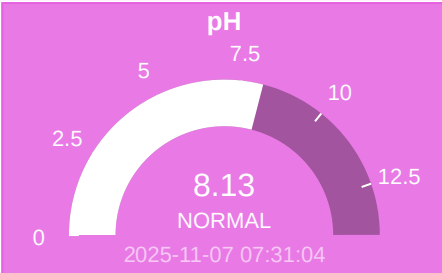
The figure displays eight water quality parameters in a 2x4 grid. Each parameter is represented by a semi-circular gauge with a needle, a current value, a status (NORMAL), and a timestamp.

Parameter	Value	Status	Timestamp
CO2	26.92	NORMAL	2025-11-07 07:50:38
Temperature	68.693 F	NORMAL	2025-11-07 08:00:24
Turbidity	6.3 NTU	NORMAL	2025-11-07 08:00:24
Specific Conductivity	1458.68	NORMAL	2025-11-07 08:00:24
Salinity	0.73 ppt	NORMAL	2025-11-07 08:00:24
DO Concentration	11.34 mg/L	NORMAL	2025-11-07 08:00:24
DO Concentration (% Sat)	126.2 %	NORMAL	2025-11-07 08:00:24
pH	8.86	NORMAL	2025-11-07 08:00:24
