## Blind Buoy Weather Station Data

Maurepas Buoy Water Quality Data

Tickfaw Buoy Water Quality Data

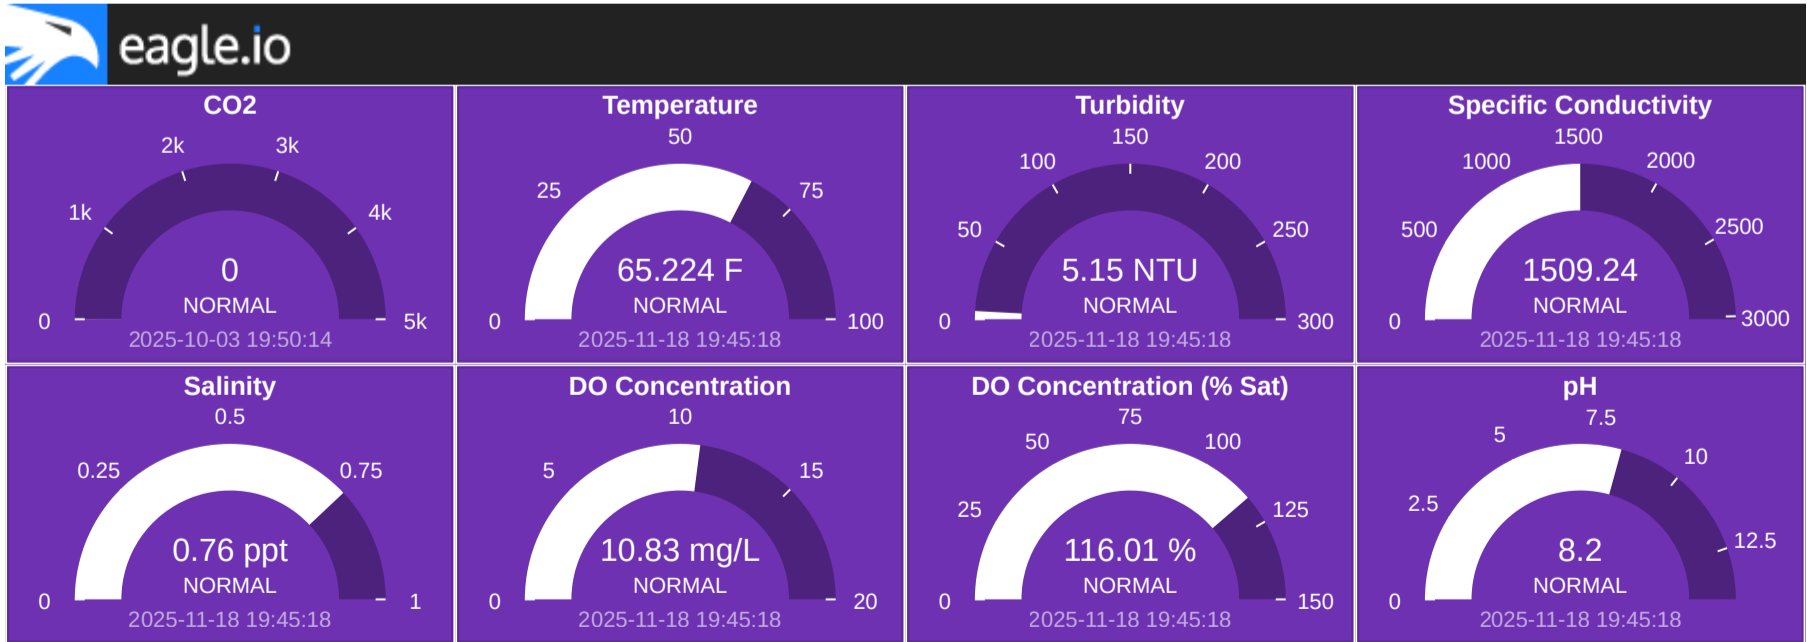
The figure displays eight water quality parameters in a 2x4 grid. Each parameter is represented by a semi-circular gauge with a needle, a numerical reading, a status indicator, and a timestamp.

Parameter	Reading	Status	Timestamp
CO2	116.73	NORMAL	2025-11-12 06:50:16
Temperature	68.058 F	NORMAL	2025-11-18 19:46:04
Turbidity	6.12 NTU	NORMAL	2025-11-18 19:46:04
Specific Conductivity	1549.23	NORMAL	2025-11-18 19:46:04
Salinity	0.78 ppt	NORMAL	2025-11-18 19:46:04
DO Concentration	10.49 mg/L	NORMAL	2025-11-18 19:46:04
DO Concentration (% Sat)	115.95 %	NORMAL	2025-11-18 19:46:04
pH	7.98	NORMAL	2025-11-18 19:46:04

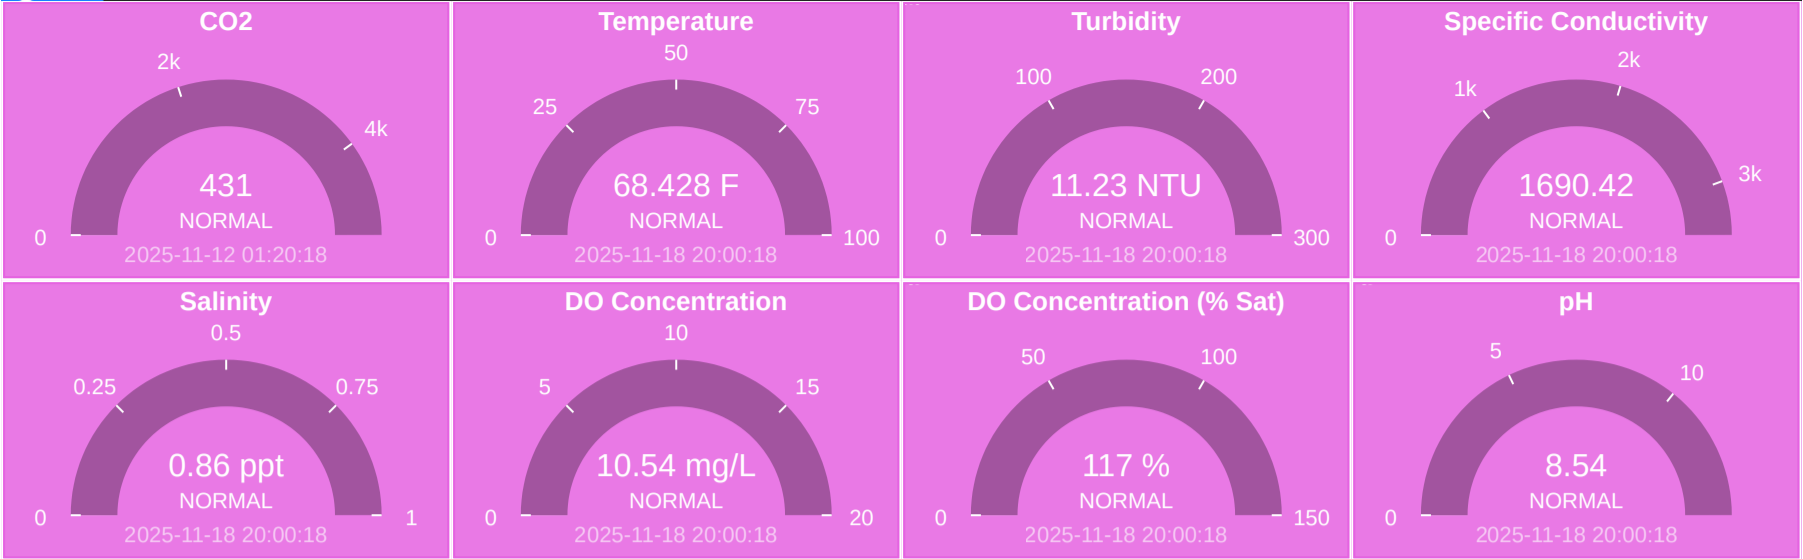
The figure displays eight water quality parameters, each represented by a semi-circular gauge. The gauges are arranged in a 2x4 grid. Each gauge shows a current value, a 'NORMAL' range, and a timestamp.

Parameter	Current Value	Normal Range	Timestamp
CO2	564.37	NORMAL	2025-11-12 07:20:38
Temperature	67.435 F	NORMAL	2025-11-18 19:45:20
Turbidity	10.15 NTU	NORMAL	2025-11-18 19:45:20
Specific Conductivity	1131.8	NORMAL	2025-11-18 19:45:20
Salinity	0.56 ppt	NORMAL	2025-11-18 19:45:20
DO Concentration	10.45 mg/L	NORMAL	2025-11-18 19:45:20
DO Concentration (% Sat)	114.62 %	NORMAL	2025-11-18 19:45:20
pH	7.83	NORMAL	2025-11-18 19:45:20
