Blind Buoy Weather Station Data

Maurepas Buoy Water Quality Data

Tickfaw Buoy Water Quality Data

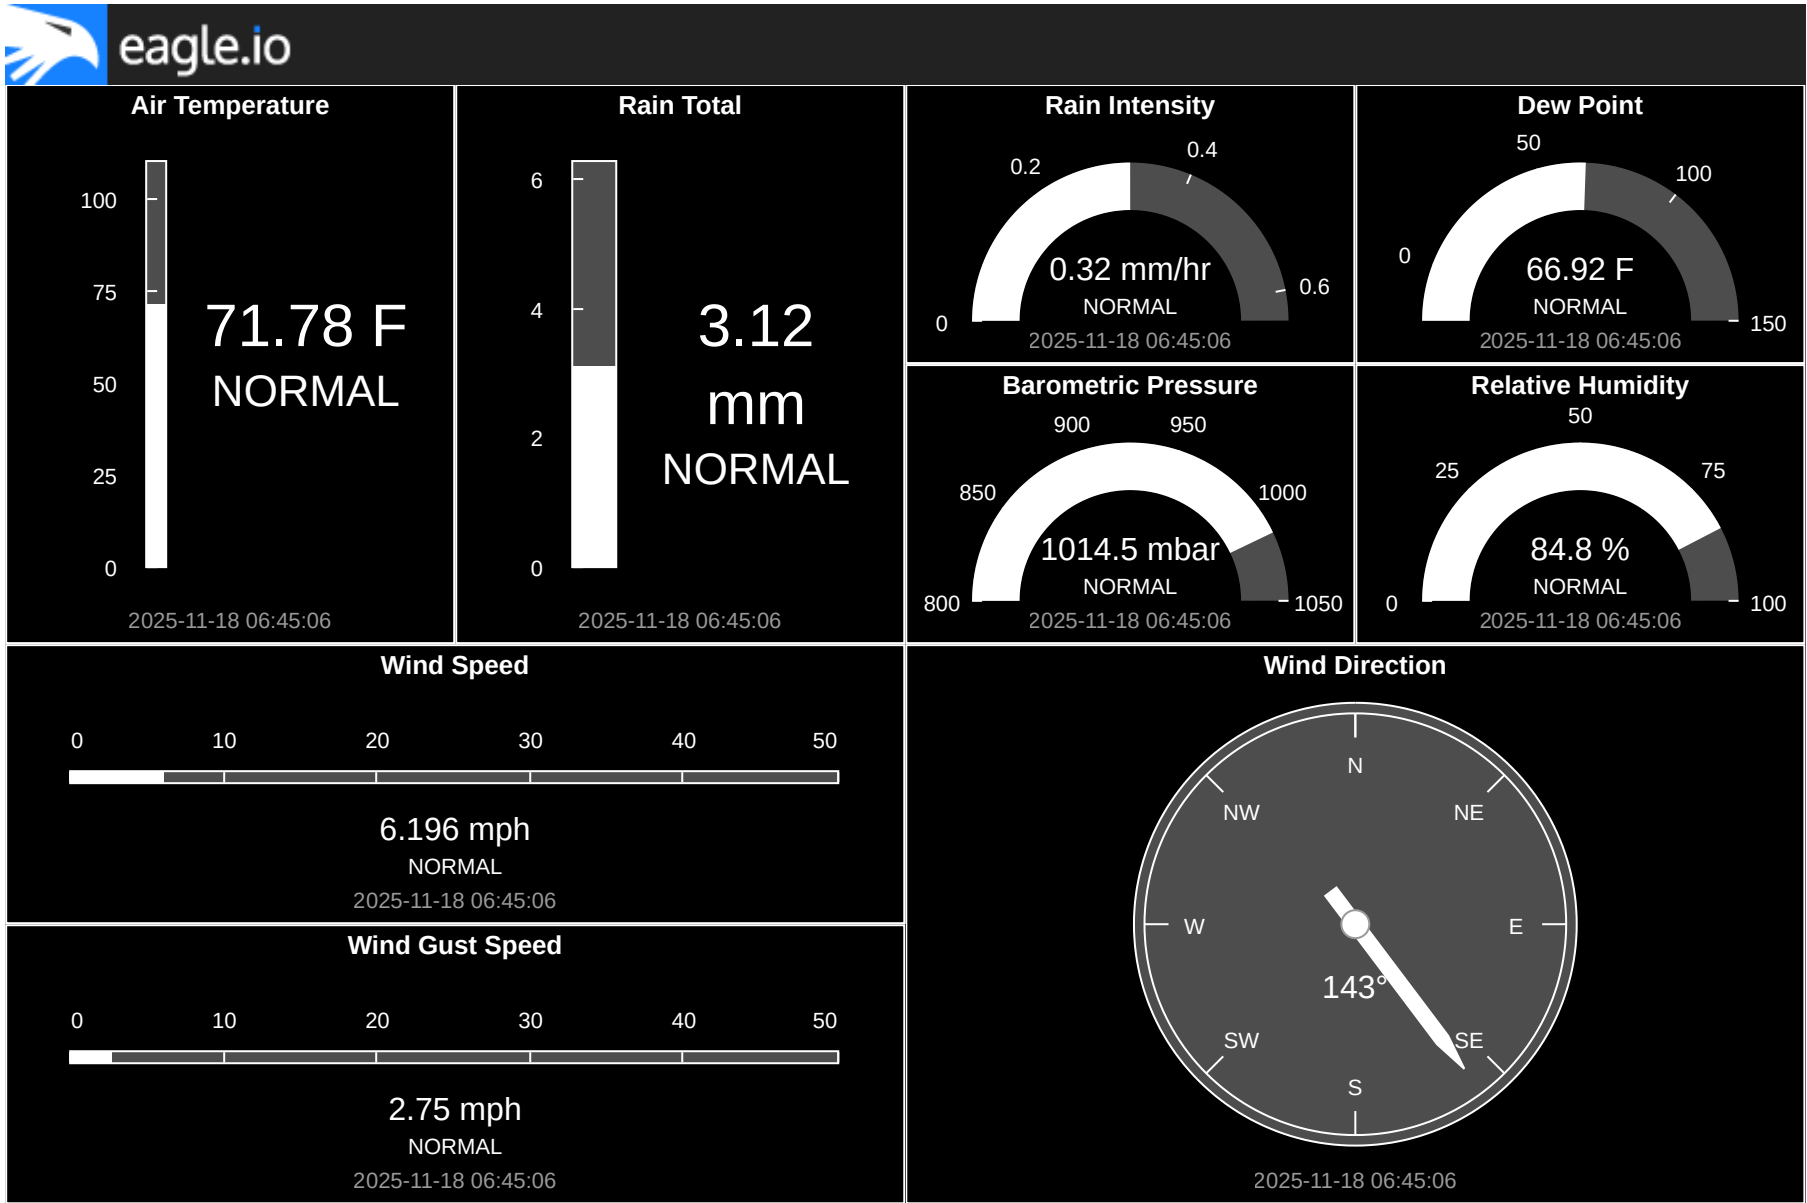
Wind Rose Chart: Historic Wind Speed and Direction

Historic wind speed and direction for the date range listed below. The frequency of winds over a time period is plotted by wind direction, with color bands showing wind speed ranges. Spoke length shows wind direction frequency.

[2025-10-18 08:13:53 - 2025-11-18 08:13:53]

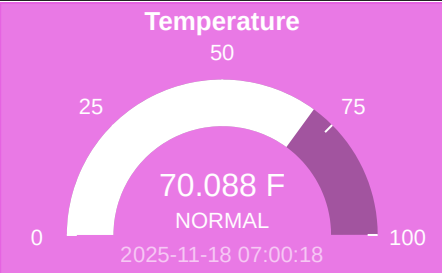
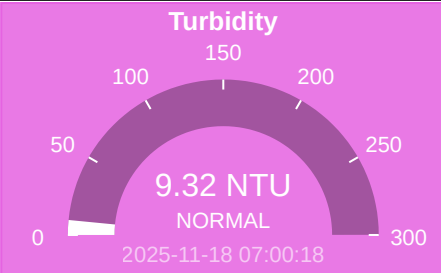
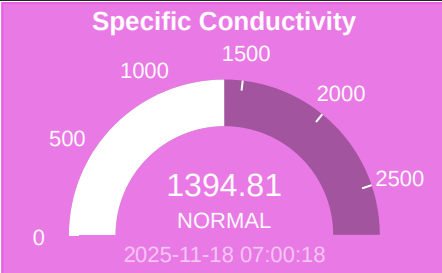
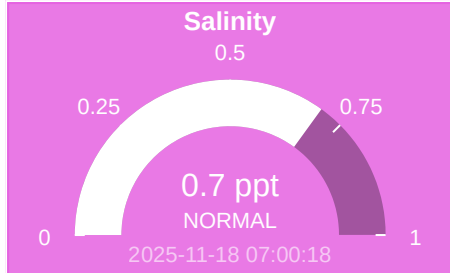
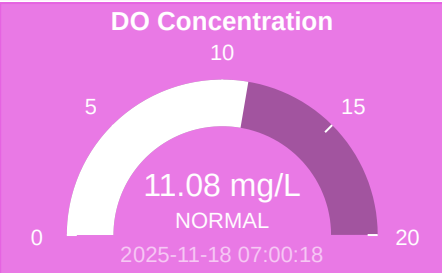
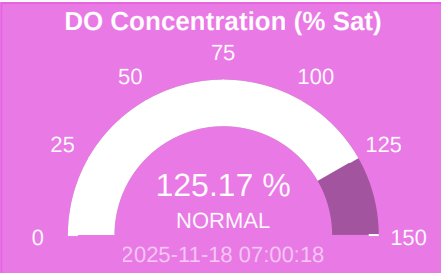
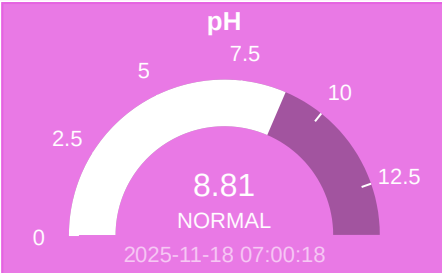
The figure displays eight water quality parameters in a 2x4 grid, each represented by a semi-circular gauge. The gauges show the current value, a status (NORMAL), and a timestamp.

Parameter	Value	Status	Timestamp
CO2	564.37	NORMAL	2025-11-12 07:20:38
Temperature	67.532 F	NORMAL	2025-11-18 06:45:20
Turbidity	11.52 NTU	NORMAL	2025-11-18 06:45:20
Specific Conductivity	1128.97	NORMAL	2025-11-18 06:45:20
Salinity	0.56 ppt	NORMAL	2025-11-18 06:45:20
DO Concentration	11.36 mg/L	NORMAL	2025-11-18 06:45:20
DO Concentration (% Sat)	124.69 %	NORMAL	2025-11-18 06:45:20
pH	8.7	NORMAL	2025-11-18 06:45:20
