# Home › College of Science and Technology › Center for Environmental Research › Lake Maurepas Monitoring Project

## BUOY DATA

This page contains the real time water quality readings from our four continuous monitoring buoys in Lake Maurepas: the Amite (blue), Blind (black), Maurepas (purple), and Tickfaw (pink) buoys. By providing real-time data, our aim is to enhance the community's understanding of Lake Maurepas' current status and to elevate their awareness regarding water quality and atmospheric conditions in the area. Click on the buoys in the interactive map below to learn more details about each one.

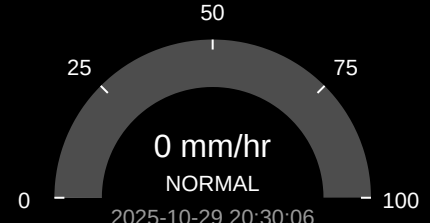
#### Rain Intensity

0 mm/hr

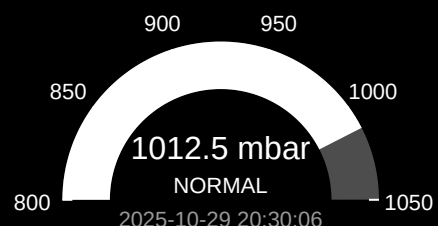
#### Barometric Pressure

1012.5 mbar
