Blind Buoy Weather Station Data

Maurepas Buoy Water Quality Data

Tickfaw Buoy Water Quality Data

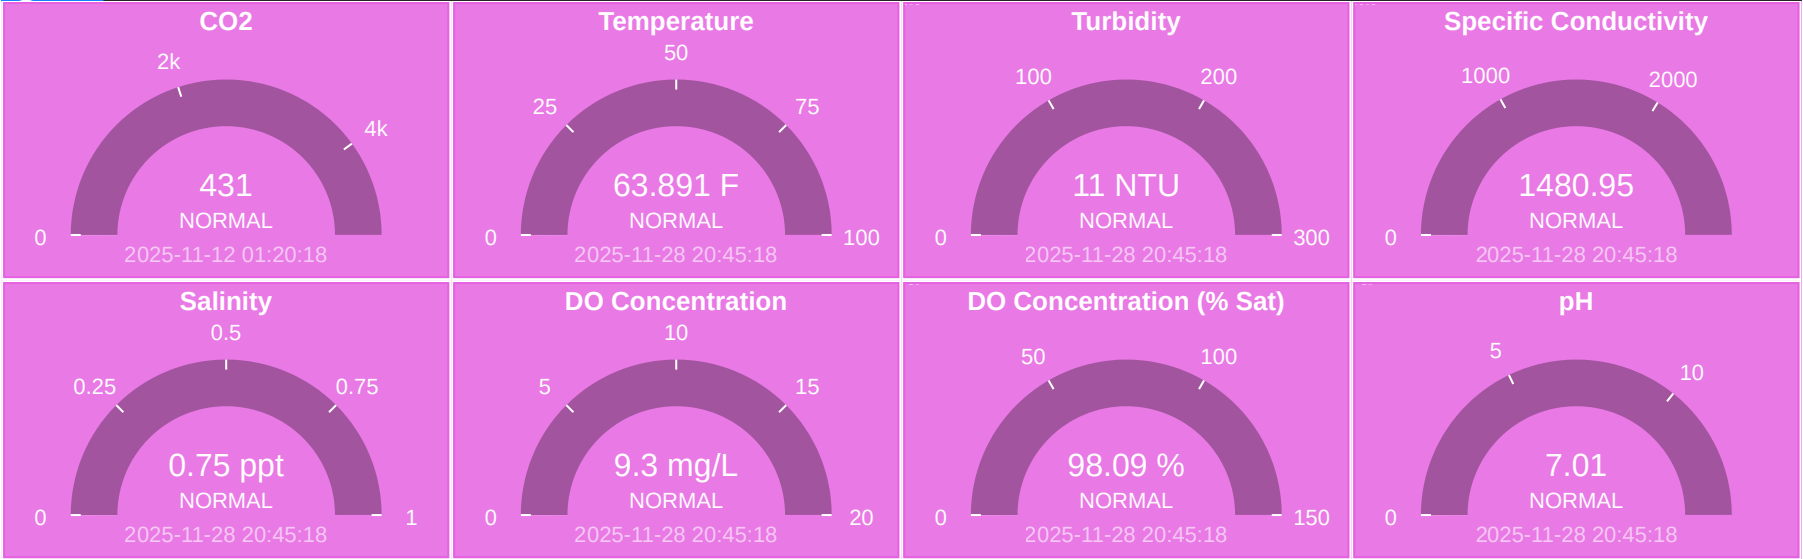
The figure displays eight water quality parameters in a 2x4 grid, each represented by a semi-circular gauge chart. The gauges show the current value, a status (NORMAL), and a timestamp.

Parameter	Value	Status	Timestamp
CO2	564.37	NORMAL	2025-11-12 07:20:38
Temperature	61.93 F	NORMAL	2025-11-28 21:00:24
Turbidity	59.29 NTU	NORMAL	2025-11-28 21:00:24
Specific Conductivity	1425.91	NORMAL	2025-11-28 21:00:24
Salinity	0.72 ppt	NORMAL	2025-11-28 21:00:24
DO Concentration	9.11 mg/L	NORMAL	2025-11-28 21:00:24
DO Concentration (% Sat)	93.89 %	NORMAL	2025-11-28 21:00:24
pH	6.78	NORMAL	2025-11-28 21:00:24
