# Home › College of Science and Technology › Center for Environmental Research › Lake Maurepas Monitoring Project

## BUOY DATA

This page contains the real time water quality readings from our four continuous monitoring buoys in Lake Maurepas: the Amite (blue), Blind (black), Maurepas (purple), and Tickfaw (pink) buoys. By providing real-time data, our aim is to enhance the community's understanding of Lake Maurepas' current status and to elevate their awareness regarding water quality and atmospheric conditions in the area. Click on the buoys in the interactive map below to learn more details about each one.

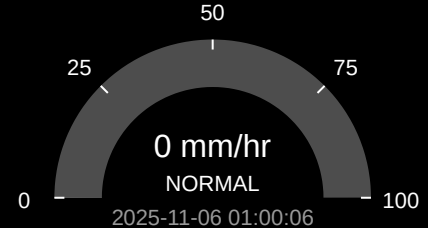
#### Rain Intensity

0 mm/hr

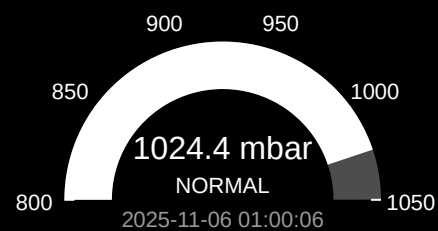
#### Barometric Pressure

1024.4 mbar
