Blind Buoy Weather Station Data

Maurepas Buoy Water Quality Data

Tickfaw Buoy Water Quality Data

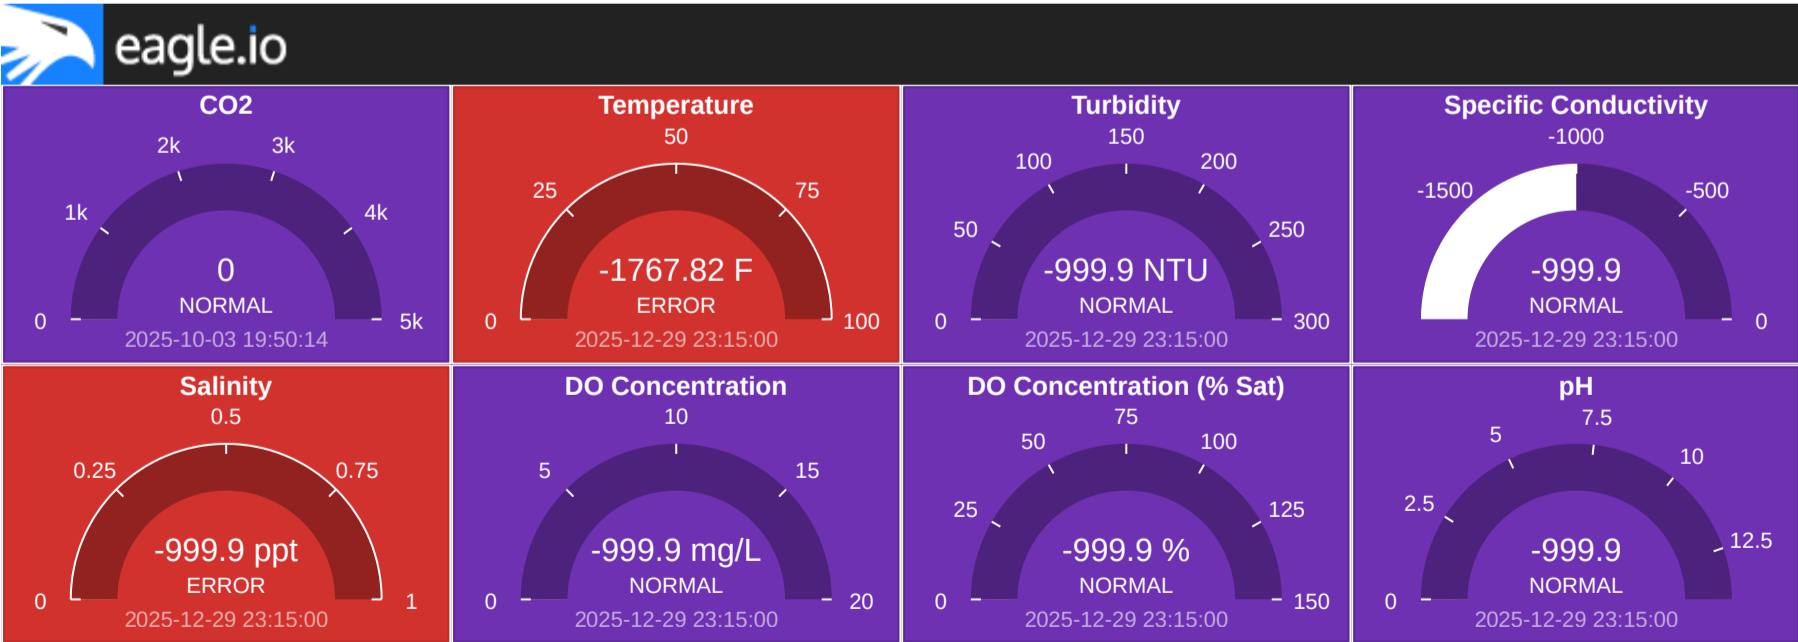
The figure displays eight water quality parameters in a 2x4 grid. Each parameter is represented by a gauge chart with a blue needle and a semi-circular scale. The parameters and their values are:

Parameter	Value	Unit	Status	Timestamp
CO2	116.73		NORMAL	2025-11-12 06:50:16
Temperature	63.351	F	NORMAL	2025-12-29 23:46:04
Turbidity	37.02	NTU	NORMAL	2025-12-29 23:46:04
Specific Conductivity	1219.83		NORMAL	2025-12-29 23:46:04
Salinity	0.61	ppt	NORMAL	2025-12-29 23:46:04
DO Concentration	8.5	mg/L	NORMAL	2025-12-29 23:46:04
DO Concentration (% Sat)	89.08	%	NORMAL	2025-12-29 23:46:04
pH	6.24		NORMAL	2025-12-29 23:46:04

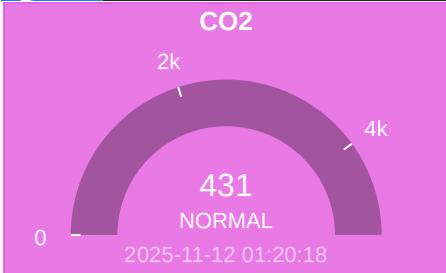
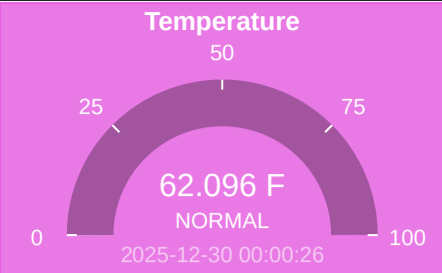
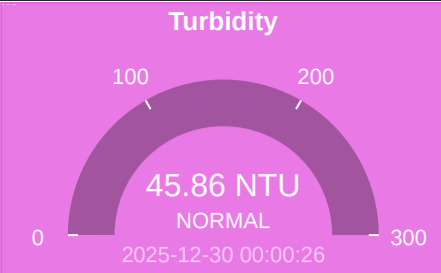
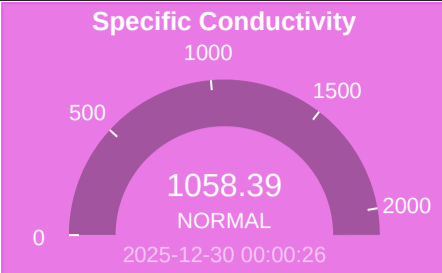
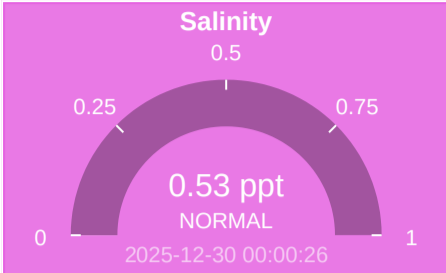
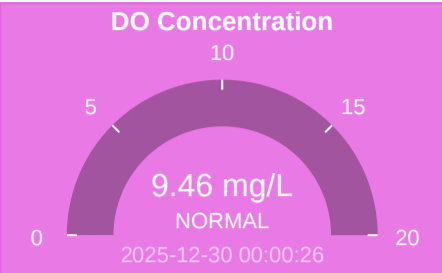
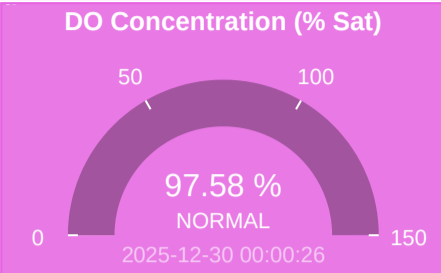
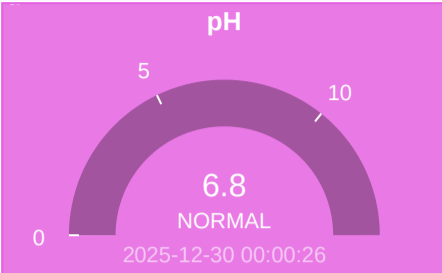
The figure displays eight water quality parameters in a 2x4 grid, each represented by a semi-circular gauge chart. The parameters and their values are:

- CO2:** 564.37 (NORMAL), timestamp: 2025-11-12 07:20:38
- Temperature:** 62.454 F (NORMAL), timestamp: 2025-12-29 23:45:20
- Turbidity:** 58.5 NTU (NORMAL), timestamp: 2025-12-29 23:45:20
- Specific Conductivity:** 817.07 (NORMAL), timestamp: 2025-12-29 23:45:20
- Salinity:** 0.4 ppt (NORMAL), timestamp: 2025-12-29 23:45:20
- DO Concentration:** 7.76 mg/L (NORMAL), timestamp: 2025-12-29 23:45:20
- DO Concentration (% Sat):** 80.3 % (NORMAL), timestamp: 2025-12-29 23:45:20
- pH:** 6.54 (NORMAL), timestamp: 2025-12-29 23:45:20
