# Precision Geometric Levelling for the Control of Vertical Displacements in the Recovery and Reinforcement of Concrete Beam, a Case Study

Article in *Revista Ingenieria de Construcción* · January 2019

M. Françoso \*, I. Pizarro <sup>1\* \*\*</sup>, L. de Almeida \*, M. da Silva \*

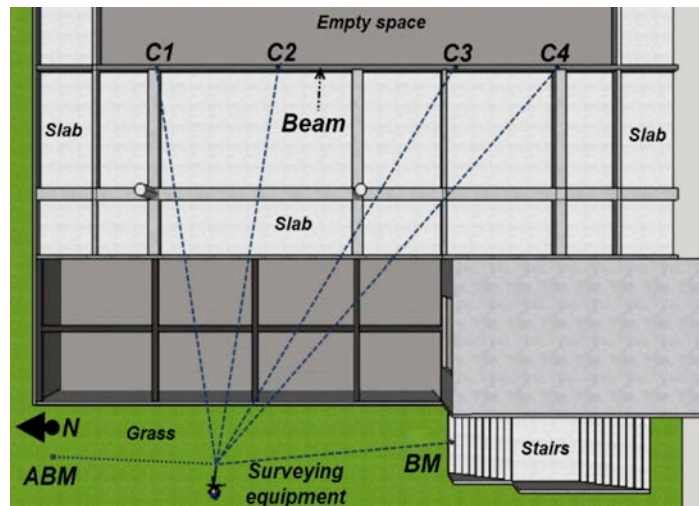
**Figure 3.** Under monitoring beam site plan with the control points location (C1, C2, C3, C4), the Benchmark (BM), the auxiliary Benchmark (ABM) and surveying equipment installation location

Both control points and reference level were marked with flat head bolts, fixed in the concrete to ensure observations on the same places always. The monitored points were denominated from left to right, as: C1, C2, C3 and C4 with average proximity to the 20,00 cm transducers. refer to details on (Figure 3) (Figure 4) (Figure 5.).

During the three stages, the level was installed outside the building with accessible line-of-sight for benchmark and the four control points as from a same installation point (Figure 3) (Figure 4). A series of readings were carried out in the first stage to allow knowing the beam's initial deformation state. On the second stage, six reading series were carried out, aiming at following up the gradual application of loads. In this process, loads were applied in ten-minute intervals, being the required time to evaluate through a visual inspection, the state of the structure and conduct the survey of the series of readings. For the third stage, four series of

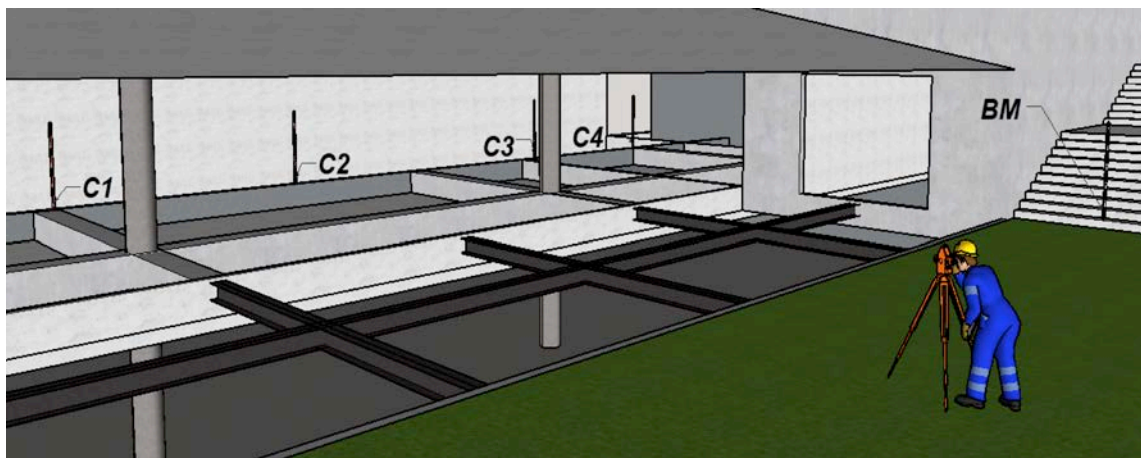
**Figure 4.** The surveying equipment installation side view as related to Benchmark location (BM) and control points (C1, C2, C3 and C4)

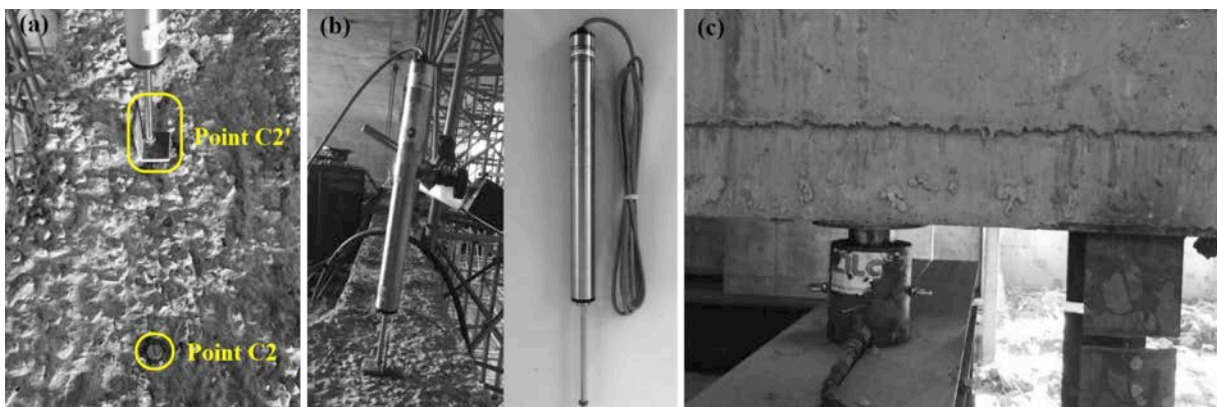
**Figure 5.** (a) Control points location (C2 and C2'); (b) Displacement transducers and (c) Jack used to apply the loads and temporary cut columns

Instrumentation monitoring was carried out by means of a computer with data acquisition system, "System 5000", model "5100b Scanner" from "Micro-Measurements" brand and four displacement transducers also from "Micro-Measurements", gauged with a precision of a thousandth of a millimetre (Figure 5.). Instrumentation technique was used exclusively in the second monitoring stage, with data acquisition at each second.

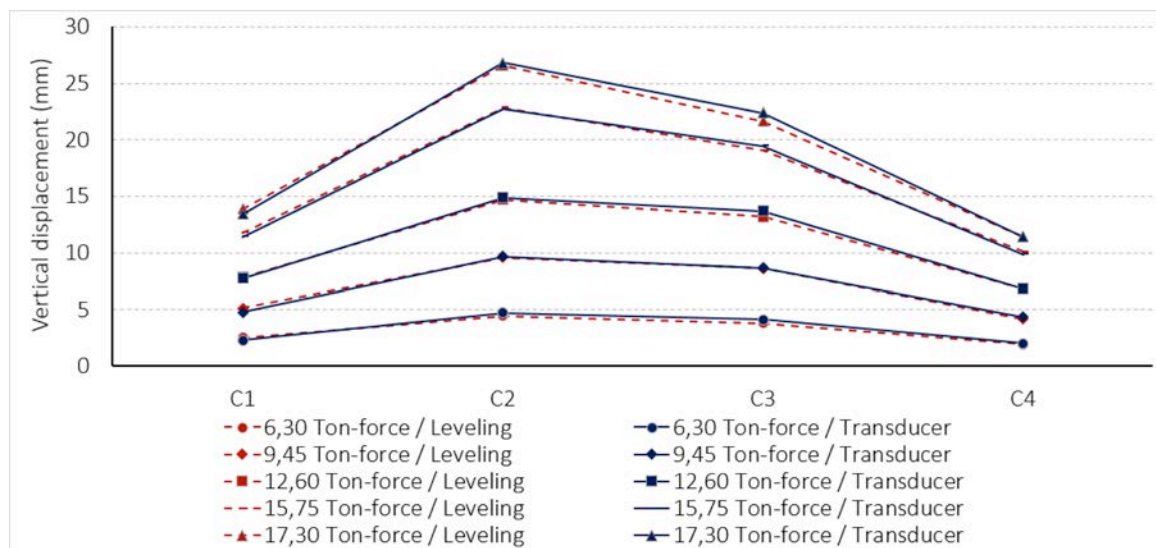
**Figure 6.** Graphic of the results' comparison obtained with levelling and displacement transducers

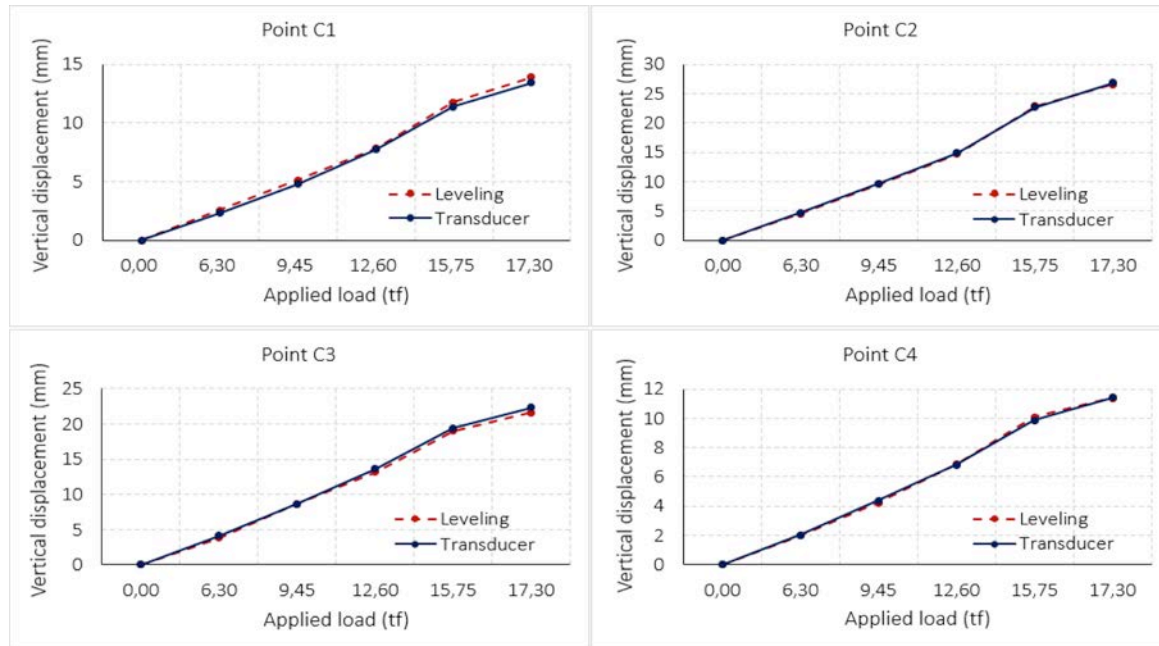
**Figure 7.** Vertical displacement given the applied load for each control point, using of the two monitoring techniques

(Figure 7) presents each control point behaviour in an isolated way, with the vertical displacements being experienced given the applied load. The graphics offer a purpose of which is to facilitate the results' comparison over each point, besides enabling the correlation analysis between the involved variables (Load and Displacement).

It is evident that irrespective of the displacements' magnitudes or the technique employed, the four graphics present bends with similar trends and forms, suggesting a strong linear correlation between the variables. The correlation coefficient ( $R^2$ ), which explains the proportion of variation between data, in all cases, was higher than 99%.

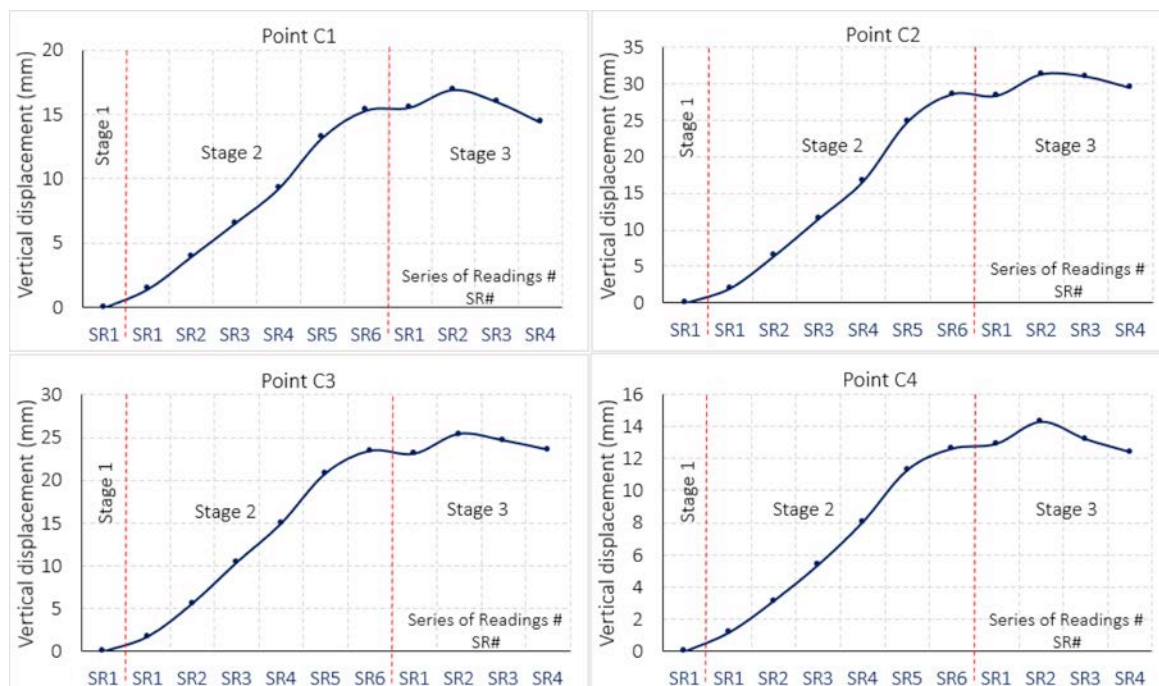
**Figure 8.** Displacement behaviour bends in each monitored point during the three Stages, using precision geometric levelling

As previously mentioned, monitoring with levelling was carried out in the three defined stages in the study, aiming at following the behaviour of the beam, prior, during and after rehabilitation process and reinforcement. Such

behaviour, in terms of vertical displacements given the stages and series of readings, is presented in (Figure 8). The trend of the four bends in the second stage was clarified in the previous paragraph; however, the displacement variations in stage 3 match the following situations:

- 1) on the transition between stages 2 and 3, after 24 hours of the recovery process with structural jacking, the structure underwent minor increases in the displacements of the extreme points ( $C1 = 0,225$  mm and  $C4 = 0,300$  mm) and a decrease in internal points ( $C2 = 0,225$  mm and  $C3 = 0,350$  mm);
- 2) 3 days after, the last applied load had to be adjusted, aiming at implementing the four columns, being observed then, a significant increase of the displacements, mainly in the internal control points ( $C1 = 1,387$  mm,  $C2 = 2,925$  mm,  $C3 = 2,325$  mm,  $C4 = 1,375$  mm) and
- 3) lastly, when the jacks were removed, the beam rested on the reinforcement columns. On this stage, as expected, the displacements decreased up until similar values to those determined in the last load applied (17,30 tf) in stage 2.
