Pulse Height Analysis of 3D pCVD Diamond Detectors

RD42 Meeting

Michael Reichmann

10th May 2019

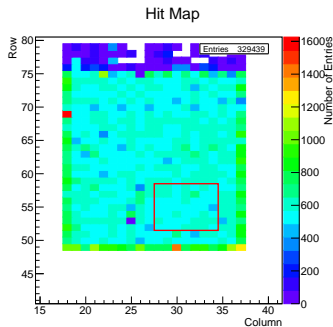
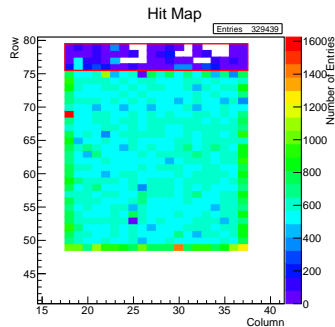
- tried different calibrations of the chip
- using the same region as at PSI
- also small region with 3D cells without bump-bonding (rows 76-79)
