Kennesaw State University
Six Sigma Green Belt Specialization

Capstone Project

**Improving Windshield Fitment on Vehicle:
Reducing Non-Conformance on the RH Side A-Pillar**

A Six Sigma DMAIC Project to Optimize Process Capability and Reduce Rework Costs

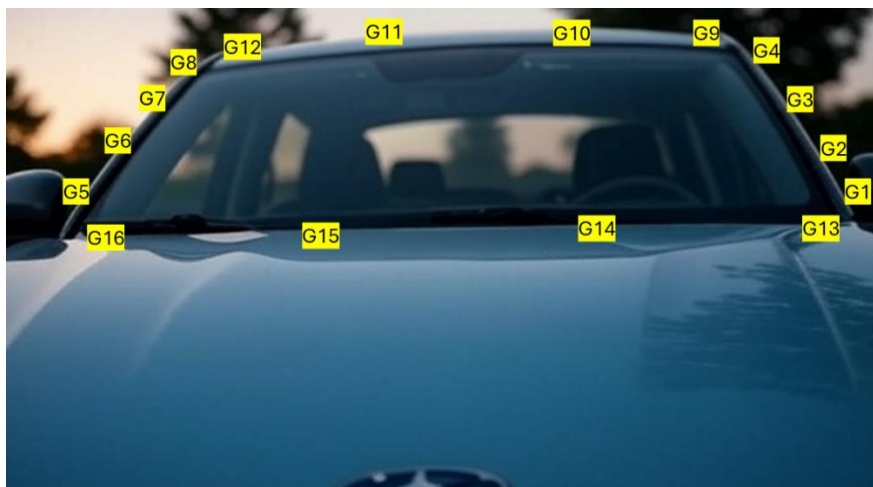
Figure 1 Windshield Gap Measurement Points

<ul style="list-style-type: none"> Access limited to team members (Tim Buck, Marco Strauss, Juan Pérez, Ng Hong, Vinush Radish) and stakeholders (Johana Barr, Jerome Guillemot, Karl Putman)
Analysis Plan	<ul style="list-style-type: none"> Use Excel for data entry and Minitab for statistical analysis. Calculate mean, standard deviation, and range of gap measurements (G1–G16). Generate: <ul style="list-style-type: none"> X-bar and R charts to monitor process variation. Box plots to compare gap distributions by operator and shift. Pareto charts to prioritize defect locations (e.g., G5–G8). Perform ANOVA to test operator and shift-based differences. Conduct chi-square tests to analyze non-conformance rates by measurement point.

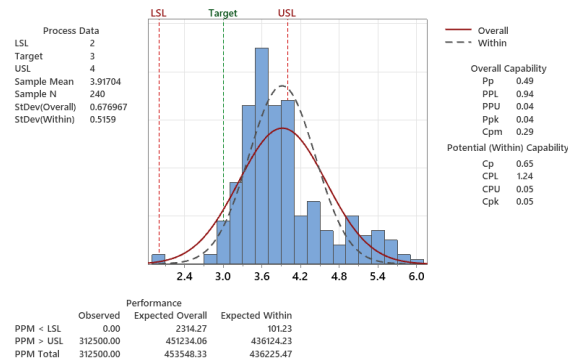
Figures 21–24 show Process Capability for Start, Post-morning, Post-lunch, Post-afternoon Shifts.

Cp (0.43–0.49) and Cpk (-0.01–0.12) indicate poor capability, worst in post-afternoon shifts (Cpk = -0.01).

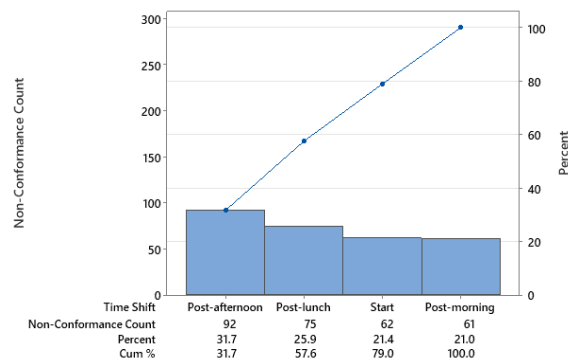
Figure 25 Pareto Chart of Shift Non-Conformances

Post-afternoon shifts contribute 32% of defects (92/290).

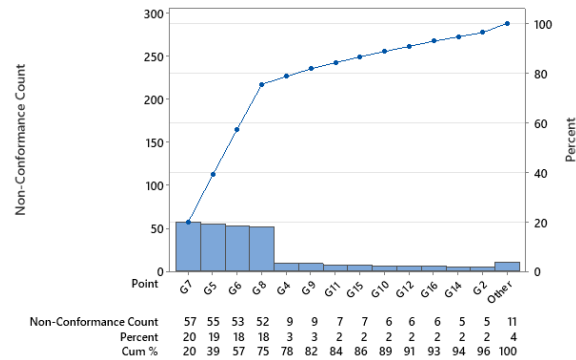
Figure 29 Pareto Chart of Measurement Point Non-Conformances

G7 (19.7%), G5 (19.0%), G6 (18.3%), G8 (17.9%) account for 74.8% of defects, confirming RH side A-pillar issues.
