## (wafer1,2,0,-1,-1,4,4) Characteristics

- **Cell Size:** 15um
- **Times Accessed:** 26
- **Last Measurement:** 2022/March/01 at 03:26:18PM

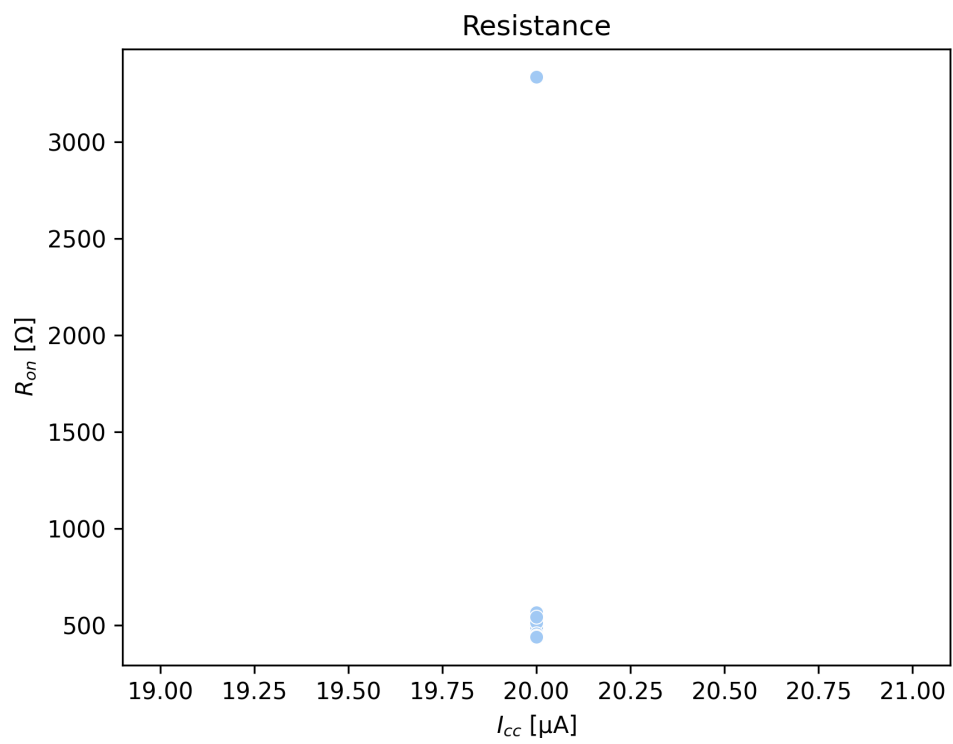
Cycle #	Set Icc ( $\mu$ A)	Set Voltage (V)	R_on ( $\Omega$ )	R2
1	20.0	1.30	415572.57	0.679
2	20.0	2.30	3334.96	1.000
3	25.0	2.15	-2344954.45	0.089
4	20.0	3.80	485.78	1.000
5	20.0	1.40	565.12	1.000
6	20.0	3.70	512.10	1.000
7	20.0	3.70	543.26	1.000
8	20.0	3.70	440.85	1.000
9	20.0	3.70	456.09	1.000
10	20.0	3.70	444.85	1.000
11	20.0	3.70	437.82	1.000

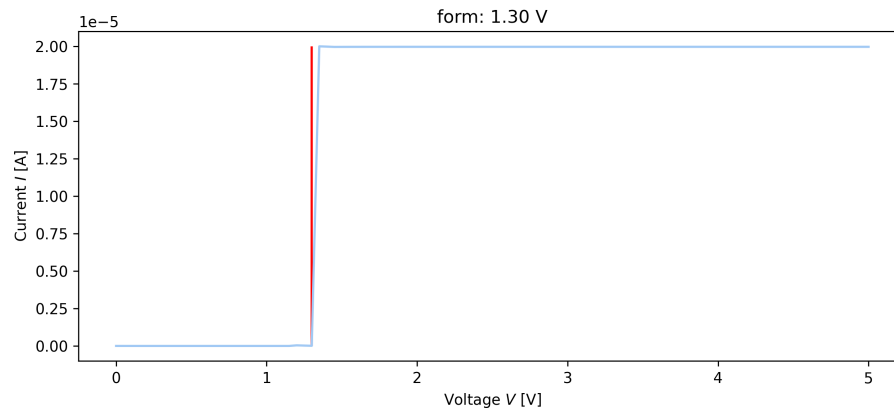
## form

- **Time:** 02:57:08PM
- **Icc:** 20.0uA
- **Voltage Range:** 0V  $\rightarrow$  5V
- **Target Ramp Rate:** 1V/s
- **True Ramp Rate:** 1.069 V/s\*
- **Cycle:** 1
- **Set Voltage:** 1.30 V

Form\* at 1.35 V. Too flimsy and reset after due to bad probe connection

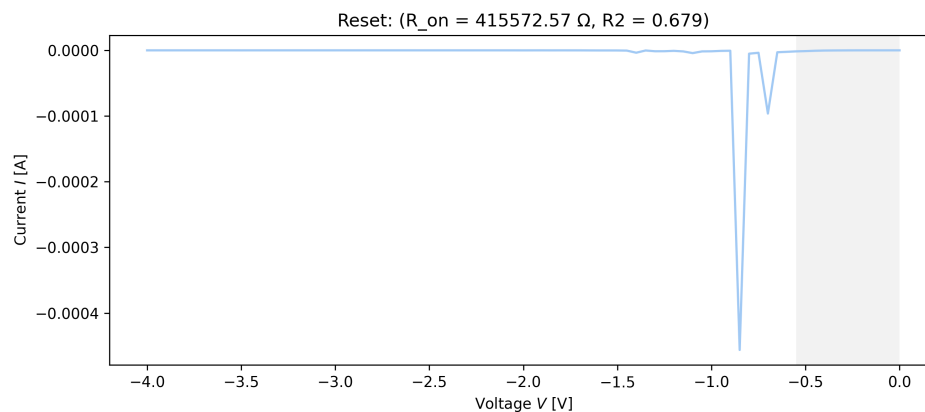
## reset

- **Time:** 02:58:34PM
- **I<sub>cc</sub>:** 5.0mA
- **Voltage Range:** 0V → -4V
- **Target Ramp Rate:** 1V/s
- **True Ramp Rate:** -1.069 V/s\*
- **Cycle:** 1
- **Resistance:** 415572.57  $\Omega$
- **Linear Fit R2:** 0.679

Cell did not conduct

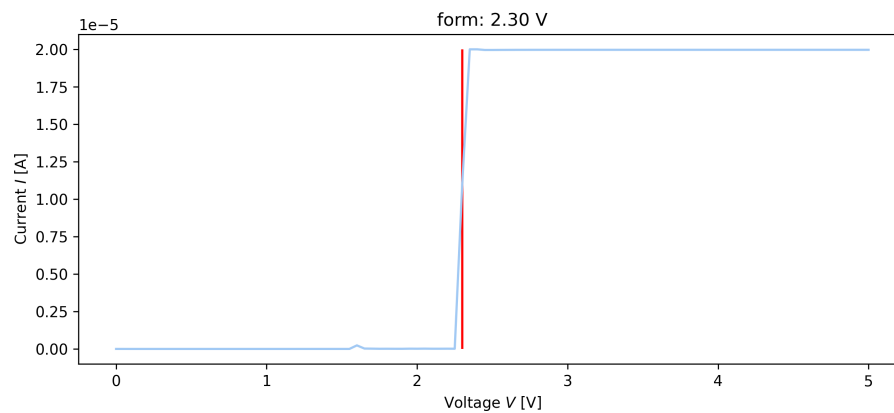
## form

- **Time:** 03:00:01PM
- **Icc:** 20.0uA
- **Voltage Range:** 0V  $\rightarrow$  5V
- **Target Ramp Rate:** 1V/s
- **True Ramp Rate:** 1.069 V/s\*
- **Cycle:** 2
- **Set Voltage:** 2.30 V

Form\* at 2.3 V. Too flimsy and reset after due to bad probe connection

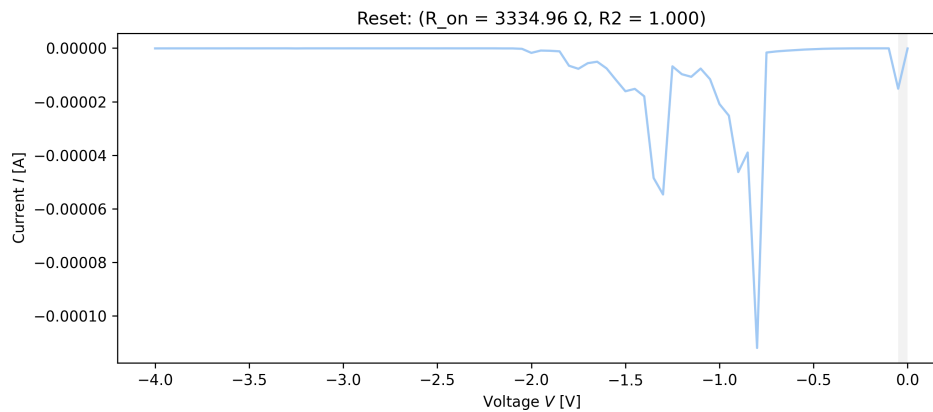
## reset

- **Time:** 03:00:49PM
- **Icc:** 5.0mA
- **Voltage Range:** 0V  $\rightarrow$  -4V
- **Target Ramp Rate:** 1V/s
- **True Ramp Rate:** -1.068 V/s\*
- **Cycle:** 2
- **Resistance:** 3334.96  $\Omega$
- **Linear Fit R2:** 1.000

Wild reset graph. Probe connection issues

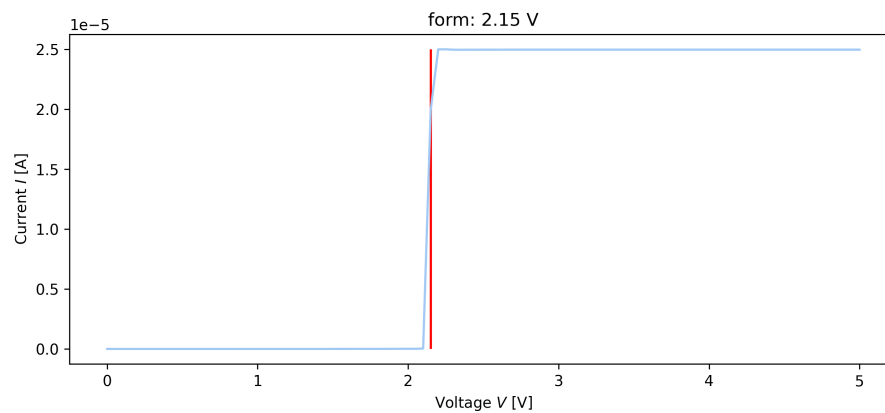
## form

- **Time:** 03:01:49PM
- **Icc:** 25.0uA
- **Voltage Range:** 0V  $\rightarrow$  5V
- **Target Ramp Rate:** 1V/s
- **True Ramp Rate:** 1.069 V/s\*
- **Cycle:** 3
- **Set Voltage:** 2.15 V

Form\* at 2.2 V. Too flimsy and reset after due to bad probe connection

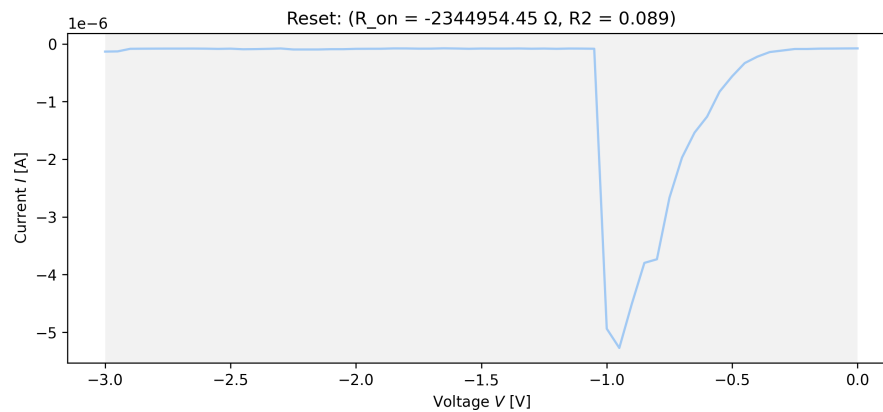
## reset

- **Time:** 03:02:52PM
- **I<sub>cc</sub>:** 5.0mA
- **Voltage Range:** 0V → -3V
- **Target Ramp Rate:** 1V/s
- **True Ramp Rate:** -1.067 V/s\*
- **Cycle:** 3
- **Resistance:** -2344954.45 Ω
- **Linear Fit R<sup>2</sup>:** 0.089

Reset at -1.05 V, but had non-ohmic behavior leading up to reset

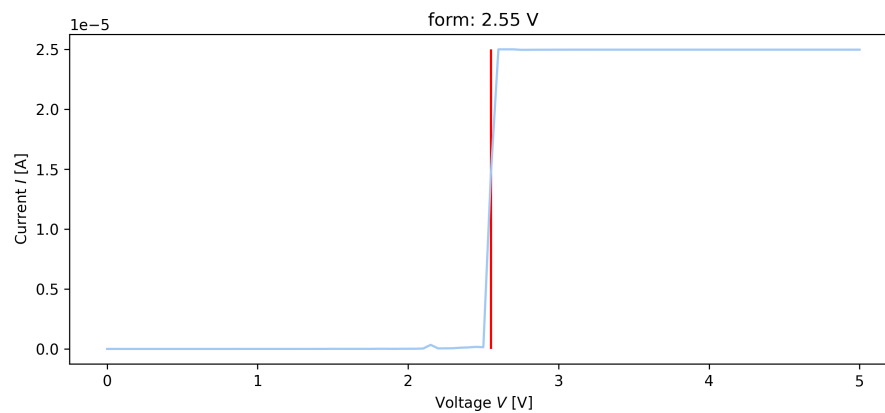
## form

- **Time:** 03:03:52PM
- **Icc:** 25.0uA
- **Voltage Range:** 0V  $\rightarrow$  5V
- **Target Ramp Rate:** 1V/s
- **True Ramp Rate:** 1.069 V/s\*
- **Cycle:** 4
- **Set Voltage:** 2.55 V

Form\* at 2.6 V. Too flimsy and reset after due to bad probe connection

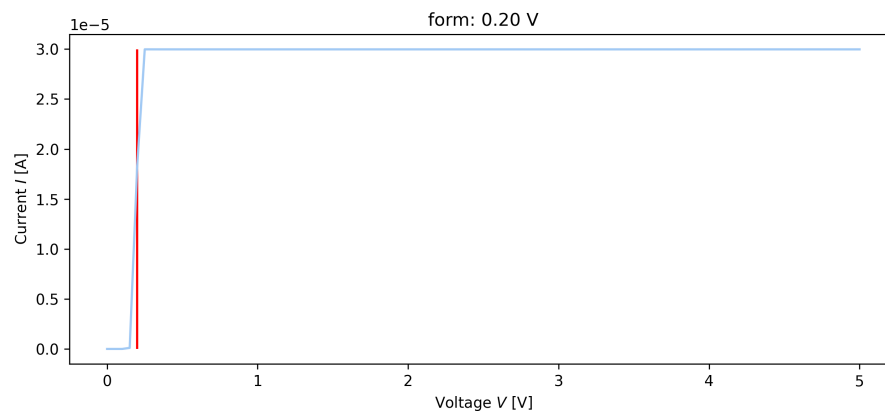
## form

- **Time:** 03:06:05PM
- **Icc:** 30.0uA
- **Voltage Range:** 0V  $\rightarrow$  5V
- **Target Ramp Rate:** 1V/s
- **True Ramp Rate:** 1.651 V/s\*
- **Cycle:** 4
- **Set Voltage:** 0.20 V

Form\* at 0.25 V, very early

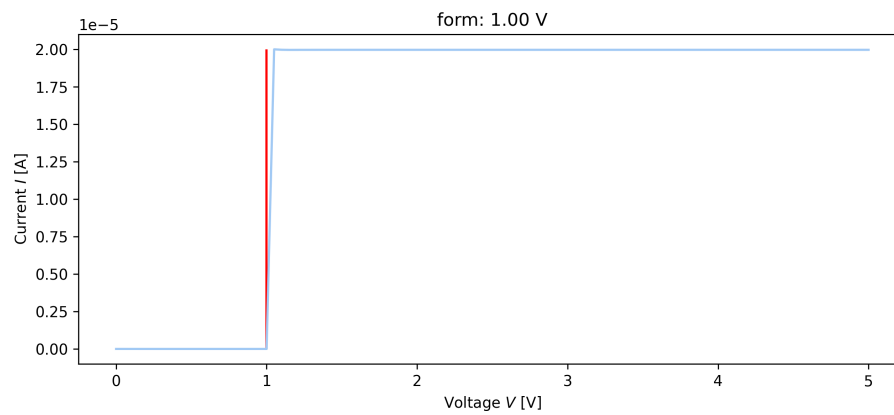
## form

- **Time:** 03:10:31PM
- **Icc:** 20.0uA
- **Voltage Range:** 0V  $\rightarrow$  5V
- **Target Ramp Rate:** 1V/s
- **True Ramp Rate:** 1.069 V/s\*
- **Cycle:** 4
- **Set Voltage:** 1.00 V

Form at 1.05 V after replacing probes

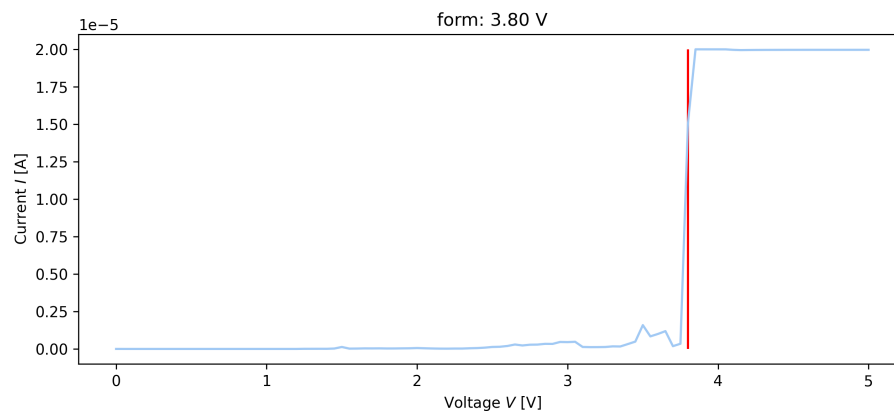
## form

- **Time:** 03:12:21PM
- **Icc:** 20.0uA
- **Voltage Range:** 0V  $\rightarrow$  5V
- **Target Ramp Rate:** 1V/s
- **True Ramp Rate:** 1.069 V/s\*
- **Cycle:** 4
- **Set Voltage:** 3.80 V

Form\* at 3.85 V

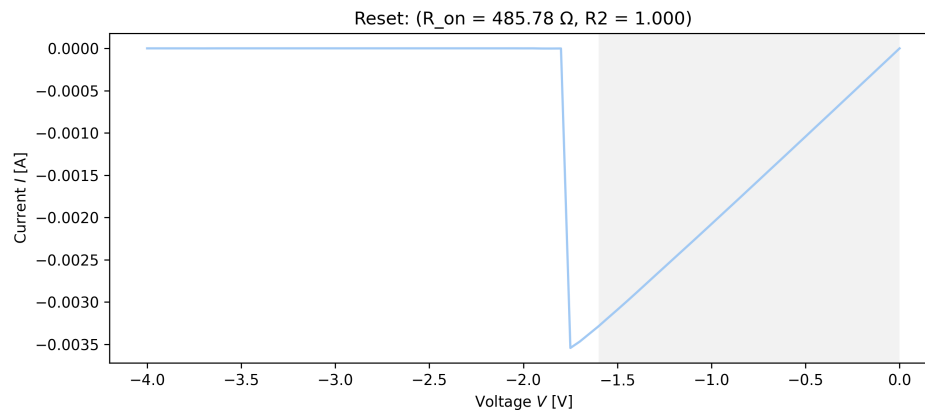
## reset

- **Time:** 03:15:33PM
- **I<sub>cc</sub>:** 5.0mA
- **Voltage Range:** 0V → -4V
- **Target Ramp Rate:** 1V/s
- **True Ramp Rate:** -1.470 V/s\*
- **Cycle:** 4
- **Resistance:** 485.78 Ω
- **Linear Fit R<sup>2</sup>:** 1.000

Reset at -1.8 V

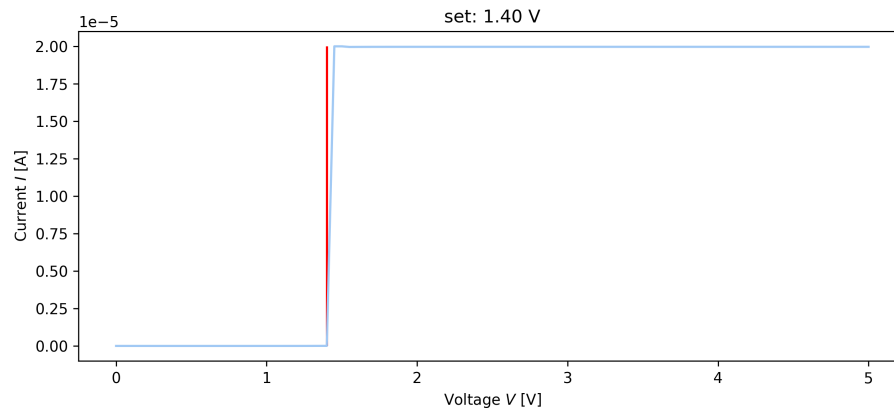
## set

- **Time:** 03:18:00PM
- **Icc:** 20.0uA
- **Voltage Range:** 0V  $\rightarrow$  5V
- **Target Ramp Rate:** 1V/s
- **True Ramp Rate:** 1.069 V/s\*
- **Cycle:** 5
- **Set Voltage:** 1.40 V

Set at 1.45 V

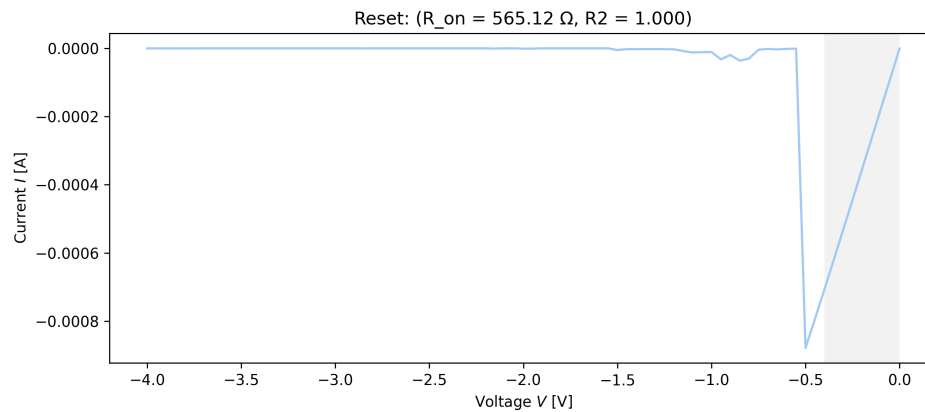
## reset

- **Time:** 03:18:44PM
- **I<sub>cc</sub>:** 5.0mA
- **Voltage Range:** 0V → -4V
- **Target Ramp Rate:** 1V/s
- **True Ramp Rate:** -1.104 V/s\*
- **Cycle:** 5
- **Resistance:** 565.12 Ω
- **Linear Fit R<sup>2</sup>:** 1.000

Reset at -0.55 V

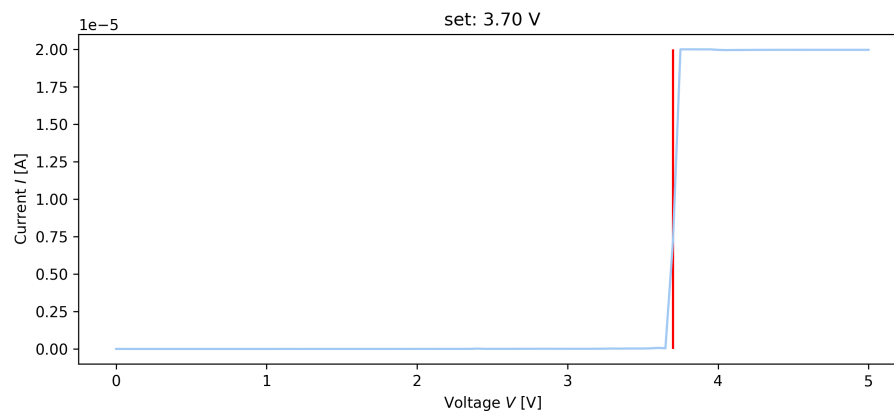
## set

- **Time:** 03:20:00PM
- **Icc:** 20.0uA
- **Voltage Range:** 0V  $\rightarrow$  5V
- **Target Ramp Rate:** 1V/s
- **True Ramp Rate:** 1.069 V/s\*
- **Cycle:** 6
- **Set Voltage:** 3.70 V

Set at 3.7 V

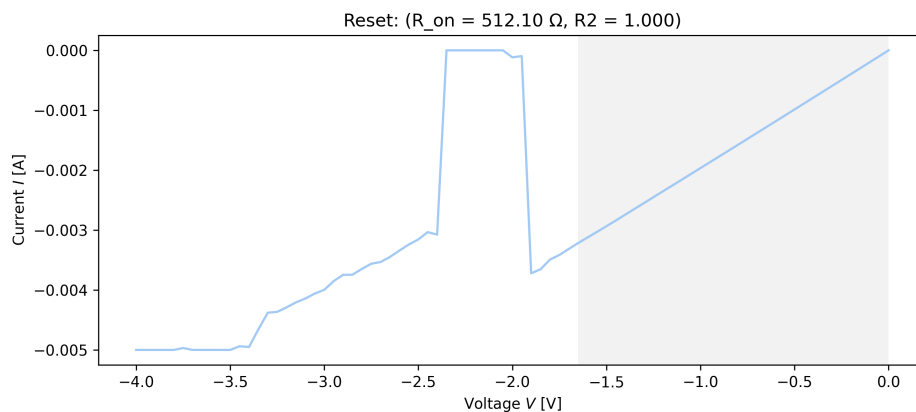
## reset

- **Time:** 03:20:44PM
- **I<sub>cc</sub>:** 5.0mA
- **Voltage Range:** 0V → -4V
- **Target Ramp Rate:** 1V/s
- **True Ramp Rate:** -1.429 V/s\*
- **Cycle:** 6
- **Resistance:** 512.10 Ω
- **Linear Fit R2:** 1.000

Failed reset

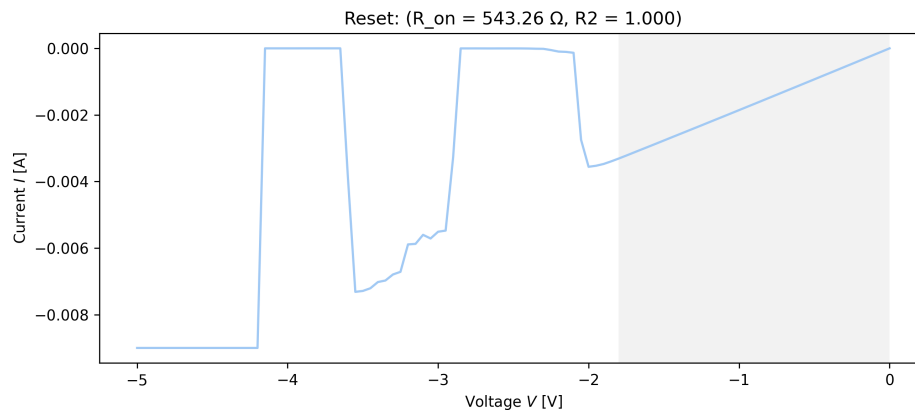
## reset

- **Time:** 03:21:22PM
- **I<sub>cc</sub>:** 9.0mA
- **Voltage Range:** 0V → -5V
- **Target Ramp Rate:** 1V/s
- **True Ramp Rate:** -1.429 V/s\*
- **Cycle:** 7
- **Resistance:** 543.26 Ω
- **Linear Fit R2:** 1.000

Failed reset

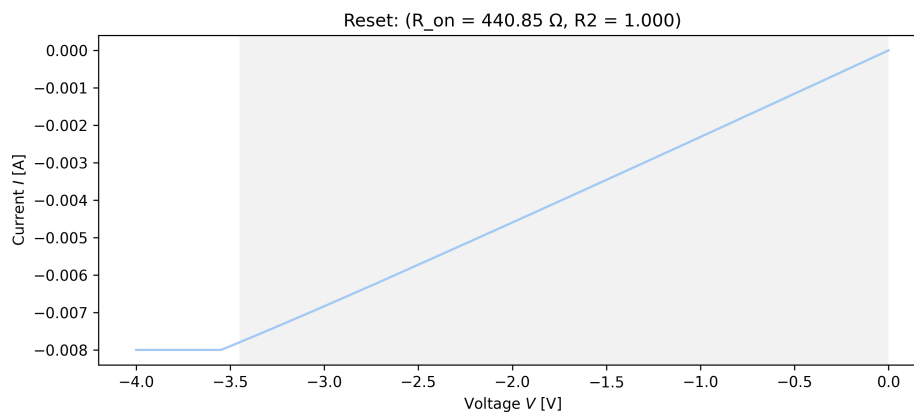
## reset

- **Time:** 03:22:34PM
- **I<sub>cc</sub>:** 8.0mA
- **Voltage Range:** 0V → -4V
- **Target Ramp Rate:** 1V/s
- **True Ramp Rate:** -1.514 V/s\*
- **Cycle:** 8
- **Resistance:** 440.85 Ω
- **Linear Fit R<sup>2</sup>:** 1.000

Failed reset

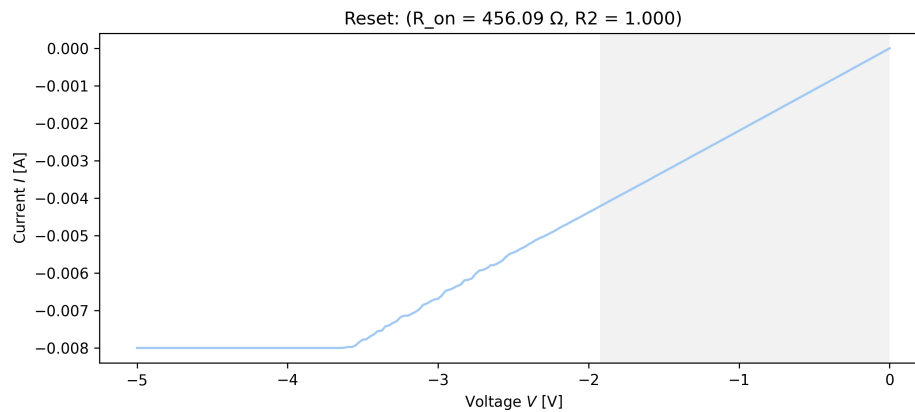
## reset

- **Time:** 03:24:39PM
- **I<sub>cc</sub>:** 8.0mA
- **Voltage Range:** 0V → -5V
- **Target Ramp Rate:** 1V/s
- **True Ramp Rate:** -0.765 V/s\*
- **Cycle:** 9
- **Resistance:** 456.09 Ω
- **Linear Fit R<sup>2</sup>:** 1.000

Failed reset. Amrita is determined this cell will reset

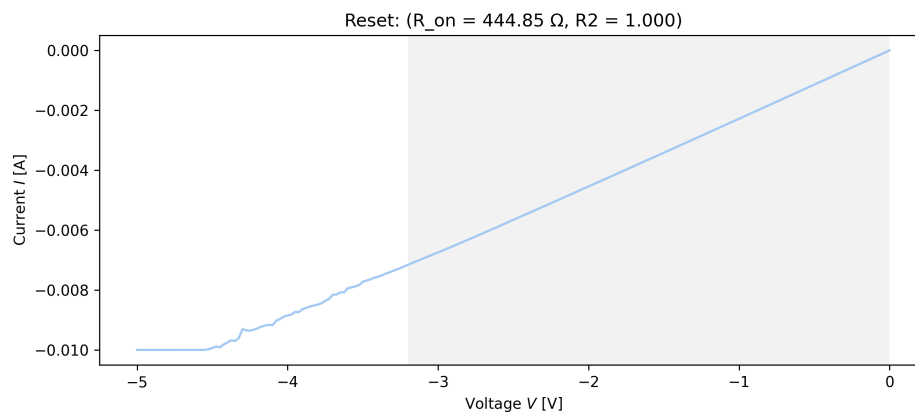
## reset

- **Time:** 03:25:42PM
- **I<sub>cc</sub>:** 10.0mA
- **Voltage Range:** 0V → -5V
- **Target Ramp Rate:** 1V/s
- **True Ramp Rate:** -0.777 V/s\*
- **Cycle:** 10
- **Resistance:** 444.85 Ω
- **Linear Fit R<sup>2</sup>:** 1.000

Failed reset

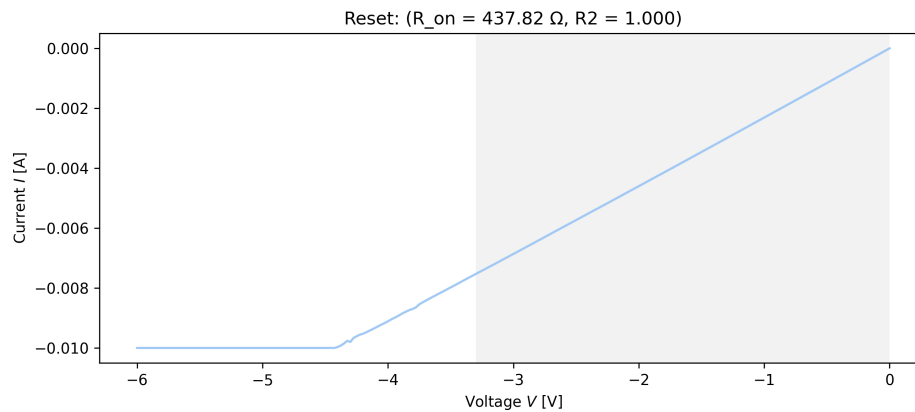
## reset

- **Time:** 03:26:18PM
- **I<sub>cc</sub>:** 10.0mA
- **Voltage Range:** 0V → -6V
- **Target Ramp Rate:** 1V/s
- **True Ramp Rate:** -0.776 V/s\*
- **Cycle:** 11
- **Resistance:** 437.82 Ω
- **Linear Fit R<sup>2</sup>:** 1.000

Failed reset
