## (wafer1,2,0,-1,-1,4,4) Characteristics

- **Cell Size:** 15um
- **Times Accessed:** 26
- **Last Measurement:** 2022/March/01 at 03:26:18PM

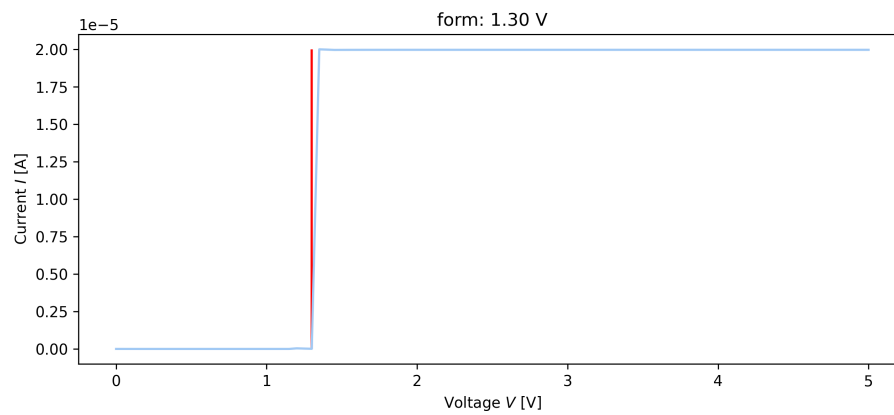
## form

- **Time:** 02:57:08PM
- **Icc:** 20.0uA
- **Voltage Range:** 0V  $\rightarrow$  5V
- **Target Ramp Rate:** 1V/s
- **True Ramp Rate:** 1.069 V/s\*
- **Cycle:** 1
- **Set Voltage:** 1.30 V

Form\* at 1.35 V. Too flimsy and reset after due to bad probe connection

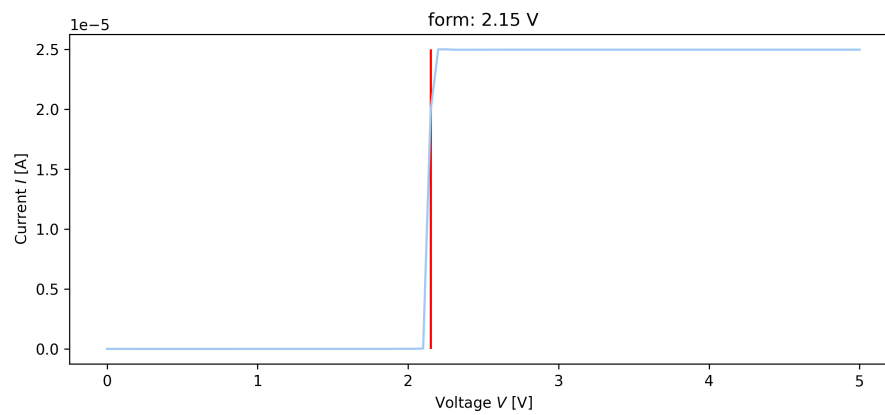
## form

- **Time:** 03:01:49PM
- **Icc:** 25.0uA
- **Voltage Range:** 0V  $\rightarrow$  5V
- **Target Ramp Rate:** 1V/s
- **True Ramp Rate:** 1.069 V/s\*
- **Cycle:** 3
- **Set Voltage:** 2.15 V

Form\* at 2.2 V. Too flimsy and reset after due to bad probe connection

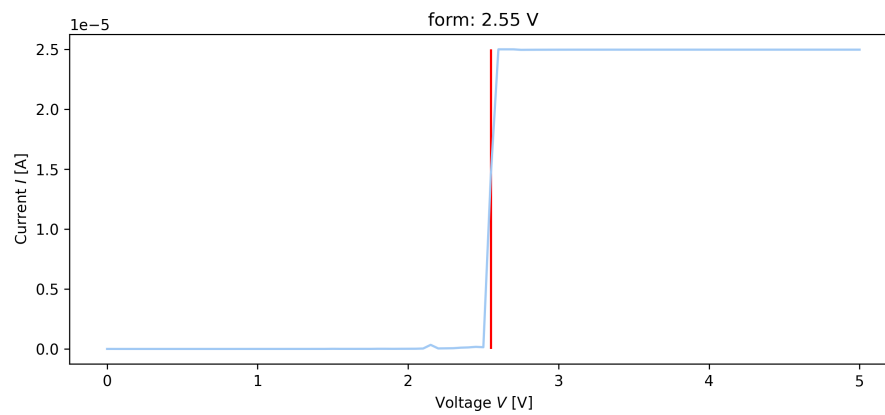
## form

- **Time:** 03:03:52PM
- **Icc:** 25.0uA
- **Voltage Range:** 0V  $\rightarrow$  5V
- **Target Ramp Rate:** 1V/s
- **True Ramp Rate:** 1.069 V/s\*
- **Cycle:** 4
- **Set Voltage:** 2.55 V

Form\* at 2.6 V. Too flimsy and reset after due to bad probe connection

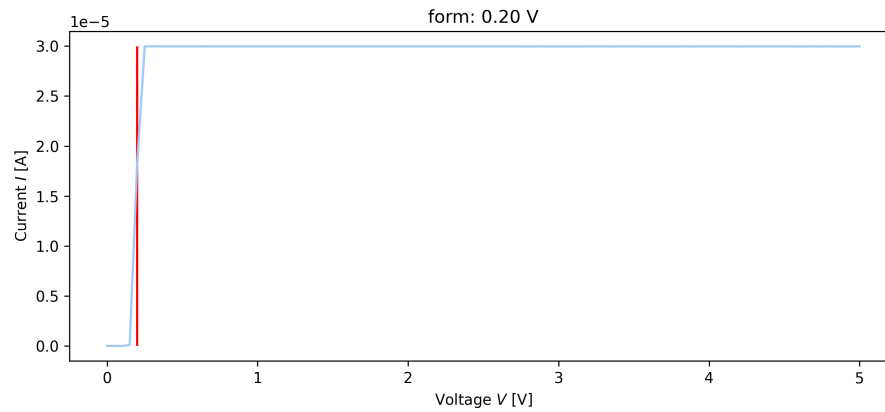
## form

- **Time:** 03:06:05PM
- **Icc:** 30.0uA
- **Voltage Range:** 0V  $\rightarrow$  5V
- **Target Ramp Rate:** 1V/s
- **True Ramp Rate:** 1.651 V/s\*
- **Cycle:** 4
- **Set Voltage:** 0.20 V

Form\* at 0.25 V, very early

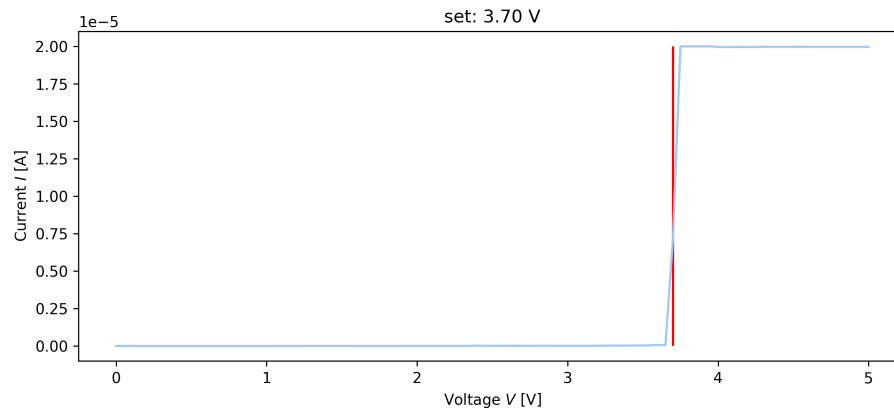
## set

- **Time:** 03:20:00PM
- **Icc:** 20.0uA
- **Voltage Range:** 0V  $\rightarrow$  5V
- **Target Ramp Rate:** 1V/s
- **True Ramp Rate:** 1.069 V/s\*
- **Cycle:** 6
- **Set Voltage:** 3.70 V

Set at 3.7 V

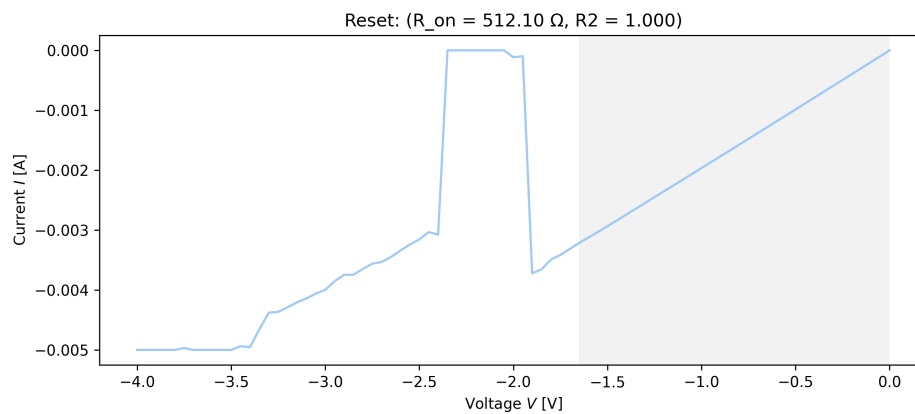
## reset

- **Time:** 03:20:44PM
- **I<sub>cc</sub>:** 5.0mA
- **Voltage Range:** 0V → -4V
- **Target Ramp Rate:** 1V/s
- **True Ramp Rate:** -1.429 V/s\*
- **Cycle:** 6
- **Resistance:** 512.10 Ω
- **Linear Fit R2:** 1.000

Failed reset

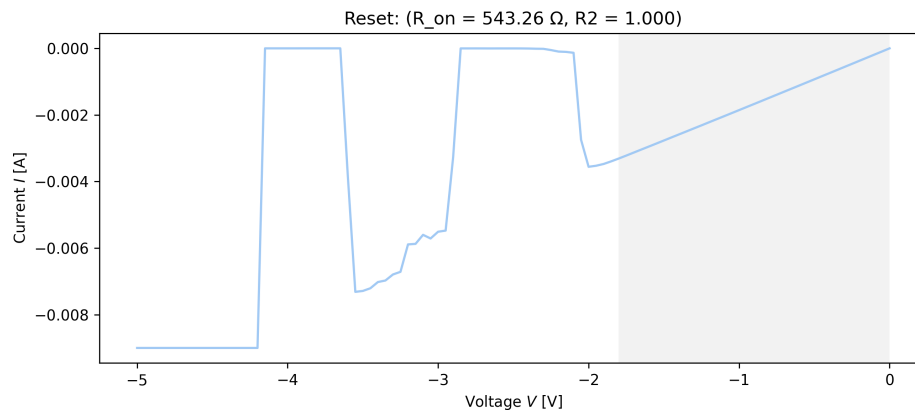
## reset

- **Time:** 03:21:22PM
- **I<sub>cc</sub>:** 9.0mA
- **Voltage Range:** 0V → -5V
- **Target Ramp Rate:** 1V/s
- **True Ramp Rate:** -1.429 V/s\*
- **Cycle:** 7
- **Resistance:** 543.26 Ω
- **Linear Fit R2:** 1.000

Failed reset

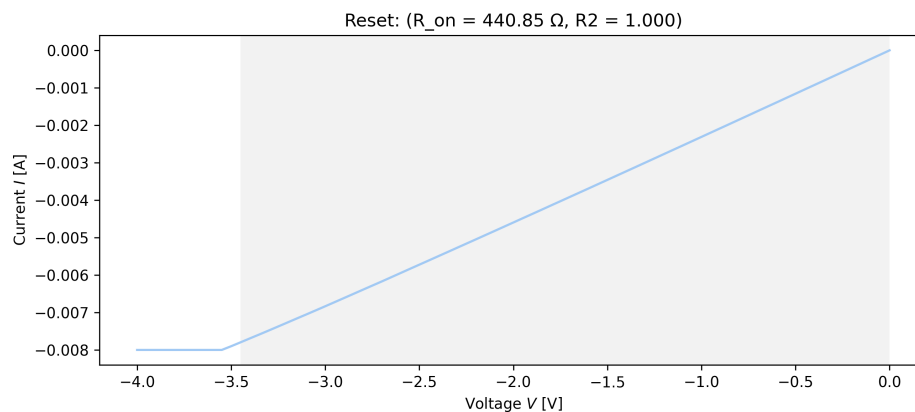
## reset

- **Time:** 03:22:34PM
- **I<sub>cc</sub>:** 8.0mA
- **Voltage Range:** 0V → -4V
- **Target Ramp Rate:** 1V/s
- **True Ramp Rate:** -1.514 V/s\*
- **Cycle:** 8
- **Resistance:** 440.85 Ω
- **Linear Fit R<sup>2</sup>:** 1.000

Failed reset

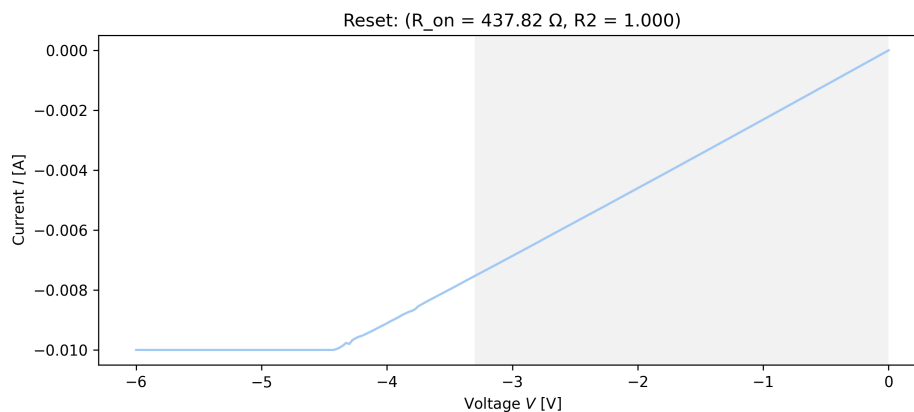
## reset

- **Time:** 03:26:18PM
- **I<sub>cc</sub>:** 10.0mA
- **Voltage Range:** 0V → -6V
- **Target Ramp Rate:** 1V/s
- **True Ramp Rate:** -0.776 V/s\*
- **Cycle:** 11
- **Resistance:** 437.82 Ω
- **Linear Fit R<sup>2</sup>:** 1.000

Failed reset
