## (wafer1,0,0,-1,-1,2,2) Characteristics

- **Cell Size:** 10um
- **Times Accessed:** 27
- **Last Measurement:** 2022/February/28 at 05:01PM

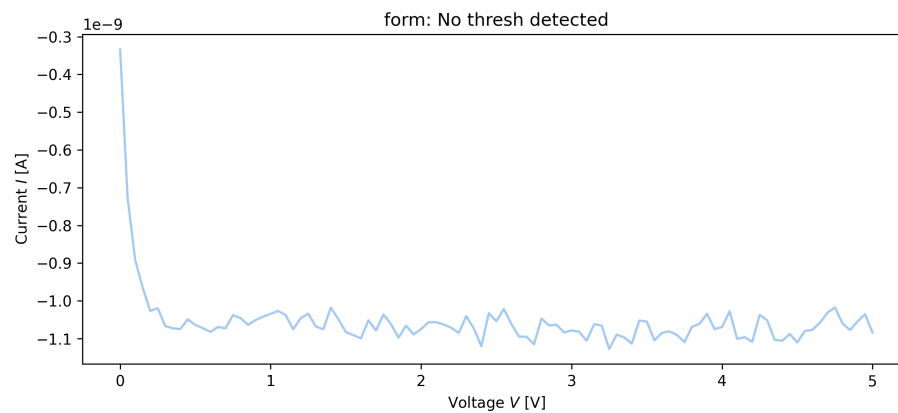
- **Time:** 04:16:09PM
- **Icc:** 10.0uA
- **Voltage Range:** 0V  $\rightarrow$  5V
- **Target Ramp Rate:** 1V/s
- **True Ramp Rate:** 1.069 V/s\*
- **Cycle:** 1
- **Error:** Set failed

Failure to form. Bad probe to pad contact. A: Copper, B: Platinum.

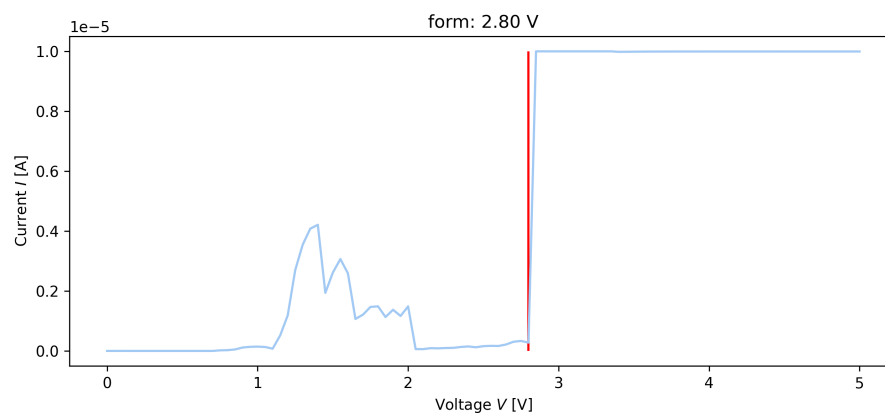
- **Time:** 04:16:59PM
- **Icc:** 10.0uA
- **Voltage Range:** 0V  $\rightarrow$  5V
- **Target Ramp Rate:** 1V/s
- **True Ramp Rate:** 1.072 V/s\*
- **Cycle:** 1
- **Set Voltage:** 2.80 V

Success, but strange curve in the beginning. A: Copper, B: Platinum.

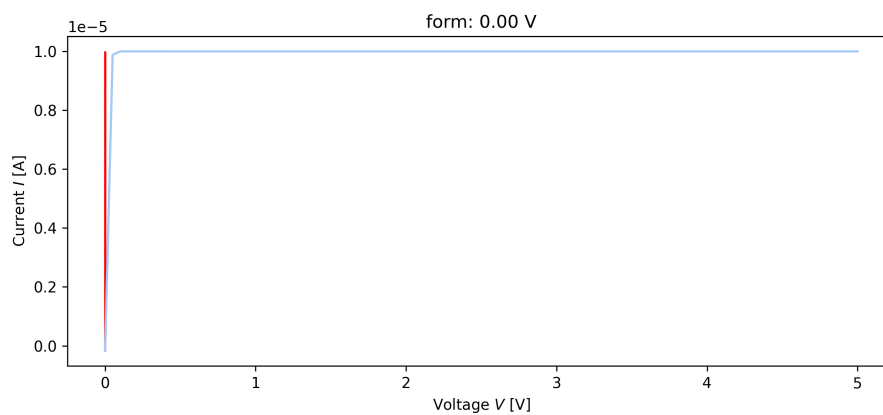
- **Time:** 04:17PM
- **Icc:** 10.0uA
- **Voltage Range:** 0V  $\rightarrow$  5V
- **Target Ramp Rate:** 1V/s
- **True Ramp Rate:** 1.842 V/s\*
- **Cycle:** 1
- **Error:** Set failed

Intention was just to observe, form success confirmed. A: Copper, B: Platinum.

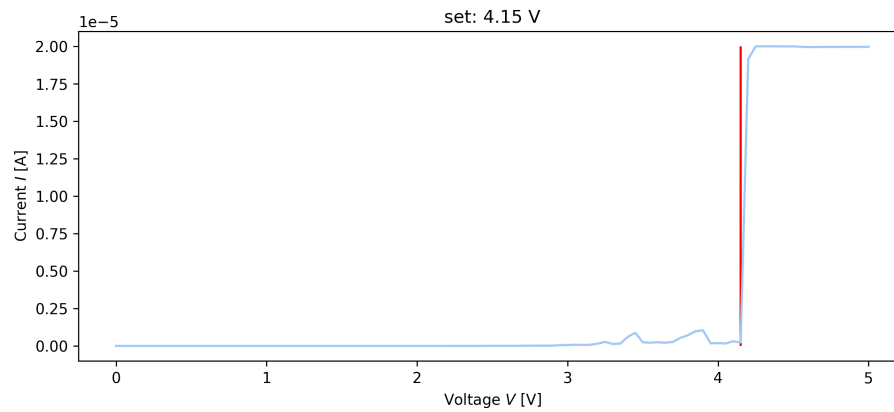
- **Time:** 04:26PM
- **Icc:** 20.0uA
- **Voltage Range:** 0V  $\rightarrow$  5V
- **Target Ramp Rate:** 1V/s
- **True Ramp Rate:** 1.069 V/s\*
- **Cycle:** 3
- **Set Voltage:** 4.15 V

Successfull set. A: Copper, B: Platinum.

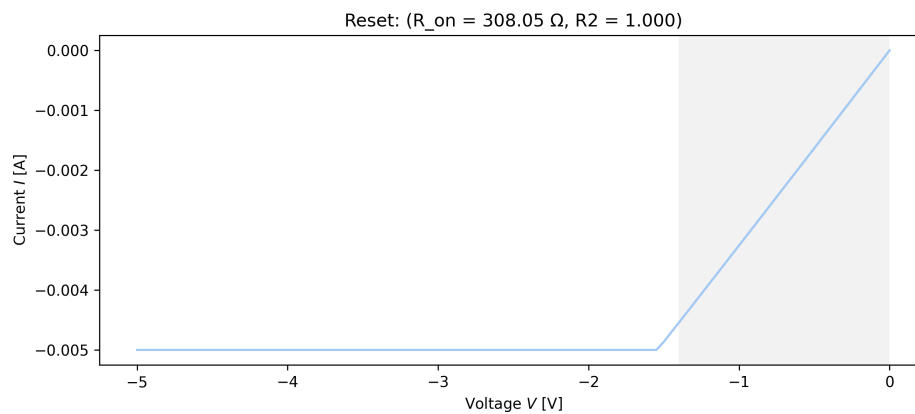
- **Time:** 04:30PM
- **I<sub>cc</sub>:** 5.0mA
- **Voltage Range:** 0V → -5V
- **Target Ramp Rate:** 1V/s
- **True Ramp Rate:** -1.609 V/s\*
- **Cycle:** 4
- **Resistance:** 308.05 Ω
- **Linear Fit R<sup>2</sup>:** 1.000

Reset failure. A: Copper, B: Platinum

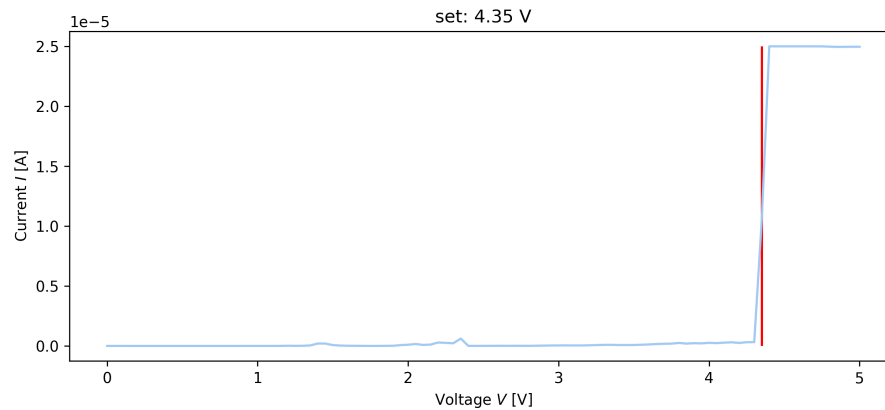
- **Time:** 04:34PM
- **Icc:** 25.0uA
- **Voltage Range:** 0V  $\rightarrow$  5V
- **Target Ramp Rate:** 1V/s
- **True Ramp Rate:** 1.069 V/s\*
- **Cycle:** 6
- **Set Voltage:** 4.35 V

Successful set. A: Copper, B: Platinum.

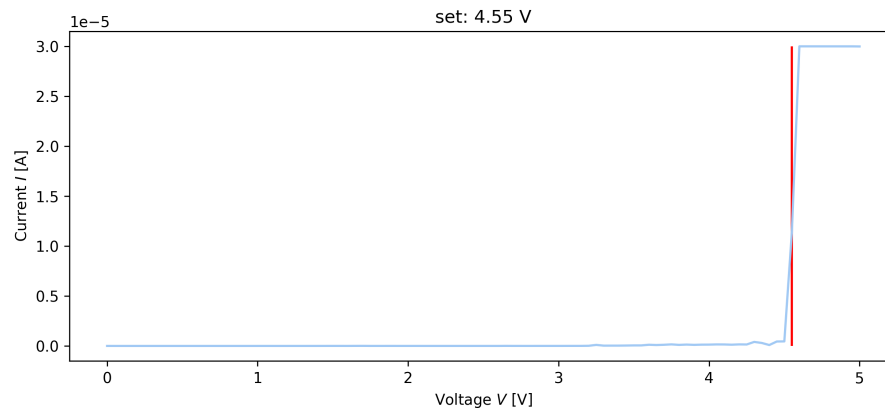
- **Time:** 04:37PM
- **Icc:** 30.0uA
- **Voltage Range:** 0V  $\rightarrow$  5V
- **Target Ramp Rate:** 1V/s
- **True Ramp Rate:** 1.069 V/s\*
- **Cycle:** 7
- **Set Voltage:** 4.55 V

Set success. A: Copper, B: Platinum.

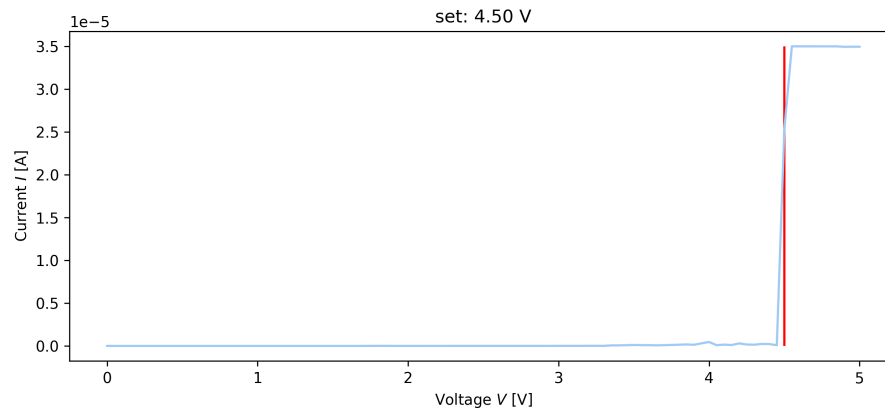
- **Time:** 04:40PM
- **Icc:** 35.0uA
- **Voltage Range:** 0V  $\rightarrow$  5V
- **Target Ramp Rate:** 1V/s
- **True Ramp Rate:** 1.068 V/s\*
- **Cycle:** 8
- **Set Voltage:** 4.50 V

Set success. A: Copper, B: platinum

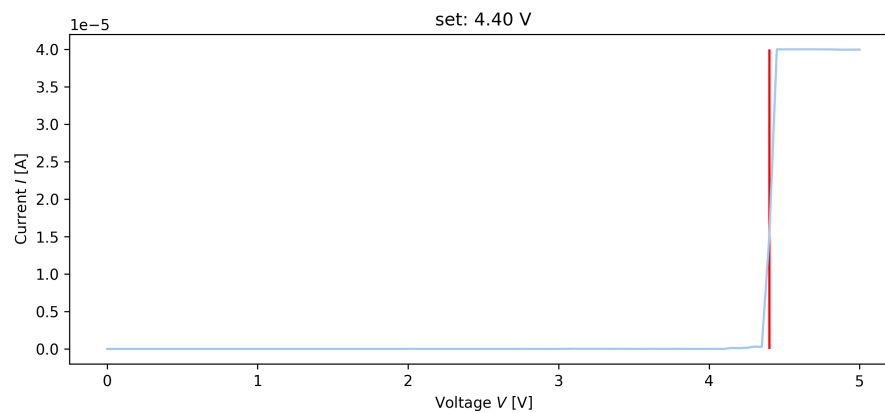
- **Time:** 04:45:00PM
- **Icc:** 40.0uA
- **Voltage Range:** 0V  $\rightarrow$  5V
- **Target Ramp Rate:** 1V/s
- **True Ramp Rate:** 1.069 V/s\*
- **Cycle:** 9
- **Set Voltage:** 4.40 V

Set sucess. A: Copper, B: Platinum.

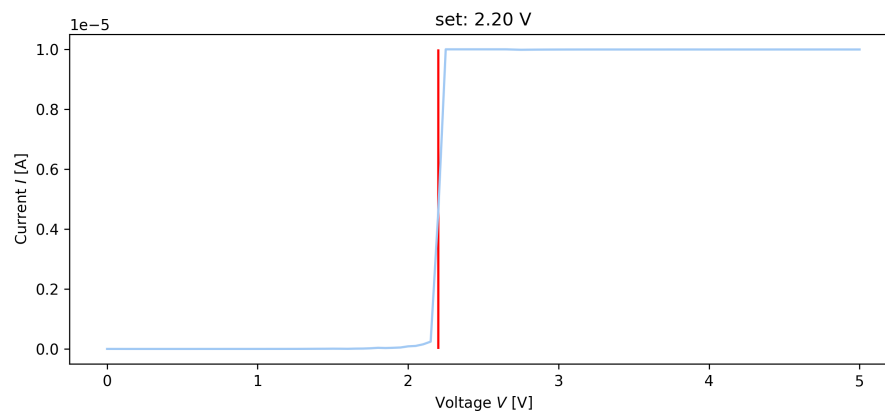
- **Time:** 04:47PM
- **I<sub>cc</sub>:** 10.0uA
- **Voltage Range:** 0V → 5V
- **Target Ramp Rate:** 1V/s
- **True Ramp Rate:** 1.069 V/s\*
- **Cycle:** 10
- **Set Voltage:** 2.20 V

Successful set. A: Copper, B: Platinum.

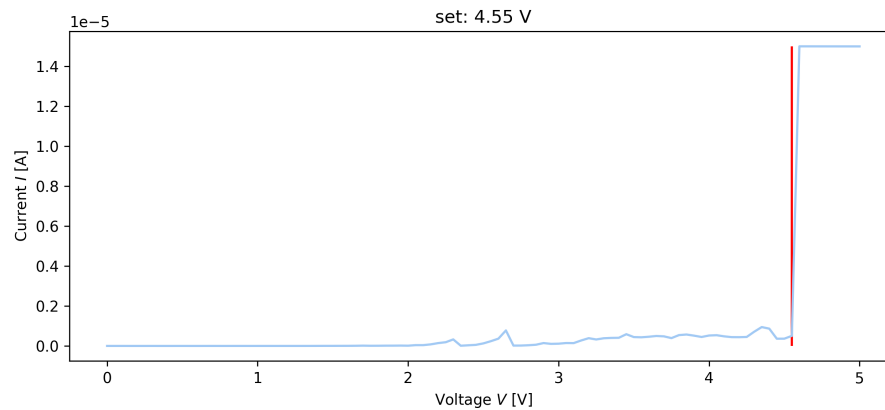
- **Time:** 04:51PM
- **Icc:** 15.0uA
- **Voltage Range:** 0V  $\rightarrow$  5V
- **Target Ramp Rate:** 1V/s
- **True Ramp Rate:** 1.069 V/s\*
- **Cycle:** 11
- **Set Voltage:** 4.55 V

Successful set. A: Copper, B: Platinum.
