## (wafer1,2,0,-1,-1,4,4) Characteristics

- **Cell Size:** 15um
- **Times Accessed:** 26
- **Last Measurement:** 2022/March/01 at 03:26:18PM

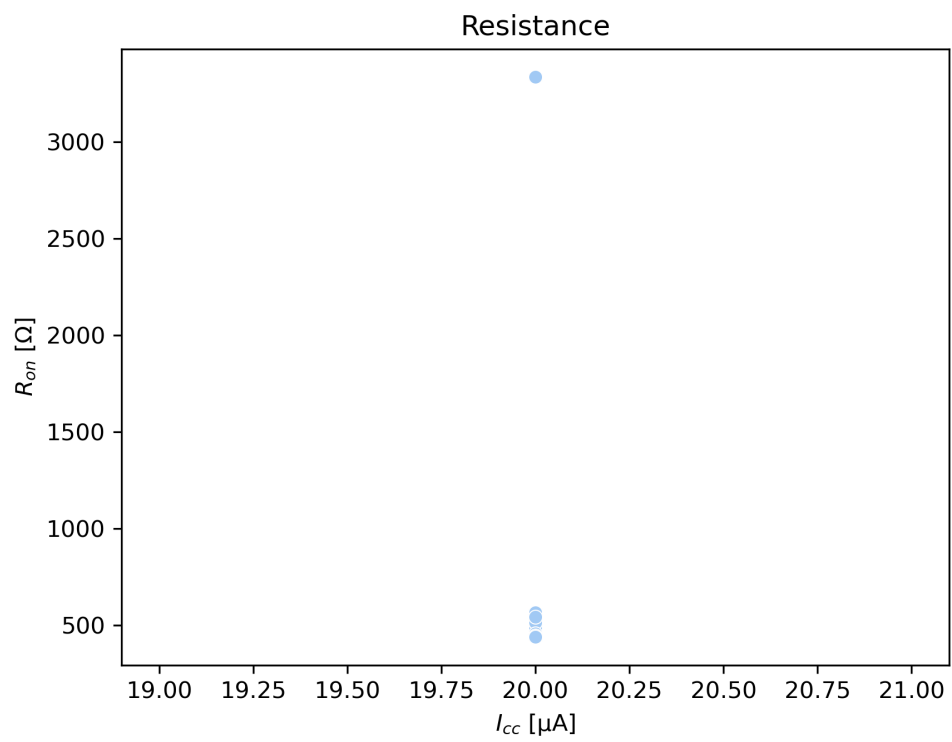
Cycle #	Set Icc ( $\mu$ A)	Set Voltage (V)	R_on ( $\Omega$ )	R2
1	20.0	1.30	415572.57	0.679
2	20.0	2.30	3334.96	1.000
3	25.0	2.15	-2344954.45	0.089
4	20.0	3.80	485.78	1.000
5	20.0	1.40	565.12	1.000
6	20.0	3.70	512.10	1.000
7	20.0	3.70	543.26	1.000
8	20.0	3.70	440.85	1.000
9	20.0	3.70	456.09	1.000
10	20.0	3.70	444.85	1.000
11	20.0	3.70	437.82	1.000

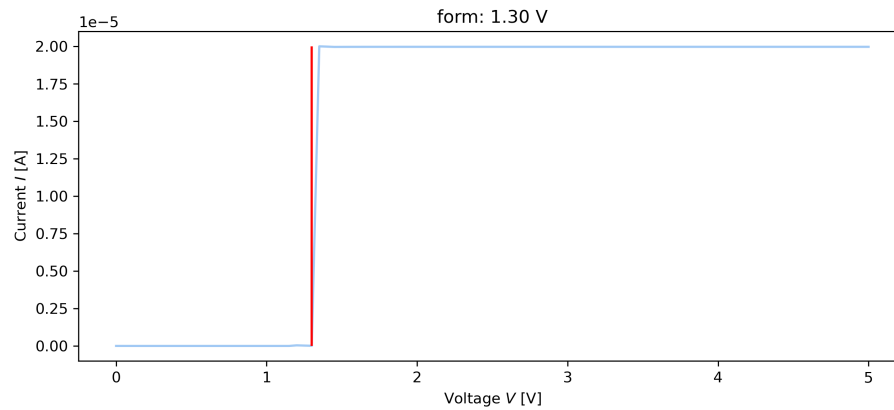
## form

- **Time:** 02:57:08PM
- **Icc:** 20.0uA
- **Voltage Range:** 0V  $\rightarrow$  5V
- **Target Ramp Rate:** 1V/s
- **True Ramp Rate:** 1.069 V/s\*
- **Cycle:** 1
- **Set Voltage:** 1.30 V

Form\* at 1.35 V. Too flimsy and reset after due to bad probe connection

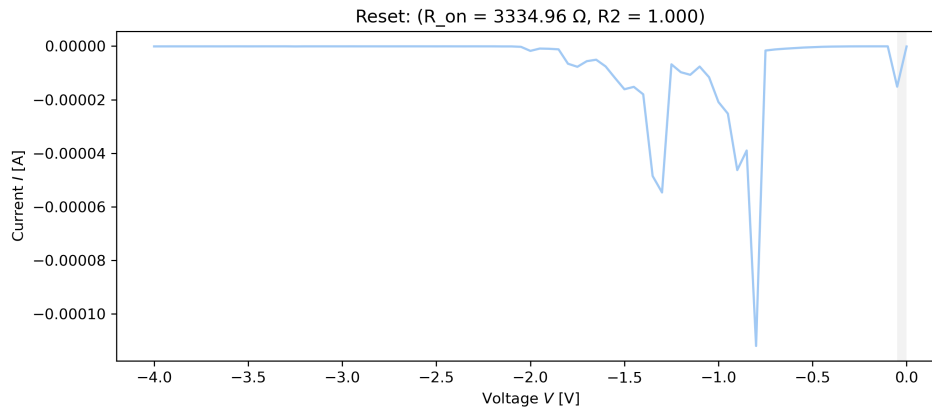
## reset

- **Time:** 03:00:49PM
- **I<sub>cc</sub>:** 5.0mA
- **Voltage Range:** 0V → -4V
- **Target Ramp Rate:** 1V/s
- **True Ramp Rate:** -1.068 V/s\*
- **Cycle:** 2
- **Resistance:** 3334.96  $\Omega$
- **Linear Fit R<sup>2</sup>:** 1.000

Wild reset graph. Probe connection issues

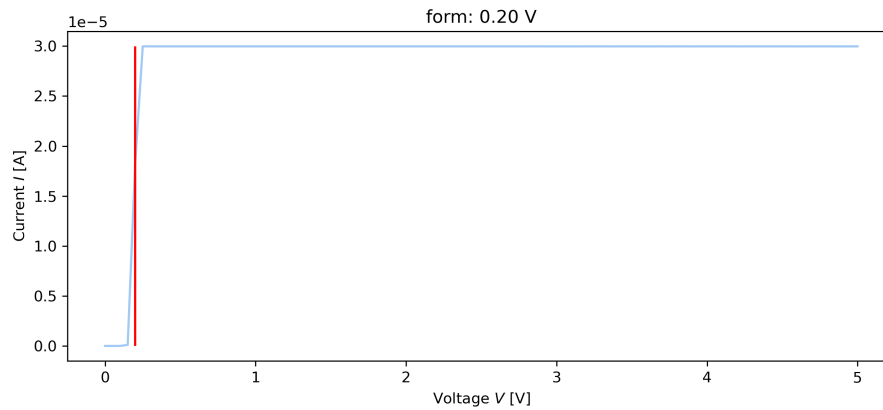
## form

- **Time:** 03:06:05PM
- **Icc:** 30.0uA
- **Voltage Range:** 0V  $\rightarrow$  5V
- **Target Ramp Rate:** 1V/s
- **True Ramp Rate:** 1.651 V/s\*
- **Cycle:** 4
- **Set Voltage:** 0.20 V

Form\* at 0.25 V, very early

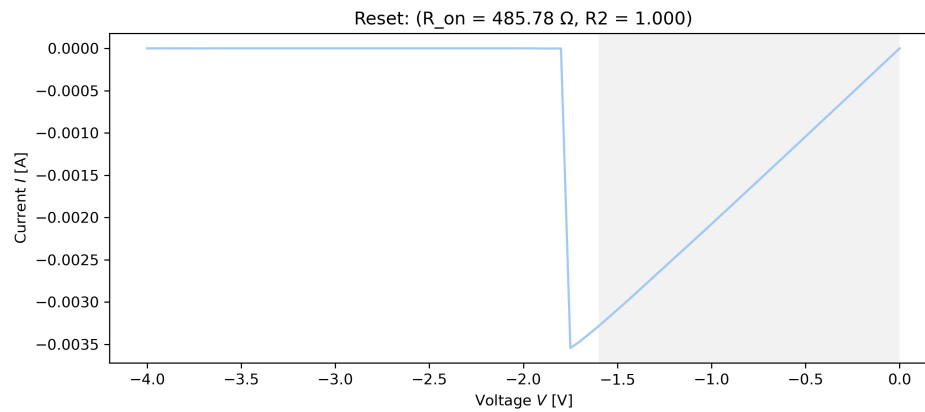
## reset

- **Time:** 03:15:33PM
- **I<sub>cc</sub>:** 5.0mA
- **Voltage Range:** 0V → -4V
- **Target Ramp Rate:** 1V/s
- **True Ramp Rate:** -1.470 V/s\*
- **Cycle:** 4
- **Resistance:** 485.78 Ω
- **Linear Fit R<sup>2</sup>:** 1.000

Reset at -1.8 V

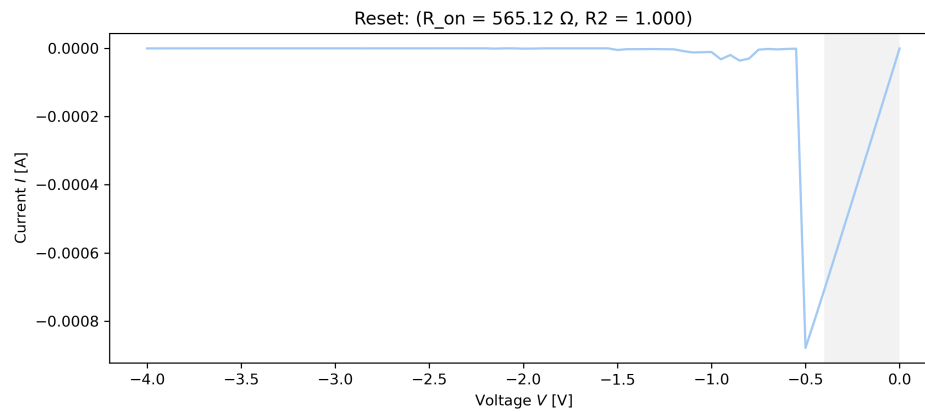
## reset

- **Time:** 03:18:44PM
- **I<sub>cc</sub>:** 5.0mA
- **Voltage Range:** 0V → -4V
- **Target Ramp Rate:** 1V/s
- **True Ramp Rate:** -1.104 V/s\*
- **Cycle:** 5
- **Resistance:** 565.12 Ω
- **Linear Fit R<sup>2</sup>:** 1.000

Reset at -0.55 V

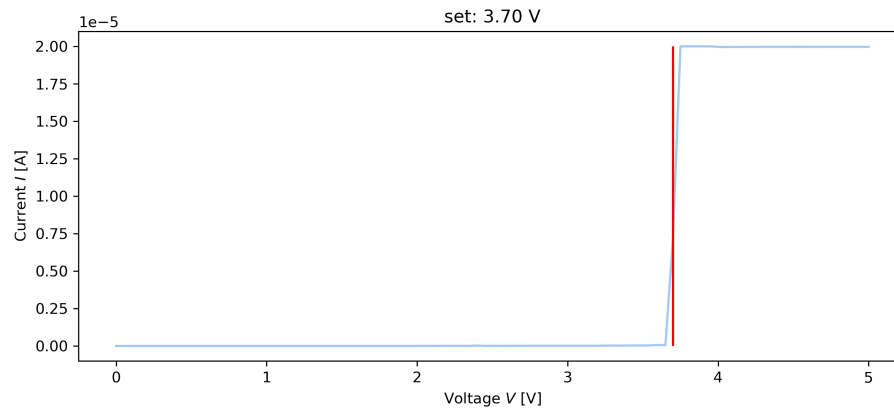
## set

- **Time:** 03:20:00PM
- **Icc:** 20.0uA
- **Voltage Range:** 0V  $\rightarrow$  5V
- **Target Ramp Rate:** 1V/s
- **True Ramp Rate:** 1.069 V/s\*
- **Cycle:** 6
- **Set Voltage:** 3.70 V

Set at 3.7 V

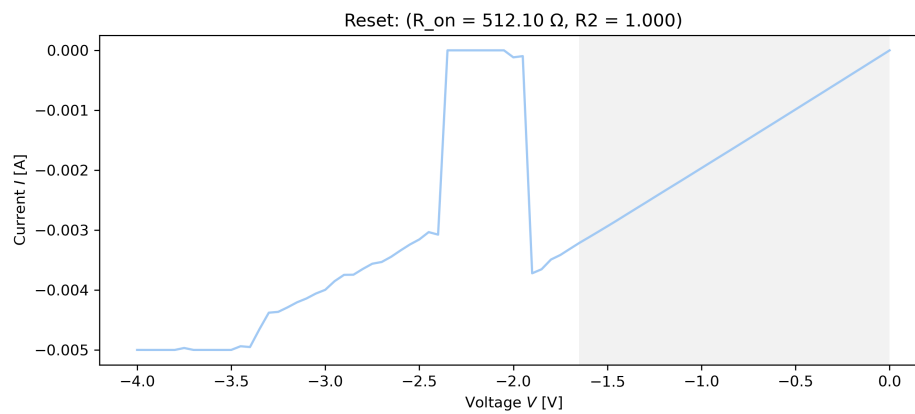
## reset

- **Time:** 03:20:44PM
- **I<sub>cc</sub>:** 5.0mA
- **Voltage Range:** 0V → -4V
- **Target Ramp Rate:** 1V/s
- **True Ramp Rate:** -1.429 V/s\*
- **Cycle:** 6
- **Resistance:** 512.10 Ω
- **Linear Fit R2:** 1.000

Failed reset

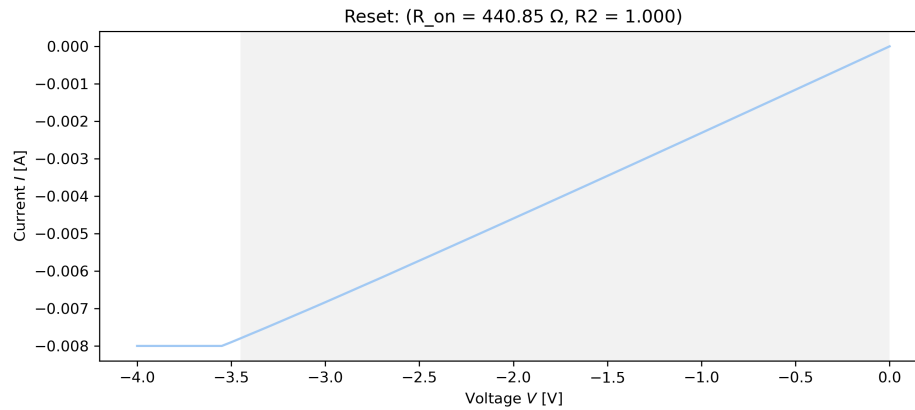
## reset

- **Time:** 03:22:34PM
- **I<sub>cc</sub>:** 8.0mA
- **Voltage Range:** 0V → -4V
- **Target Ramp Rate:** 1V/s
- **True Ramp Rate:** -1.514 V/s\*
- **Cycle:** 8
- **Resistance:** 440.85 Ω
- **Linear Fit R<sup>2</sup>:** 1.000

Failed reset

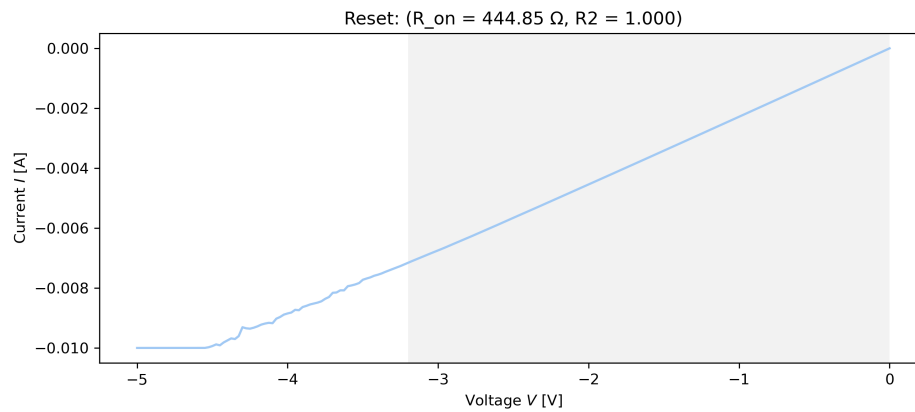
## reset

- **Time:** 03:25:42PM
- **Icc:** 10.0mA
- **Voltage Range:** 0V  $\rightarrow$  -5V
- **Target Ramp Rate:** 1V/s
- **True Ramp Rate:** -0.777 V/s\*
- **Cycle:** 10
- **Resistance:** 444.85  $\Omega$
- **Linear Fit R2:** 1.000

Failed reset

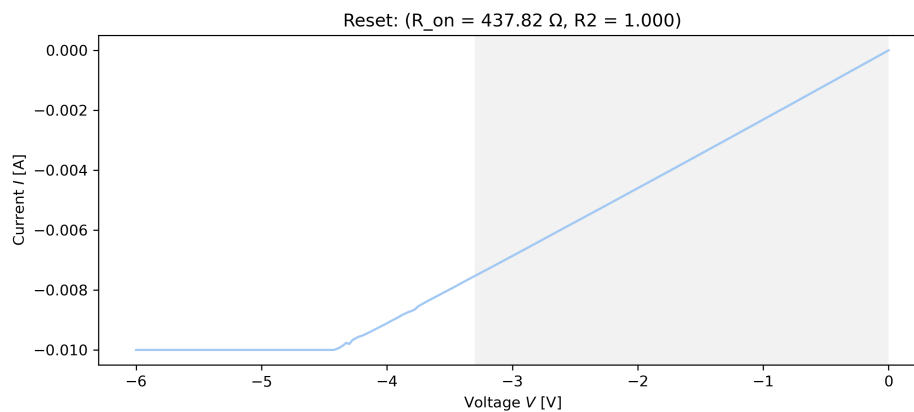
## reset

- **Time:** 03:26:18PM
- **I<sub>cc</sub>:** 10.0mA
- **Voltage Range:** 0V → -6V
- **Target Ramp Rate:** 1V/s
- **True Ramp Rate:** -0.776 V/s\*
- **Cycle:** 11
- **Resistance:** 437.82 Ω
- **Linear Fit R<sup>2</sup>:** 1.000

Failed reset
