(wafer2,0,1,-1,-1,1,1) Characteristics

- **Cell Size:** 10um
- **Times Accessed:** 3
- **Last Measurement:** 2022/March/17 at 03:54:56PM

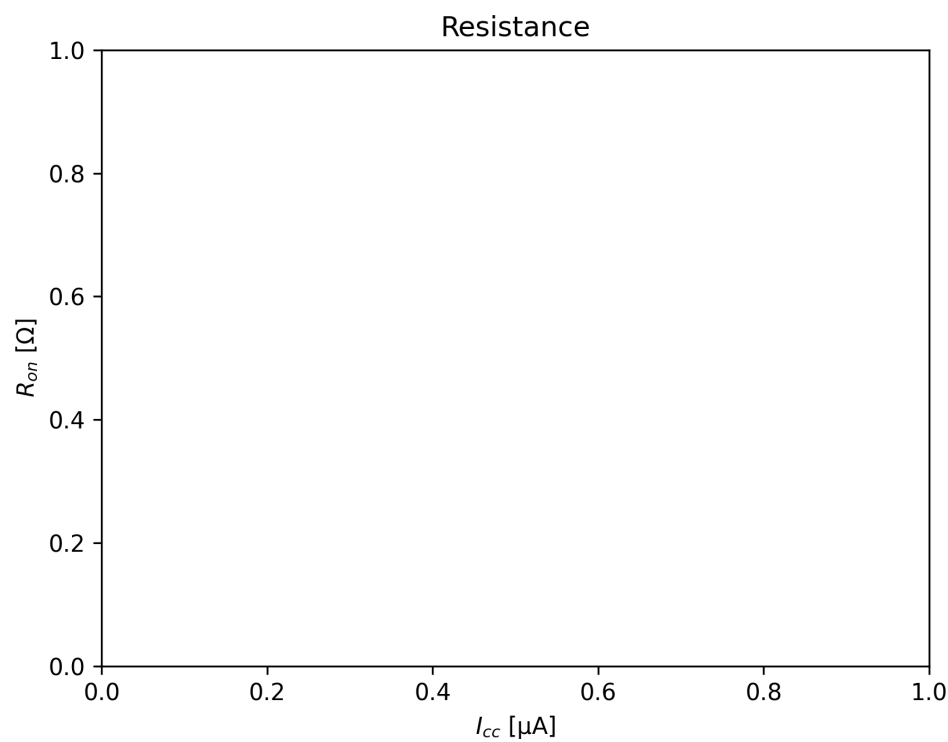
form

- **Time:** 03:53:44PM
- **Icc:** 20.0uA
- **Voltage Range:** 0V \rightarrow 5V
- **Target Ramp Rate:** 1V/s
- **True Ramp Rate:** 1.069 V/s*
- **Cycle:** 1
- **Error:** Set failed

Not conducting

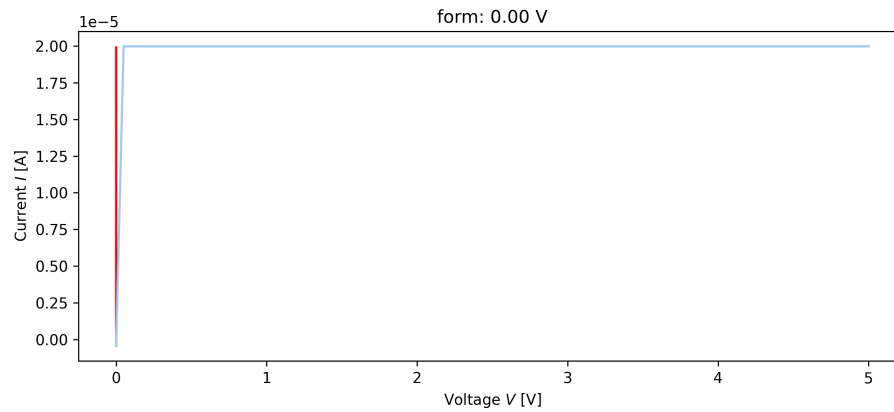
form

- **Time:** 03:54:05PM
- **Icc:** 20.0uA
- **Voltage Range:** 0V \rightarrow 5V
- **Target Ramp Rate:** 1V/s
- **True Ramp Rate:** 1.838 V/s*
- **Cycle:** 1
- **Error:** Set failed

Immediately set.. double ramp rate. Amrita is frustrated

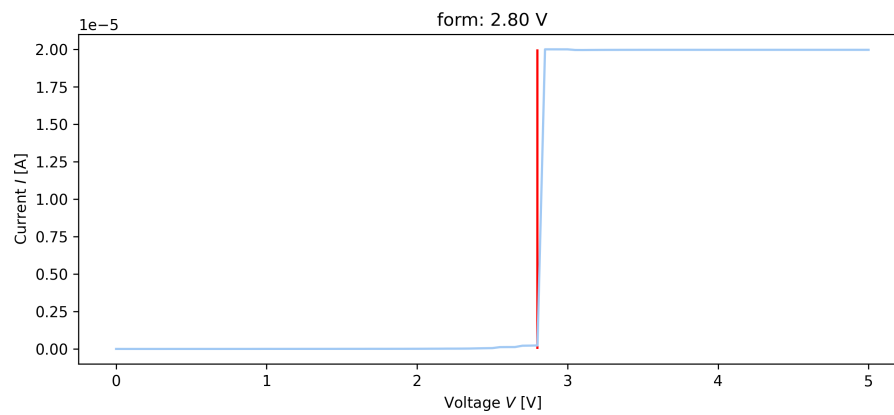
form

- **Time:** 03:54:56PM
- **Icc:** 20.0uA
- **Voltage Range:** 0V \rightarrow 5V
- **Target Ramp Rate:** 1V/s
- **True Ramp Rate:** 1.069 V/s*
- **Cycle:** 1
- **Set Voltage:** 2.80 V

Formed at 2.85
