## (wafer1,0,0,-1,-1,2,2) Characteristics

- **Cell Size:** 10um
- **Times Accessed:** 27
- **Last Measurement:** 2022/February/28 at 05:01PM

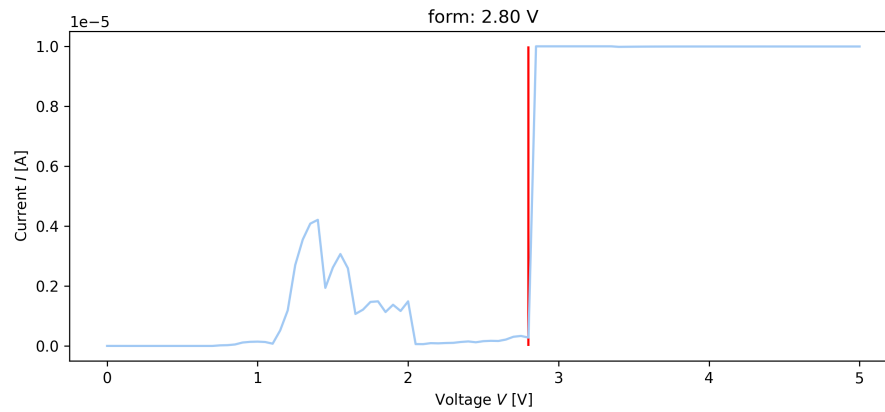
- **Time:** 04:16:59PM
- **Icc:** 10.0uA
- **Voltage Range:** 0V  $\rightarrow$  5V
- **Target Ramp Rate:** 1V/s
- **True Ramp Rate:** 1.072 V/s\*
- **Cycle:** 1
- **Set Voltage:** 2.80 V

Success, but strange curve in the beginning. A: Copper, B: Platinum.

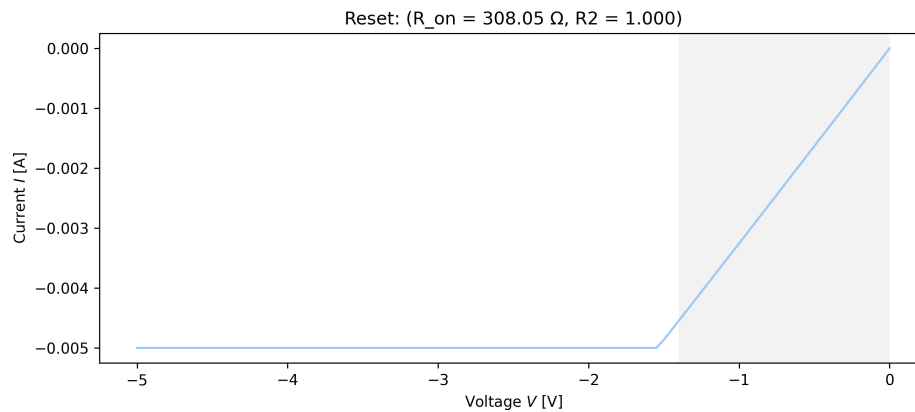
- **Time:** 04:30PM
- **I<sub>cc</sub>:** 5.0mA
- **Voltage Range:** 0V → -5V
- **Target Ramp Rate:** 1V/s
- **True Ramp Rate:** -1.609 V/s\*
- **Cycle:** 4
- **Resistance:** 308.05 Ω
- **Linear Fit R<sup>2</sup>:** 1.000

Reset failure. A: Copper, B: Platinum

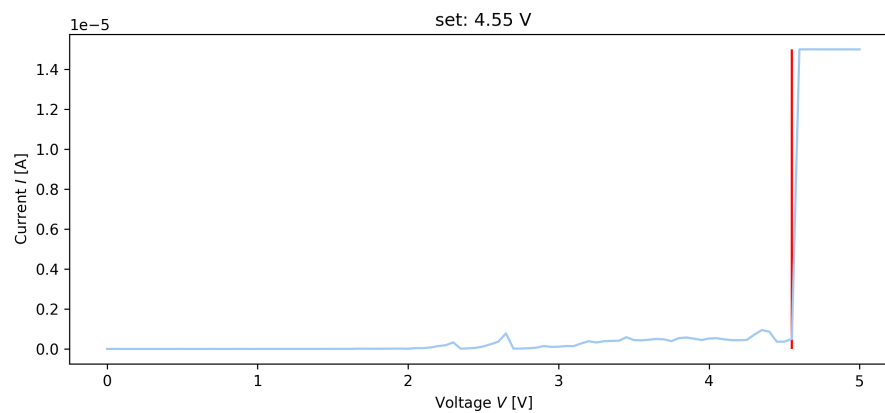
- **Time:** 04:51PM
- **Icc:** 15.0uA
- **Voltage Range:** 0V  $\rightarrow$  5V
- **Target Ramp Rate:** 1V/s
- **True Ramp Rate:** 1.069 V/s\*
- **Cycle:** 11
- **Set Voltage:** 4.55 V

Successful set. A: Copper, B: Platinum.
