(wafer2,0,7,-1,-1,1,2) Characteristics

- **Cell Size:** 10um
- **Times Accessed:** 5
- **Last Measurement:** 2022/March/28 at 04:27:00PM

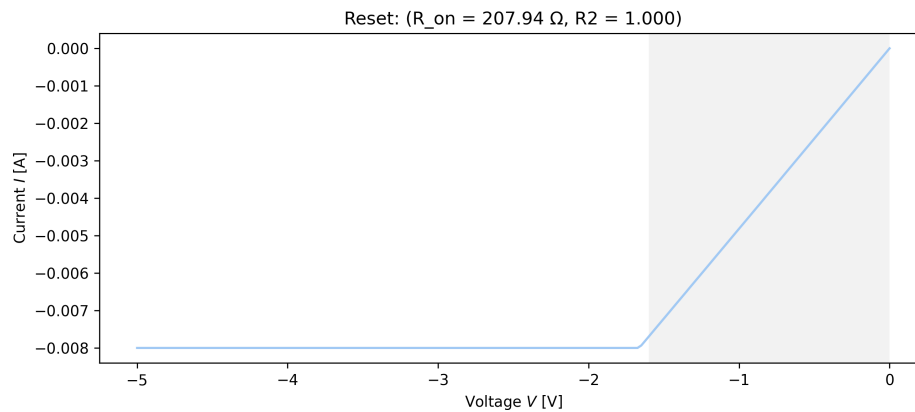
reset

- **Time:** 04:26:33PM
- **I_{cc}:** 8.0mA
- **Voltage Range:** 0V → -5V
- **Target Ramp Rate:** 1V/s
- **True Ramp Rate:** -0.867 V/s*
- **Cycle:** 1
- **Resistance:** 207.94 Ω
- **Linear Fit R2:** 1.000

Did not reset, bad cell

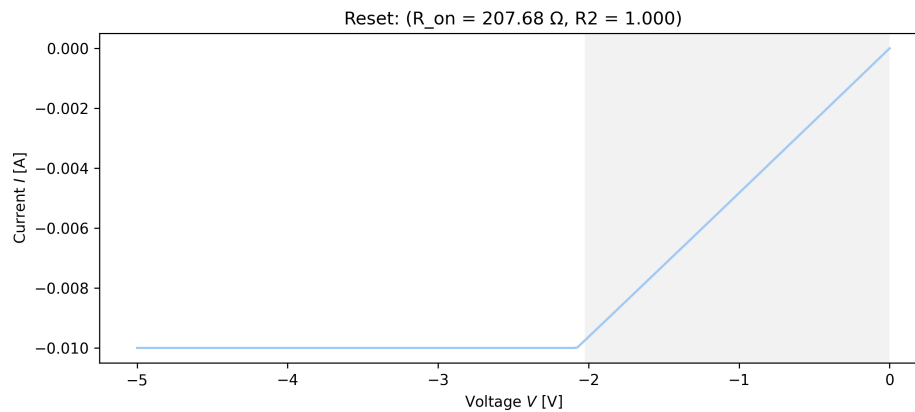
reset

- **Time:** 04:27:00PM
- **I_{cc}:** 10.0mA
- **Voltage Range:** 0V → -5V
- **Target Ramp Rate:** 1V/s
- **True Ramp Rate:** -0.867 V/s*
- **Cycle:** 1
- **Resistance:** 207.68 Ω
- **Linear Fit R2:** 1.000

Did not reset, bad cell
