(wafer1,2,0,-1,-1,4,4) Characteristics

- **Cell Size:** 15um
- **Times Accessed:** 26
- **Last Measurement:** 2022/March/01 at 03:26:18PM

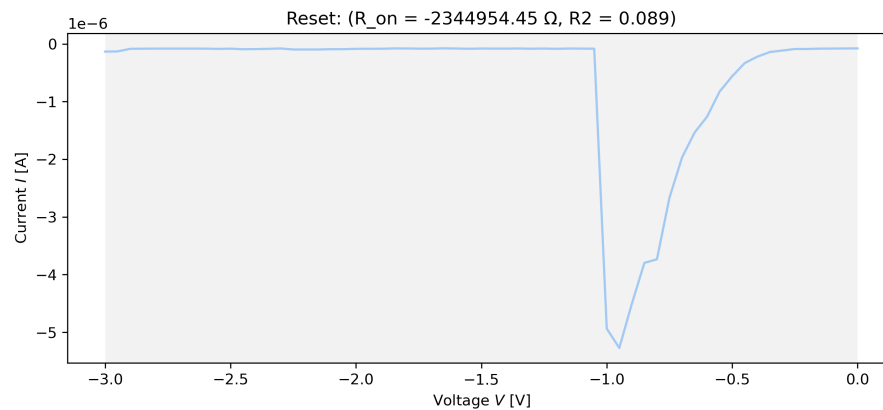
- **Time:** 03:02:52PM
- **I_{cc}:** 5.0mA
- **Voltage Range:** 0V → -3V
- **Target Ramp Rate:** 1V/s
- **True Ramp Rate:** -1.067 V/s*
- **Cycle:** 3
- **Resistance:** -2344954.45 Ω
- **Linear Fit R2:** 0.089

Reset at -1.05 V, but had non-ohmic behavior leading up to reset

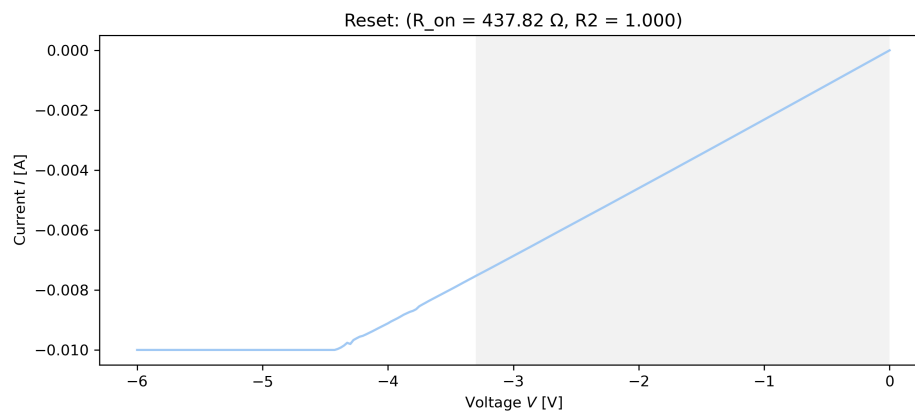
- **Time:** 03:26:18PM
- **Icc:** 10.0mA
- **Voltage Range:** 0V \rightarrow -6V
- **Target Ramp Rate:** 1V/s
- **True Ramp Rate:** -0.776 V/s*
- **Cycle:** 11
- **Resistance:** 437.82 Ω
- **Linear Fit R2:** 1.000

Failed reset
