# DEVELOPING FIELD PROTOCOLS FOR USING ROBOTS TO SUPPLEMENT FORENSIC INVESTIGATIONS

When conducting forensic investigations or structural condition surveys, robots have proven invaluable where physical access to interior voids cannot be accomplished. While global protocols exist for conducting general forensic investigations as well as structural condition surveys, only rudimentary protocols exist for the operation of robots within this domain. Therefore, application protocols and site-specific field protocols must be developed on a case-by-case basis when using robots. Specifically, robots can effectively identify and quantify the existence and extent of damage when properly equipped and operated. Robots can also provide real-time photogrammetry as well as a means of recording pre-deconstructive conditions. This paper serves to identify state of the art use of robots within forensic engineering by discussing the proper outfitting, operating, and field use of robots to supplement forensic investigations as well as structural condition surveys.

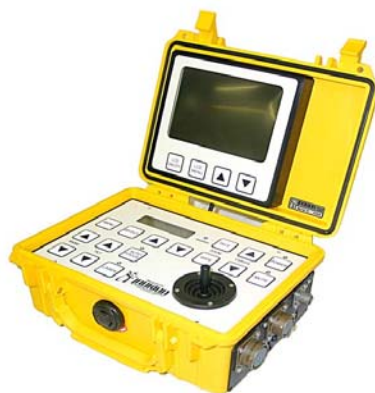
Fig. 3: Operator control unit for running the VGTV-Xtreme through a confined space.

The robot is to be operated through a small operator control unit (OCU). This unit should provide joystick control and a video display. Additional functionality should include water resistant touch buttons on the control panel along with connections for power, tether, video, audio, and USB. Field review of data requires a shaded and low-noise environment so as to provide higher clarity for the operator’s video screen and audio.

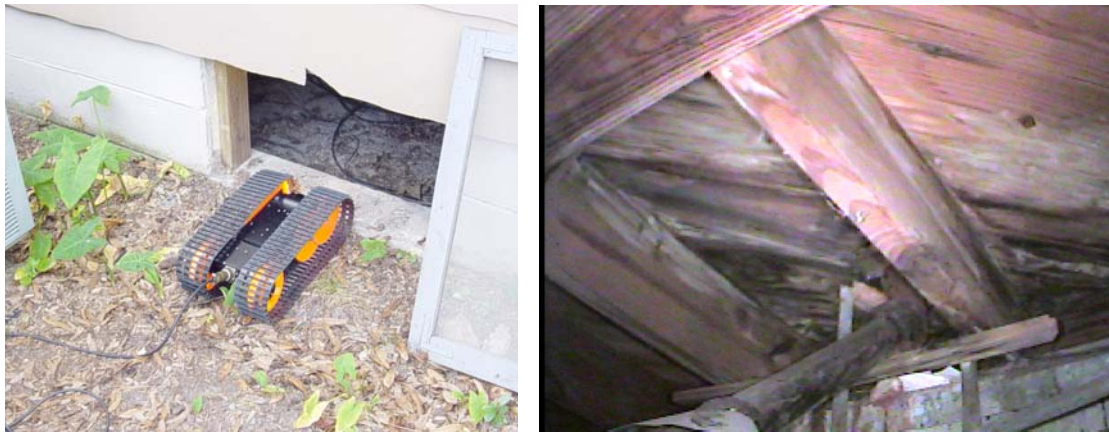
Fig. 4: (Left) VGTV-Xtreme ready to explore the underside of a house to determine if engineers need to enter. (Right) The robot quickly identifies water damage to the sub-floor.

The engineer then began to guide the robot operator through the underside of the sub-floor. This guided tour was intended to document the style of construction and to approximate the age of the house. At a far corner of the house, a large drain pipe was noticed with discoloration of the soil below. The operator maneuvered the robot over to this area and it was immediately determined that there had been previous water damage to the sub-floor around this drain pipe. Mold and deteriorated wood was easily seen by the robot and confirmed the location of interest.

At this point, the engineering team had determined that the house was structurally sound and the location of damage. It was decided that two engineers would proceed into the crawlspace for first-hand inspection of the damage. Upon entering the space, the two engineers found themselves interacting with the robot as an active member of their team, asking the robot operator to “come take a look at this” and “can you get a picture of this joist”. The robot was able to provide clear audio and video to the property owner and to give outside personnel a first-person view of the damage that had occurred.

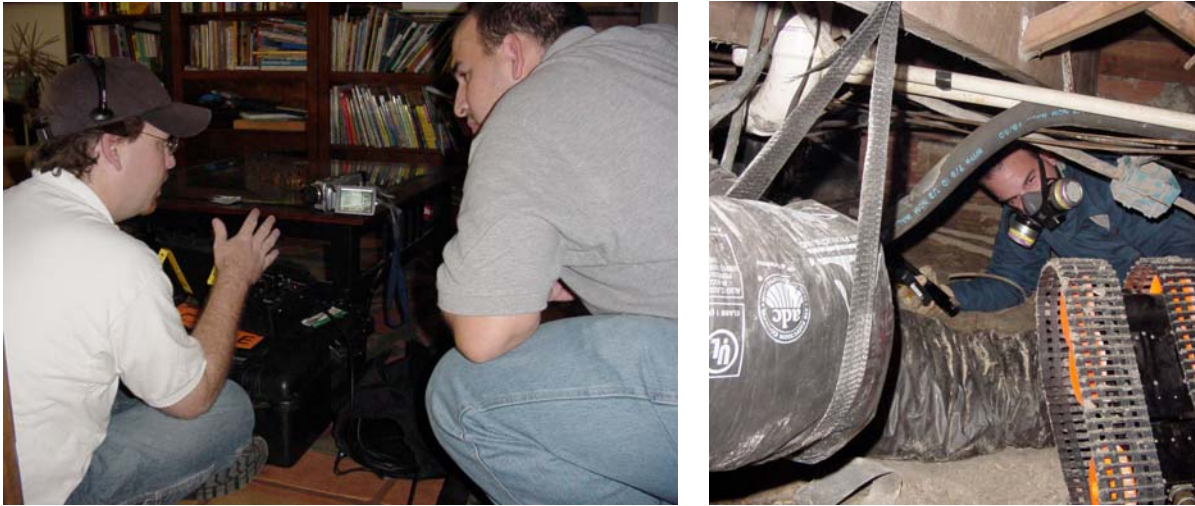
Fig. 5: (Left) Operator and engineer do a rapid assessment of the sub-floor. (Right) The engineer helps the VGTV-Xtreme explore spaces he cannot reach.

The robot then attempted to move toward the area of damage. Within 6 feet of the robot’s initial position, a large HVAC duct was blocking the path. All attempts to circumvent this problem failed due to the sheer height of the duct compared to the robot. At this point, the senior engineer decided that human intervention was needed and the inspection engineer prepared to enter the space. Upon lowering himself below the floor, the engineer immediately noted the high moisture content in the air and surrounding soil. The engineer crawled to the robot and lifted it over the HVAC duct. He also climbed past this obstruction and the two slowly made their way to the damaged area. Interestingly, throughout this exercise, the engineer could talk through the robot as if it was an active member of his inspection team. As they progressed, he was able to ask questions of the residence owner and receive immediate replies. This interaction also allowed the senior engineer to continually assess and evaluate conditions with an eye toward the safety of the inspecting engineer.

The engineer reached a point where he could no longer continue forward due to pipes and other obstructions. Fortunately, he was able to help the robot push forward further into the structure and collect the necessary data.
