CHELTON AVENUE  
(Day 2: Completed)

8/30/2017

SURFACE MOUNT  
FIORÉ Type SHELTER

WAYNE AVENUE

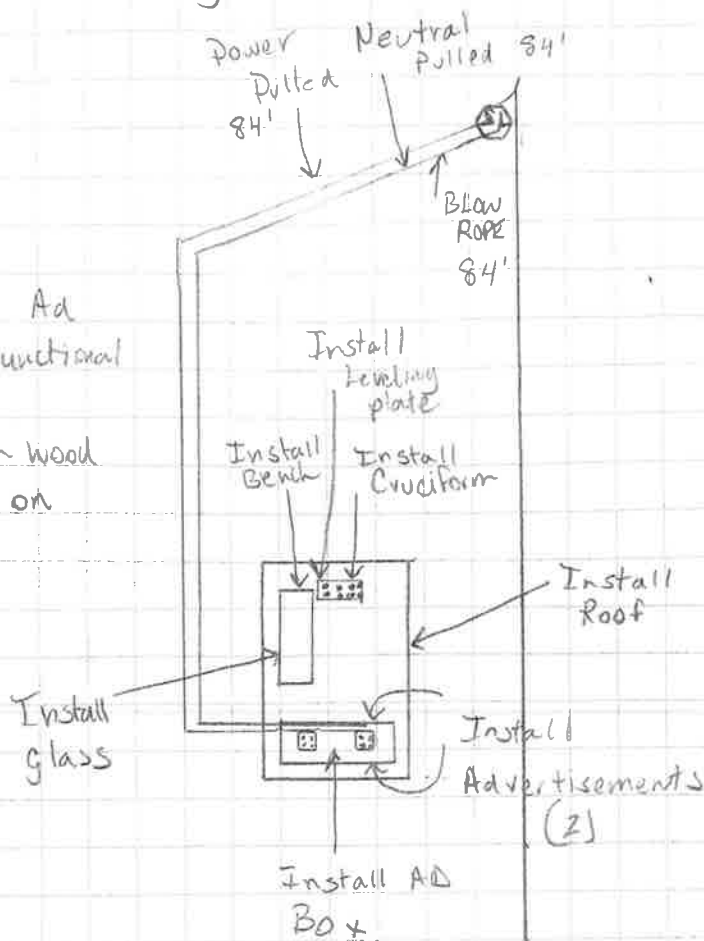
- ① Light Inside Ad Box Not Functional
- ② Small Crack in wood on one slat on bench

Leveling plate = (1)

AD Box = (8) 3/4 S.S Rods Drilled & Epoxy.

Cruciform = (4) 3/4 S.S Rods Drilled & Epoxy.

BENCH = (10) 3/4 S.S Rods Drilled & Epoxy.

GLASS = 3 sections installed: set, spacers, chalked

Rope, Neutral, Positive = 84', 84', 84'

groove = leveling plate, bench, ad box
