ASSESSING FEMUR AND PELVIS INJURY RISK IN CAR-PEDESTRIAN COLLISIONS: COMPARISON OF FULL BODY PMTO IMPACTS, AND A HUMAN BODY FINITE ELEMENT MODEL

Paper number 05-103

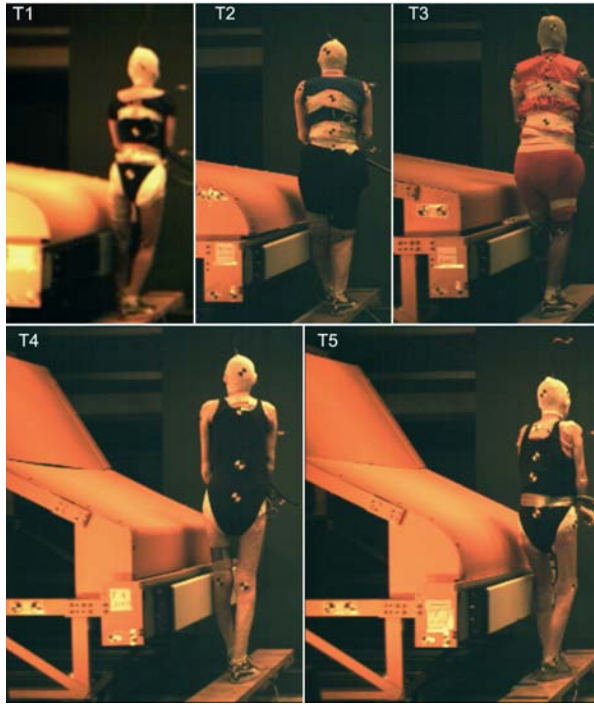
Figure 4. While geometries for a given vehicle class have identical hood edge height as defined by the current EEVC protocol, the effective hood leading edge height is higher with respect to smaller stature pedestrians.

For each PMTO, one of the four automotive geometries described above was bolted to the test sled. The initial velocity of the sled was 40.0 ± 0.3 kph at time of impact, and the sled was decelerated at 13 m/s^2 after contact. Details about the impact conditions of each test are listed in Table 3. Impact and post-impact kinematics were recorded at 1,000 frames per second from two high speed digital video cameras mounted perpendicularly to the sled track. A lateral view of the car geometries and relative statures of the PMTOs is shown in Figure 4.

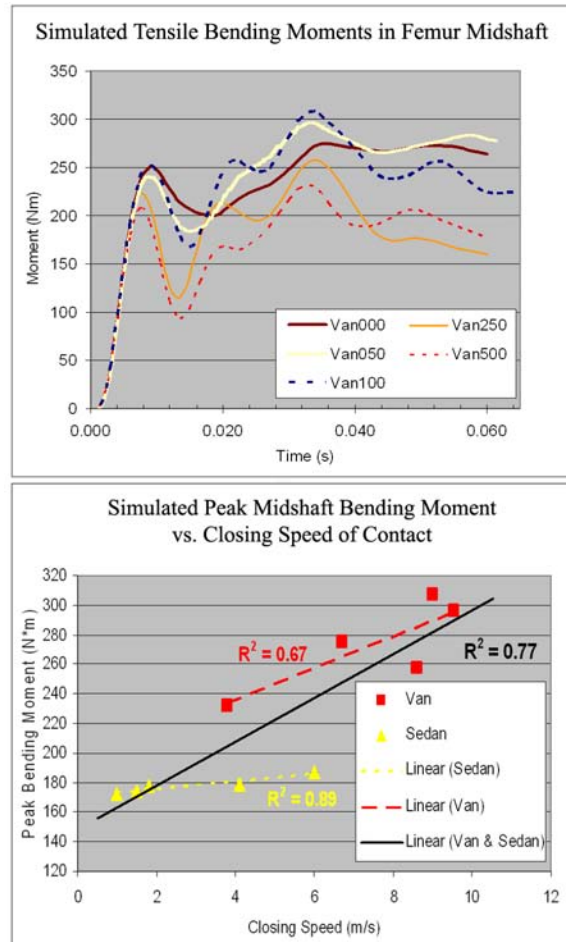
Figure 6. (Top) The larger leading edge radii impart a rolling motion to the thigh. This effectively reduces the closing velocity, and consequently, the peak bending moment in the femur. **(Bottom)** As closing speed increases, so does the bending load applied to the femoral shaft due to hood contact. These trends were also observed in the PMTO experiments.

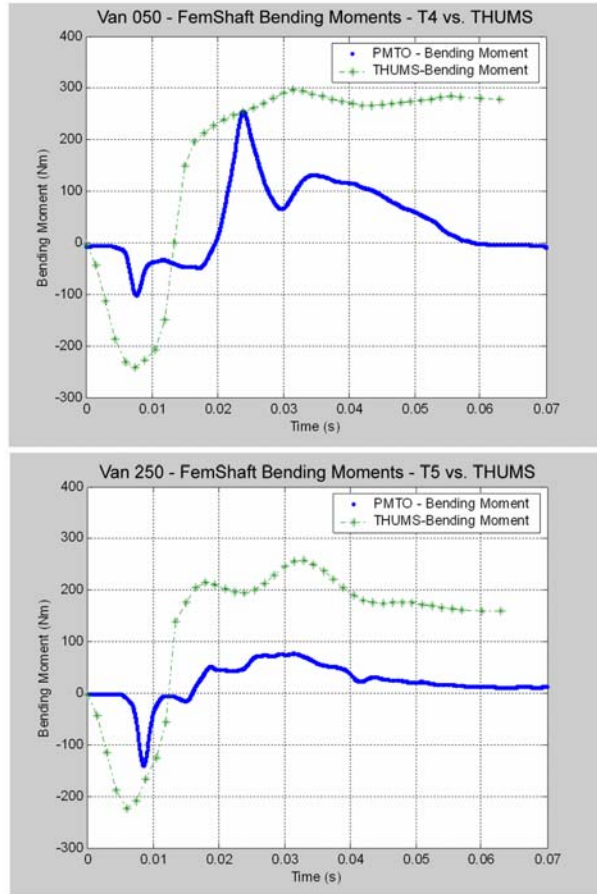
Figure 8. In both van impacts, a catastrophic failure of the acetabulum and superior pubic ramus on the struck side of the PMTO may have contributed to decreased loading of the femur.

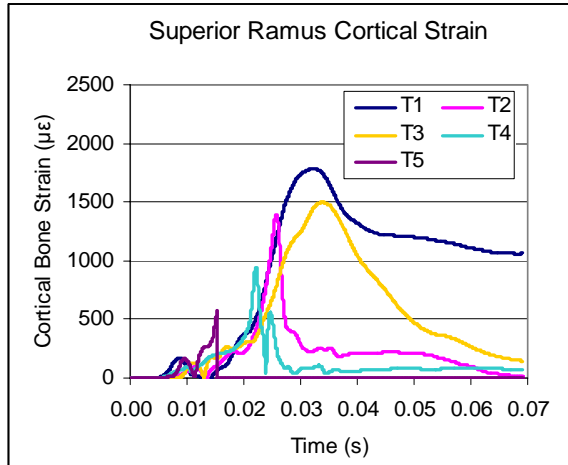
Figure 10. Cortical bone stresses in the superior pubic ramus. Pelvises of T2, T4, and T5 were fractured during impact, as indicated by the sharp drop in strain.

The recorded pubic rami strains were similar for all PMTO's (Figure 10). Bone strain increased rapidly after contact between the thigh/buttocks and the hood, then either dropped immediately in the case of pelvic fracture, or continued to rise and then gradually decrease in cases of non-fracture.

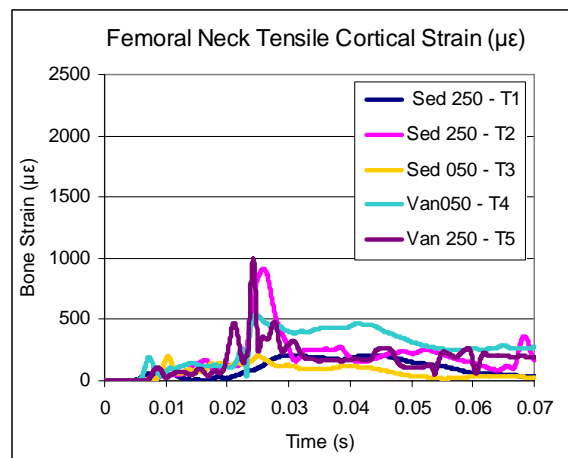
Figure 12. Cortical bone strains in the femoral neck.

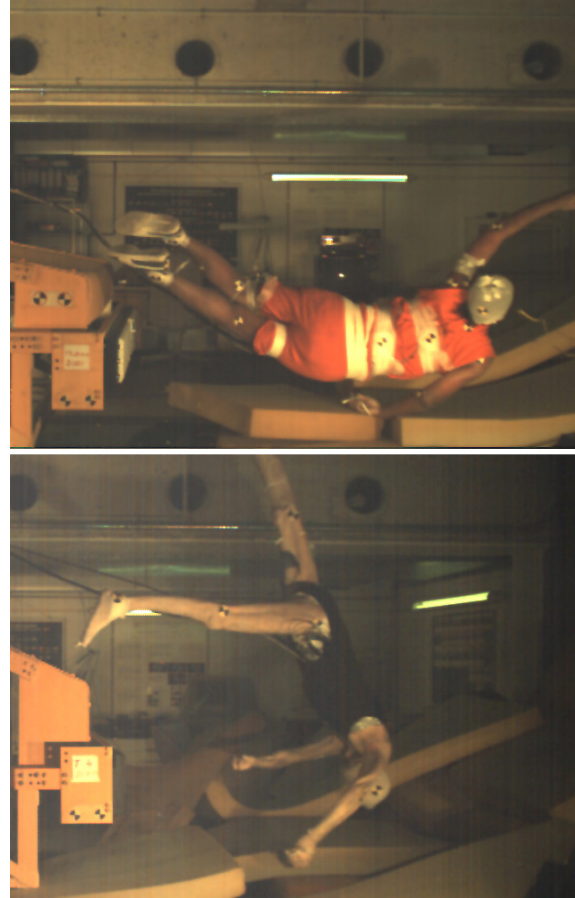
Figure 13. Secondary road impact is an very important design consideration that is often neglected. PMTOs struck by the sedan landed on their sides. PMTOs struck by the vans were thrown onto their heads. Notice the use of ground padding cushioned secondary impact, possibly resulting in fewer injuries than would be observed against a rigid road surface.

Video analysis revealed that all PMTOs were rotated between 190 and 270 degrees in the sagittal plane depending upon the shape of the vehicular hood. The pedestrians struck by the sedan geometries often made a secondary impact with the hood before landing on the ground. This secondary impact provided additional rotation of the body, and prevented the PMTO from landing head-first on the test track. The shorter, angled hoods of the van geometries, and head contact with the van windscreen caused PMTOs T4 and T5 to rotate approximately 190 degrees, thus resulting in a head-first contact with the ground (Figure 13). It should be noted that PMTO T4 had a cranial fracture, and PMTO T4 and T5 both experienced cervical spine fractures at C7. However, it is not clear whether these injuries occurred as a result of primary, or secondary impact.

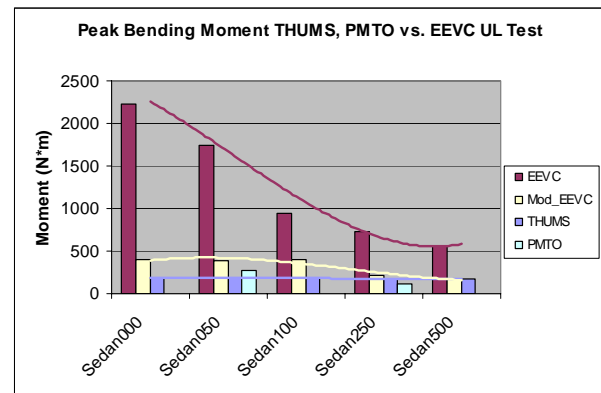
Figure 16. Comparison of the peak bending moments for impact against sedan geometries.

The proposed modifications to the EEVC test conditions greatly improved correlation to both the THUMS pedestrian model and PMTO impact results for bending moments (Figure 16). However, the modified EEVC simulations still predict higher bending moments than the THUMS simulations or PMTO tests.

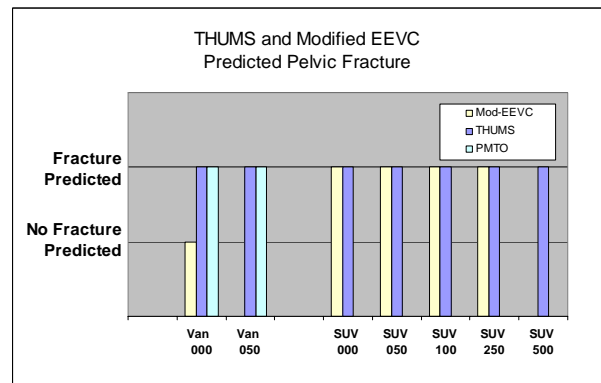
Figure 17. Comparison of pelvic fracture predictions between the modified EEVC protocol, PMTO test results, and the THUMS model.

A separate test condition (11.1 kg impact mass instead of 7.5 kg) and failure criterion (10kN peak impact force) were applied to those vehicles with an Mod-EEVC LEH greater than 90 cm. Thus, the Van000 geometry and all SUV geometries except SUV500, were tested for pelvic impact. As can be seen in Figure 17, the 10 kN peak impactor force threshold yielded a good correlation with THUMS injury prediction. However, the modified EEVC protocol simulation predicts that a van geometry with no leading edge radius (Van000) will cause no pelvic fracture, while the THUMS model and PMTO experiments predict that this geometry will cause a pelvic fracture to occur. The modified EEVC test

Thus the SUV000 and Van050 geometries, for which THUMS simulations predicted pelvic fracture and for the latter of which PMTO tests showed pelvic fracture, were not tested for pelvic injury risk according to the modified EEVC proposal. As indicated by the PMTO test results, it may therefore be necessary to apply both force and bending moment injury criteria to vehicles with LEH near the pelvis/femur decision threshold.
