## **Toyota Motor Manufacturing, U.S.A., Inc.**

*Professor Kazuhiro Mishina prepared this case with the assistance of Kazunori Takeda, MBA '93, as the basis for class discussion rather than to illustrate either effective or ineffective handling of an administrative situation.*

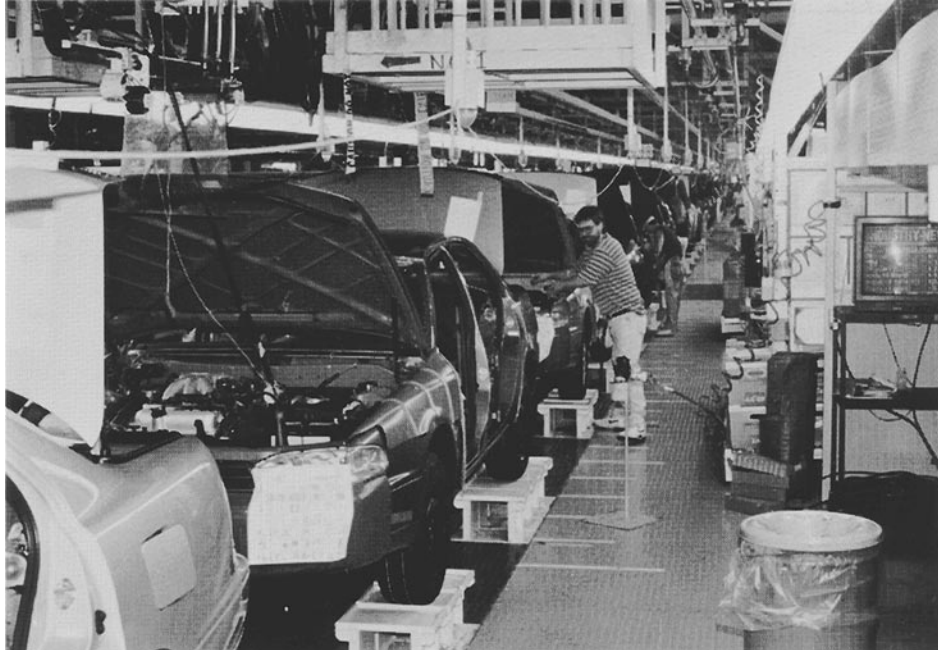
## (1) Assembly Line and Andon Cord

**Exhibit 4**      The Assembly Line

Every station on the assembly line embodied *jidoka* and *kaizen* tools. A standardized work chart was posted adjacent to each work station on the line, showing the cycle time of that station, the sequence of work tasks, and the timing to perform them within one cycle. Colored tape marked out areas of the floor to specify where just about everything in sight belonged, and promoted the “4Ss (sift, sort, sweep, spic-and-span).” In the resulting work environment, any deviations from normal conditions stood out visually.

A green line and a red line drawn at right angles to the assembly line marked the beginning and the end of each work station. A team member would start the work for one cycle when a car reached the green line and finish all tasks by the red line. A yellow line in between marked a point by which 70% of the work had to be completed. If the team member was behind at this yellow line or found any other problem, he or she pulled the *andon* cord: a rope running along the assembly line over the work area. An *andon* pull turned on a flashing light, triggered loud music, and lit up the work station's "address number" on the *andon* board (see **Exhibit 4**). The team leader then rushed to that work station to ask what the problem was and, if it was correctable, turned off the lights and music by pulling the *andon* cord again. If, however, the team leader could not resolve the problem immediately, he or she left the *andon* on and allowed the line segment to stop at the red line, that is, when the other work stations completed their cycles. This stoppage instantly attracted the group leader's attention. A team member, on average, pulled the *andon* cord nearly one dozen times per shift, and typically, one of these *andon* pulls resulted in an actual line stoppage. Doug Friesen explained:

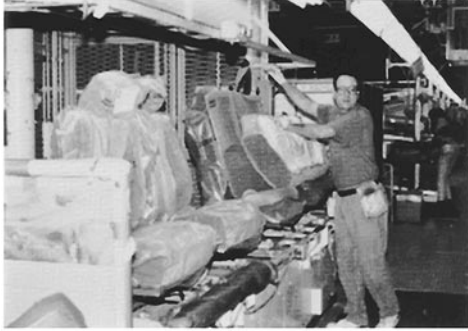
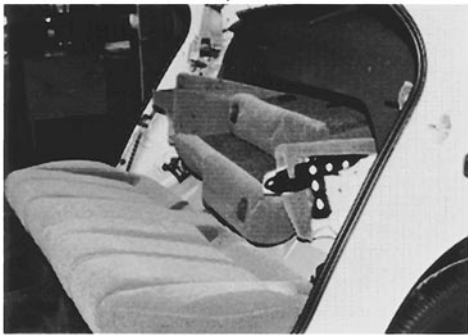
Rear Seat Loading

## Exhibit 5      Seat Installation

KFS' manifest specified the style and color of the seat, and triggered seat production much like a *kanban* of lot size one. As cars traveled down TMM's five-mile-long assembly line, so did all the seat assembly pieces travel down KFS' own lines. All the matching pieces then merged at the end of the KFS lines to be strapped together, 100% inspected, and loaded onto a trailer in the same order. A truckload consisted of 58 seat sets and arrived at TMM in about half an hour after leaving the KFS factory. Once at TMM's receiving dock, the seats were unloaded directly from the trailer to the staging line, which was barely big enough to hold one truckload of the seat sets. The seat sets waited here in the exact sequence of the manifest printouts until hoisted up one by one onto the overhead conveyor.

Synchronized with the assembly line, the overhead seat conveyor line ran above panels of steel mesh that shielded cars and people below. After traveling 250 meters or so, the seat sets reached the rear seat loading work station on the final assembly line segment called Final 1. The appropriate seat set was then lowered to the side of the Final 1 line every 57 seconds. This is where the seat met the matching car for the first time. At the rear seat loading work station, a team member unstrapped the seat set and placed all the rear seat pieces into the car. Meanwhile, the front seat assemblies automatically slid to the side to make room for the next seat set. The front seats were returned to the conveyor line and moved to the proper side of the assembly line a few work stations downstream. At the front seat installation work stations, team members guided the front seat assemblies (left and right) into the car and fixed the four bolts in place with a pneumatic wrench. The rear seat pieces were bolted in the next line segment called Final 2 (see **Exhibits 5 and 6**).

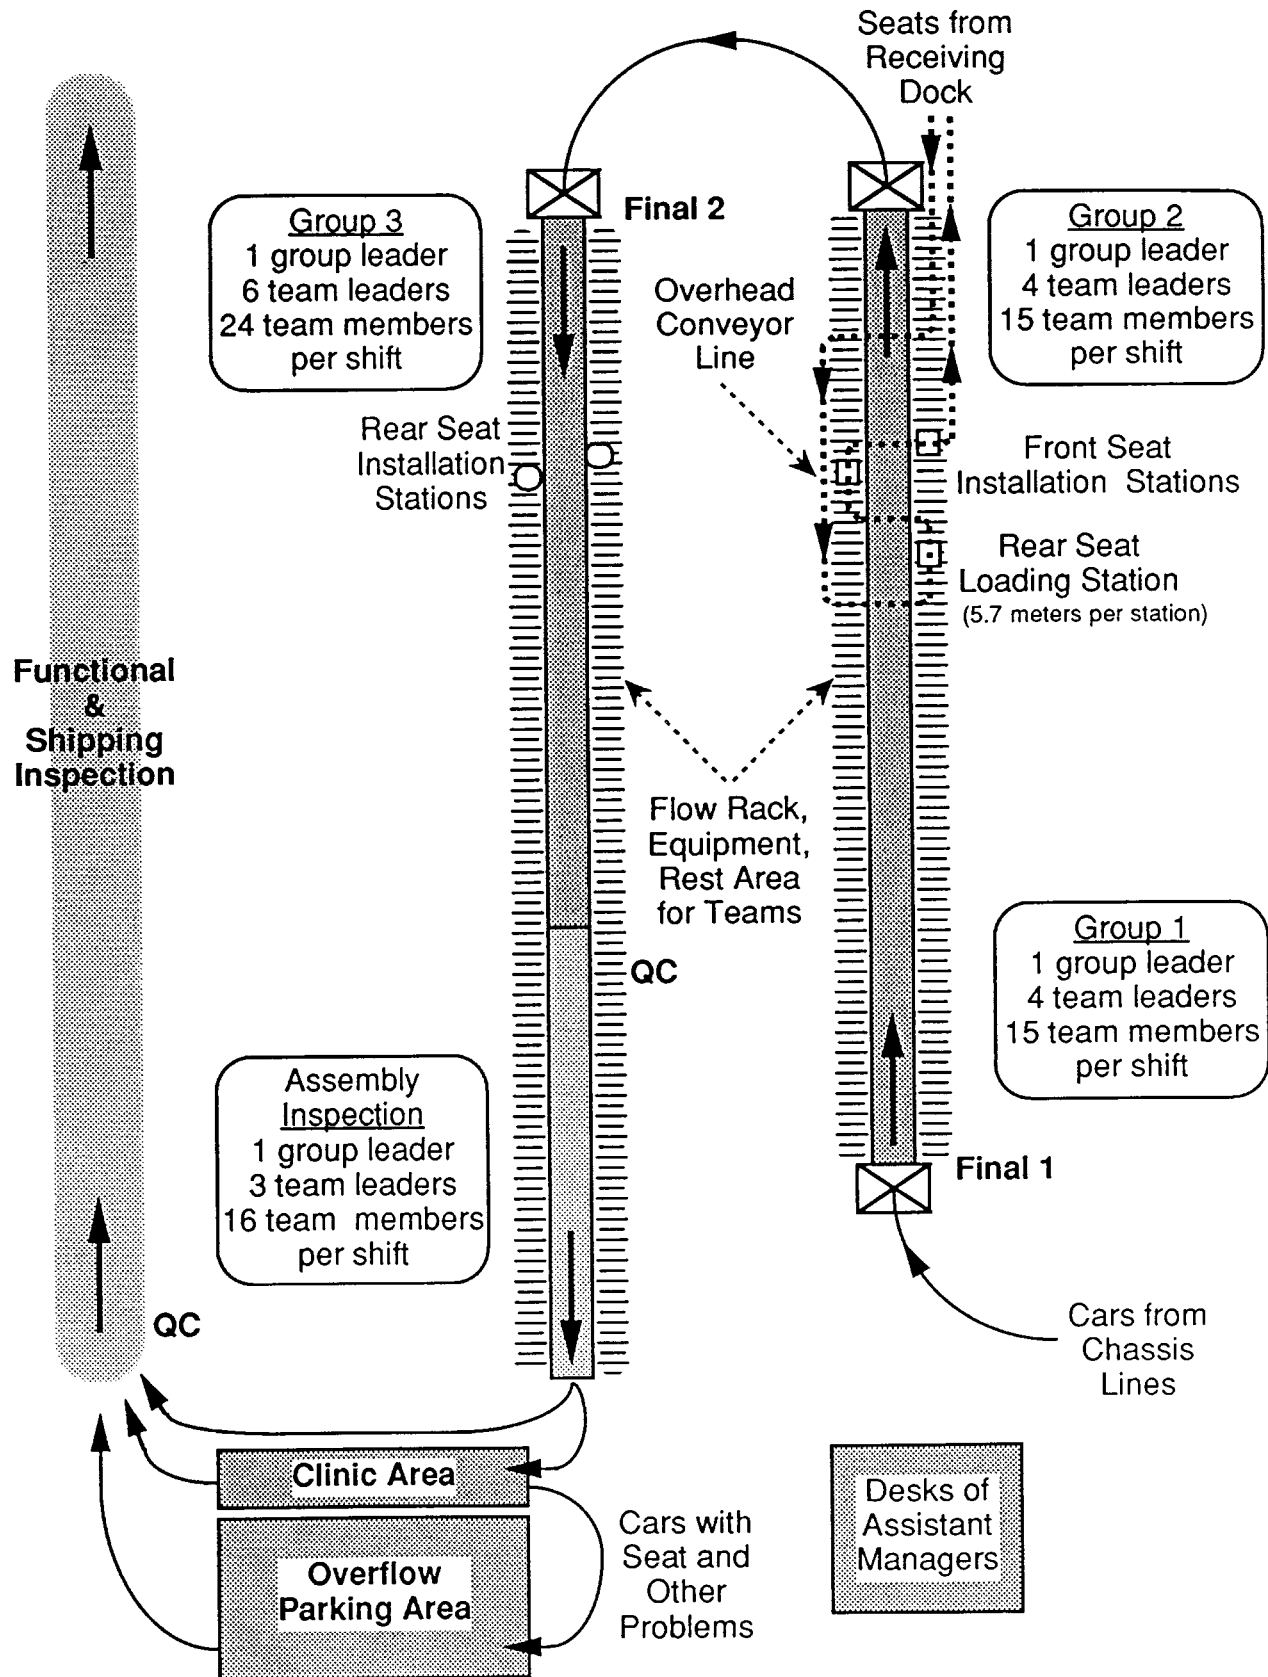
**Exhibit 6** Final Assembly Area (Staffed by Group 1-3 plus Assembly Inspection)

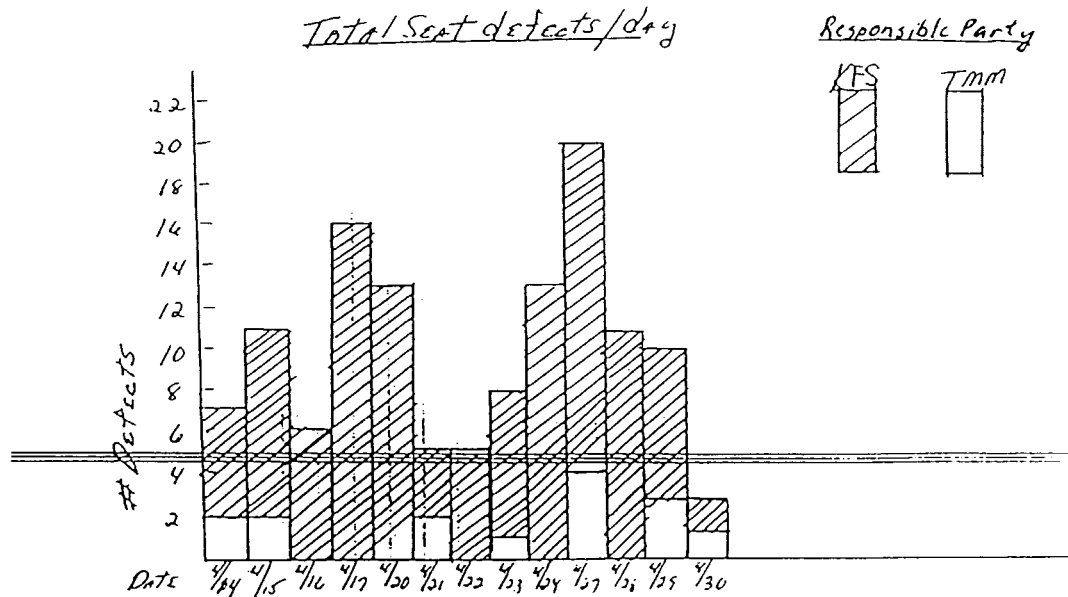
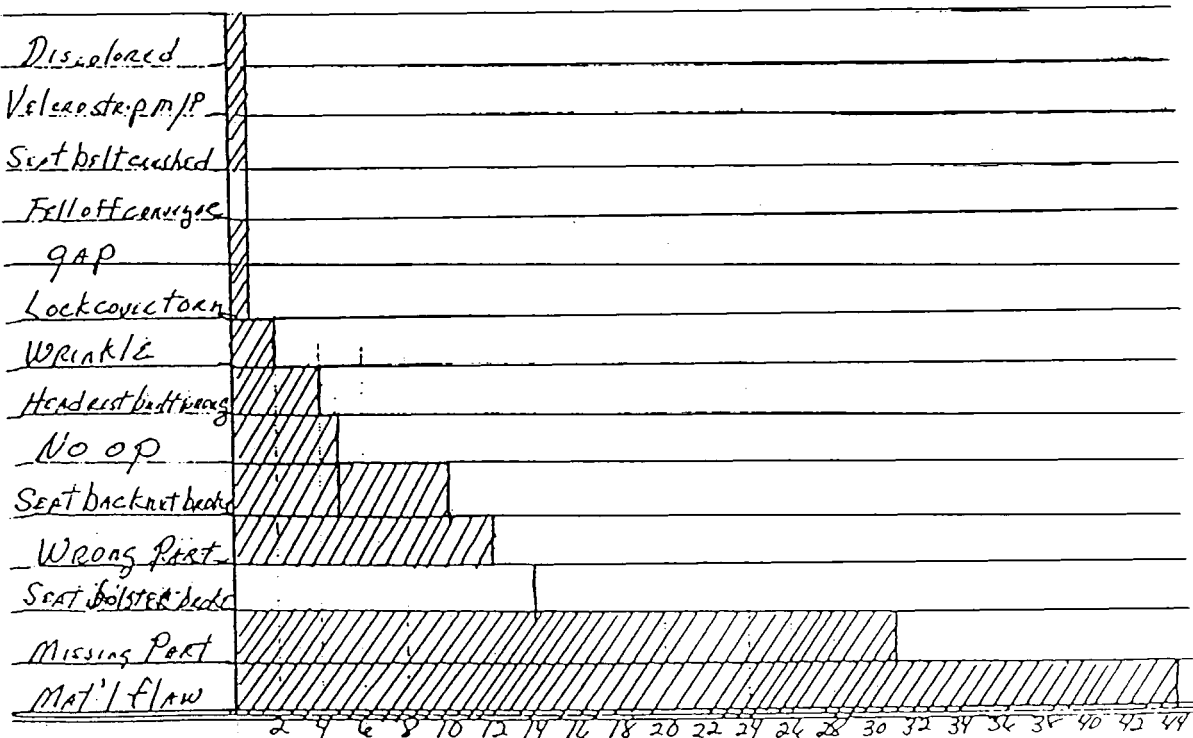
**Exhibit 8**      Group Leader's Seat Defect Data (April 14-30, 1992)

Defect Occurrences

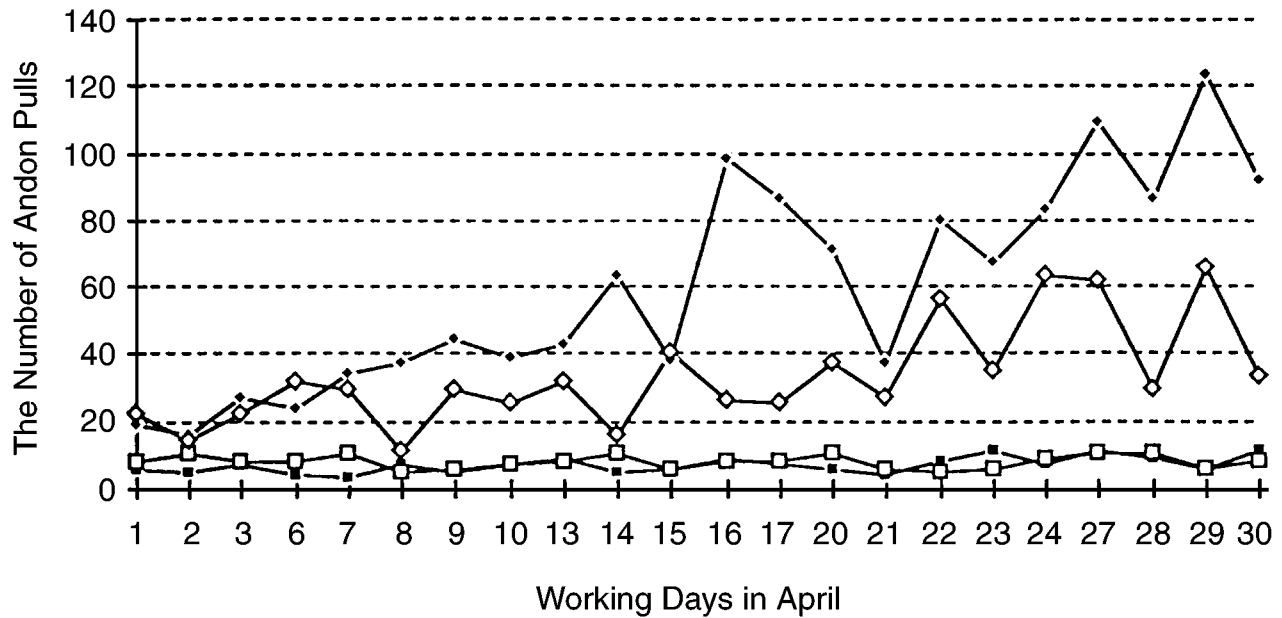
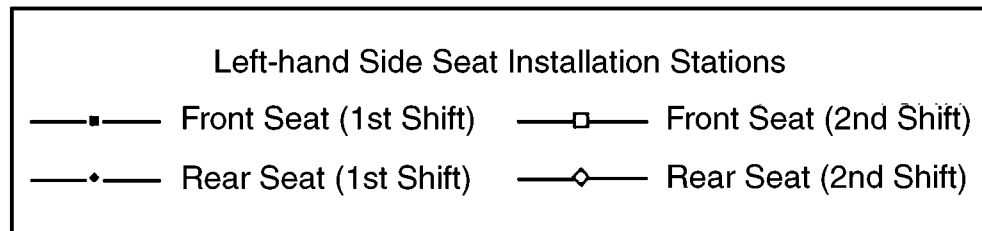
**Exhibit 10** Andon Pulls at Left-Hand Side Seat Installation

Note: The date showed a similar trend for the right-hand side stations.

After the group dispersed, Friesen walked down the aisle between Final 1 and Final 2, determined to learn more about the problem. While studying some data posted at work stations along the lines (**Exhibit 10**), he found a few people near the front seat installation area and asked them about seats. The only problem they could think of was occasional incidents of cross-threading, that is, when a team member shot a bolt at an angle. Team leaders, however, could fix this familiar problem on-line in 30 seconds with a re-tapping tool. The team members also reminded Friesen of rare incidents when someone would accidentally damage the seat covering with hand tools, but they could not recall any recent occurrences. Being used to seat defects, they looked increasingly puzzled when Friesen kept asking about seat problems.

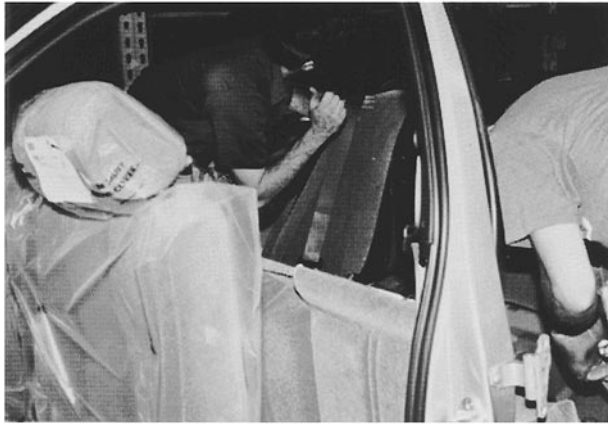
### (1) Installation

## Exhibit 11 Rear Seat Side Bolster

<sup>3</sup>These bolsters provided lateral support for rear seat passengers and concealed the gap between the back rests and the car body.
