Stavební Obzor - Civil Engineering Journal

IMPACT OF IMAGE RESOLUTION ON PAVEMENT DISTRESS DETECTION USING PICUCHA METHODOLOGY

Reus Salini¹, Bugao Xu² and Mena Souliman³

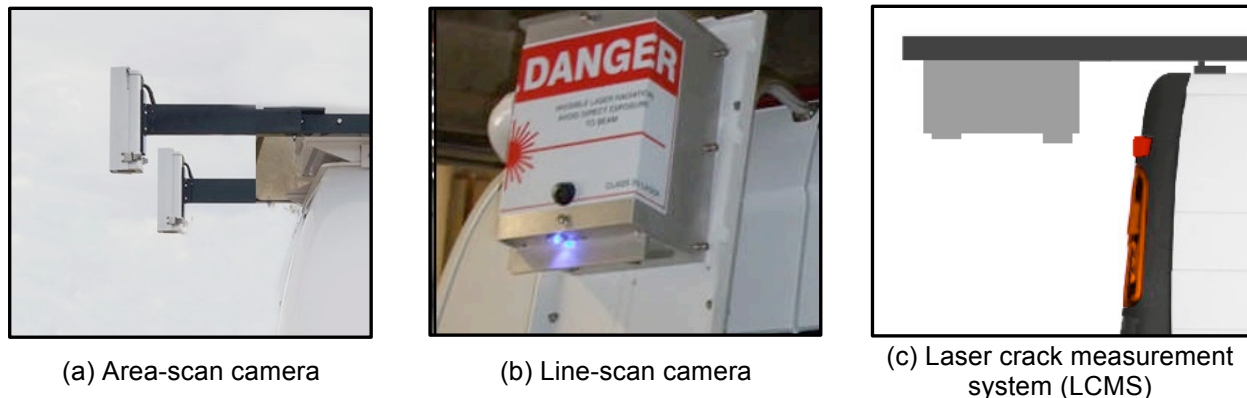
Figure 2 - Camera technologies for pavement surveys

Area-scan cameras were the first generation of equipment for pavement survey. They are adaptations of general purpose cameras (*Figure 2.a*) and are notorious for its low cost. Some integrators assemble two cameras together for a higher resolution. This type of camera takes a rectangular image on every shot (e.g. 2048x512 pixels) that results in a number of problems, especially image distortions since some pavement areas are closer to the camera lens then others, and non-homogeneous illumination, because some areas of the pavement are closer to the illumination source then others. Those problems are especially visible when two or more images are assembled together and generate an extra challenge for the distresses detection by software. Area-scan cameras are not compatible with laser illumination, requiring many lamps that usually are strobe flashlights.

Line-scan cameras represent an advance in technology and image quality (*Figure 2.b*). As its name suggests, it takes one single line of pixels on every shot (e.g. 2048 x 1 pixels). Image distortions and illumination heterogeneity are minimal. The line-scanned pixels can be assembled together to generate a consistent and flat rectangular image. It is compatible with laser (beam) illumination in addition to incandescent, LED and others.

The laser crack measurement systems (LCMS) collect two different information at the same time: an image and a transverse profile (*Figure 2.c*). The image is usually a by-product for this equipment and its quality tends to be low. The analysis is performed by using the profile data to locate the cracks over the image. It is especially accurate to identify cracks and rutting. Some

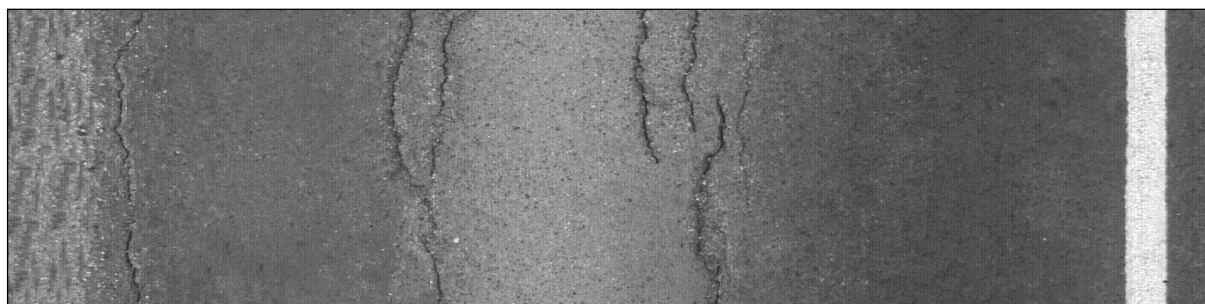
Figure 3 - Image with original resolution of 2048 x 512 pixels

An image taken with a line-scan camera with an original resolution of 2048 x 512 pixels, and covering an area of approximately 3.6 x 0.9 m (Figure 3), was downsized to the tested resolutions. Such image was chosen because it is representative of how PICUCHA performs. In addition it shows different kinds of patterns, including good pavement, raveling, cracks with different severities and a white strip. The 3D points mesh as well as the pixels decks with artificial colors for such image are shown on Figure 4 and Figure 5, respectively. They are part of

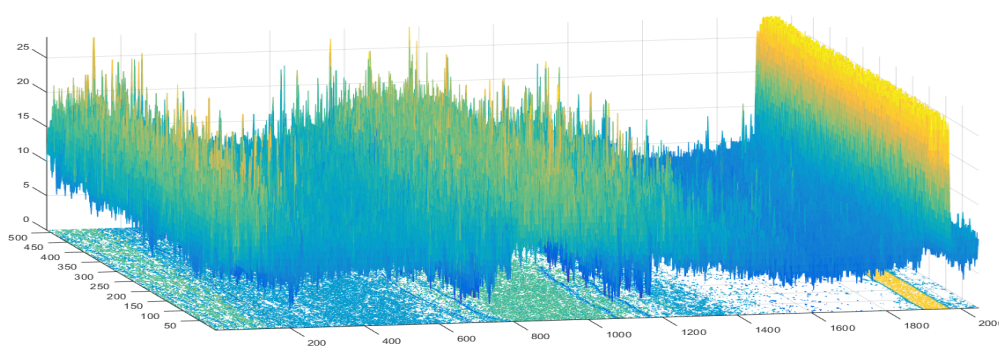
Figure 4 - The 3D mesh of points representation for the 2048x512 pixels image

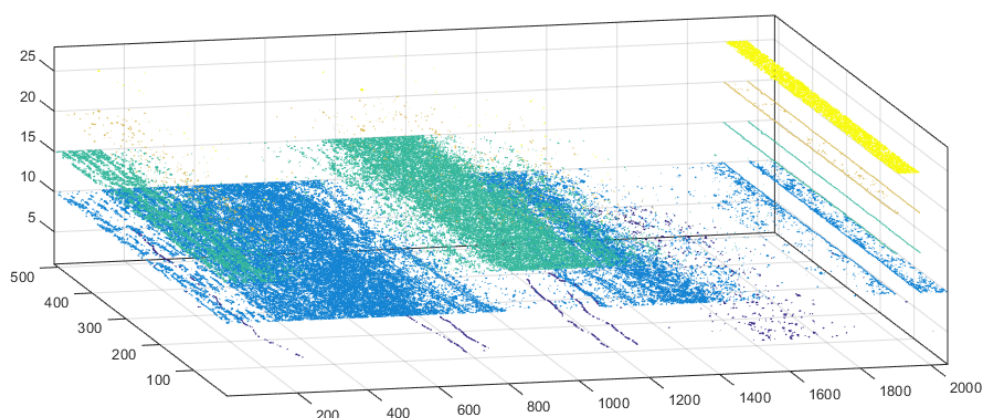
Figure 5 - The 3D pixel decks for the 2048x512 pixels image

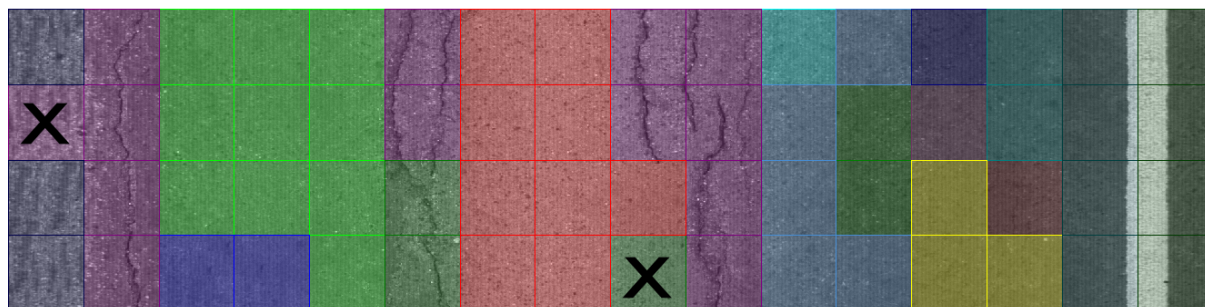
Figure 6 - Cells classification for the 2048x512 pixels image

The image, at its five different resolutions, was submitted for classification using PICUCHA algorithms. To keep the test consistency and the image slicing to the same number of cells for every case, the cell size was reduced in the same proportion of the image resizing, as shown in Table 2. The classification results are shown in Figure 6-10 where the generated groups can be seen. Because of the unsupervised nature of this artificial intelligence approach the cells marked with the same color belong to the same group and should have the same pattern. The cells that do not attend that criteria, i.e., were included in a group with a different predominant pattern, represent the algorithm error and are marked with a "x". The identification of misclassified cells was performed by an experienced pavement engineer. In this study the colors are used only for the groups' identification and, because every image (Figure 6-10) represents a different processing started from the ground, same colors in different images may represent different patterns. Another situation that frequently happens is that the algorithms, while performing the self-learning, may decide to create different groups for cells with patterns that, from a human perspective, look similar. When this situation happens the (human) pavement expert analyst will, in the step 3 of this methodology (Figure 1), set that groups with the same description for the distresses accounting.

As expected, the number of misclassified cells rose as the resolution dropped, but not in a linear way. At the highest resolution, 2048x512 pixels, the error was the smallest, with just two cells being misclassified among 64. At the lowest resolution, 1024x256 pixels, six cells were misclassified with an error rate of 9.4%. The largest error was found at resolution of 1280x320 pixels with seven cells misclassified, corresponding to an error of 10.9% as shown in Table 2.

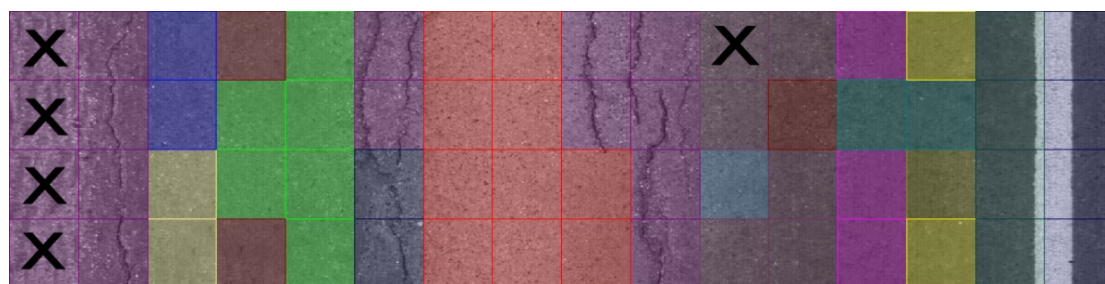
Figure 7 - Cells classification for the 1792x448 pixels image

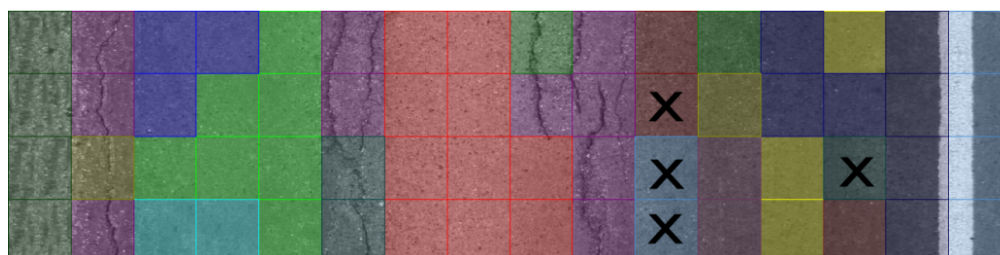
Figure 8 - Cells classification for the 1536x384 pixels image

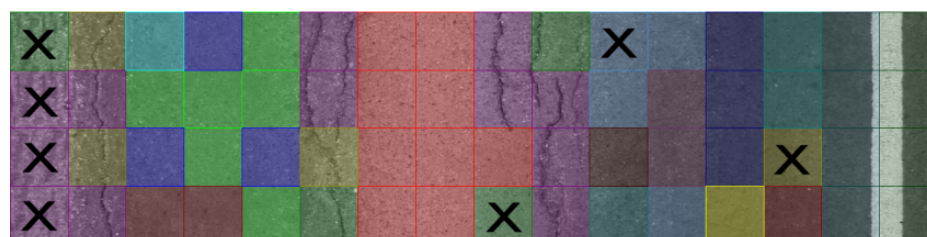
Figure 9 - Cells classification for the 1280x320 pixels image

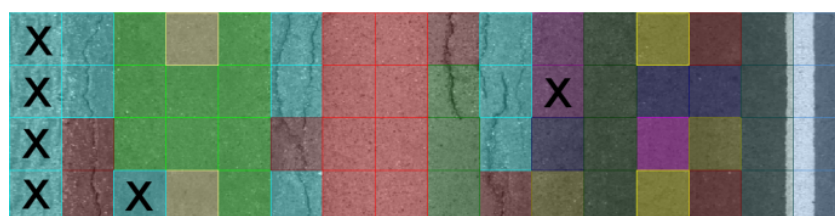
Figure 10 - Cells classification for the 1024x256 pixels image

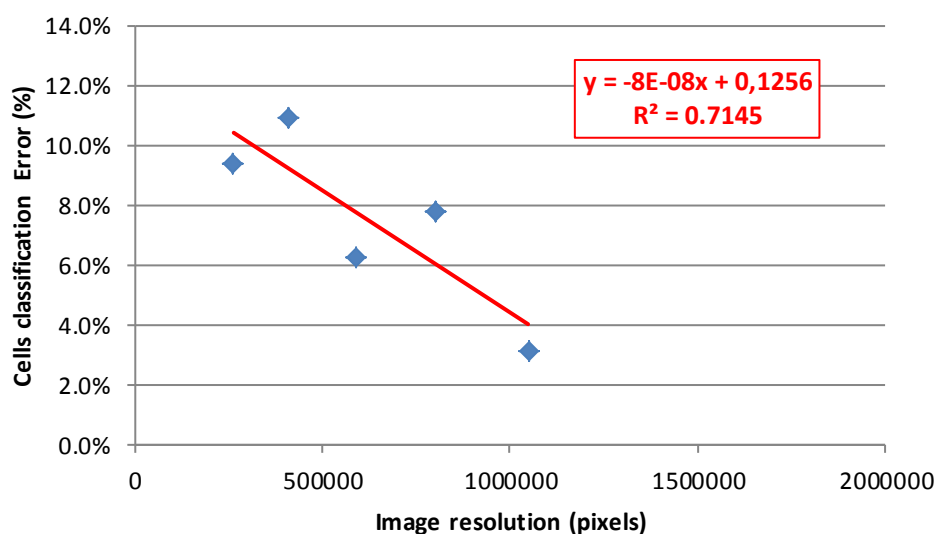
Figure 11 - Classification error according to the image resolution

Figure 11 shows the found errors graphically with a respective trend line and a prediction equation. On the basis of the trend line, the upper and lower limits can be plotted with a plus and minus standard deviation (3.0%), as shown in Figure 12. By extrapolating the upper limit, the ideal image dimension can be identified at a location near 2 megapixels where the theoretical error is zero. This dimension is equivalent to an image size of 2900x725 pixels, or a resolution of 1.24 mm/pixel.

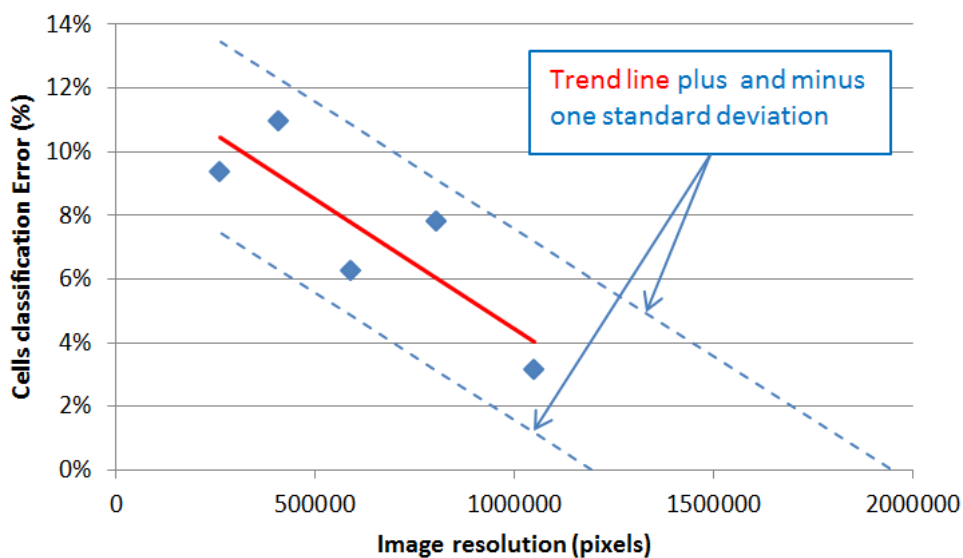
Figure 12 - Projection of ideal image resolution for PICUCHA method

The error trend line analysis suggests the optimum transverse image resolution should be more than 2900 pixels, i.e., around 1.24 mm/pixel. Although this should not be assumed as a definitive parameter, it is a good resolution reference for selecting a camera system for pavement surveys when PICUCHA will be used for the analysis.
