Source of Ghost and Carryover Peaks in GC

This Information Applies To: Agilent GC Systems

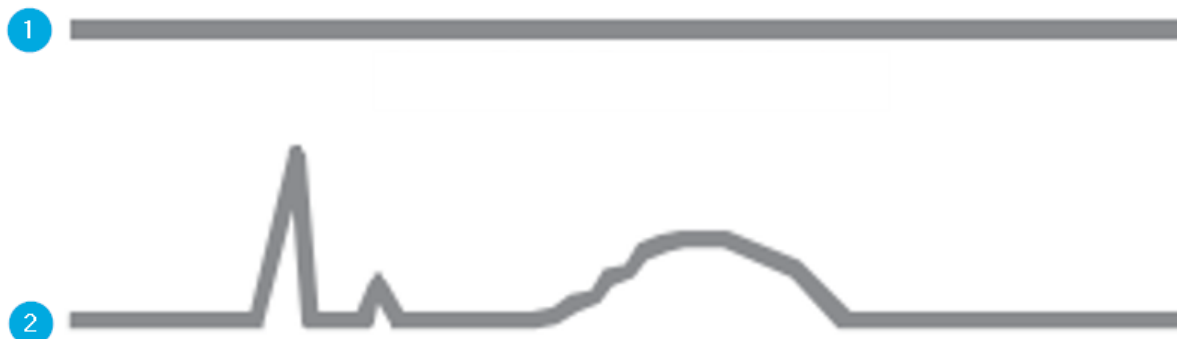
Figure 1. Ghost peaks and carryover

Over time sample deposits can accumulate in the analytical pathway and slowly leach out during subsequent sample analyses. This situation can cause peaks that are not from the current sample to appear in your chromatogram ([Figure 1](#)). The additional peaks can appear at any random retention time over one or more analytical runs and include:

- Ghost peaks: Unknown, symmetrical, or unsymmetrical peaks that can occur at any time that are not expected to come from the current sample
- Carryover peaks: Peaks from previous injections.

1. Normal contamination free run, 2. Contaminated with ghost peaks and carry over
