# *VOLVO PENTA SPEED RELAY*

A Guide to Testing & Repair

# Volvo Penta Speed Relay

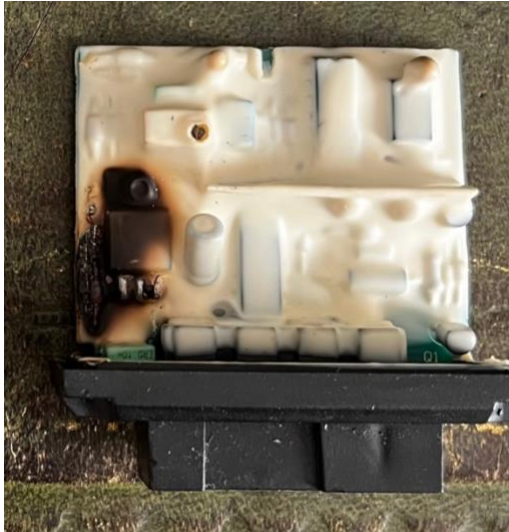
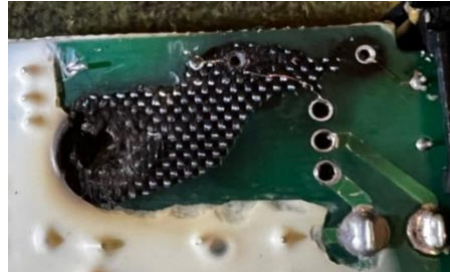
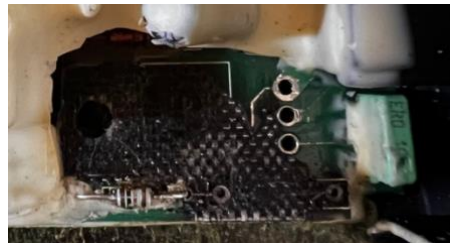
Whilst the board has suffered from heat damage which has also damaged some of the tracks and the pads it is still repairable, although the repair will be obvious.

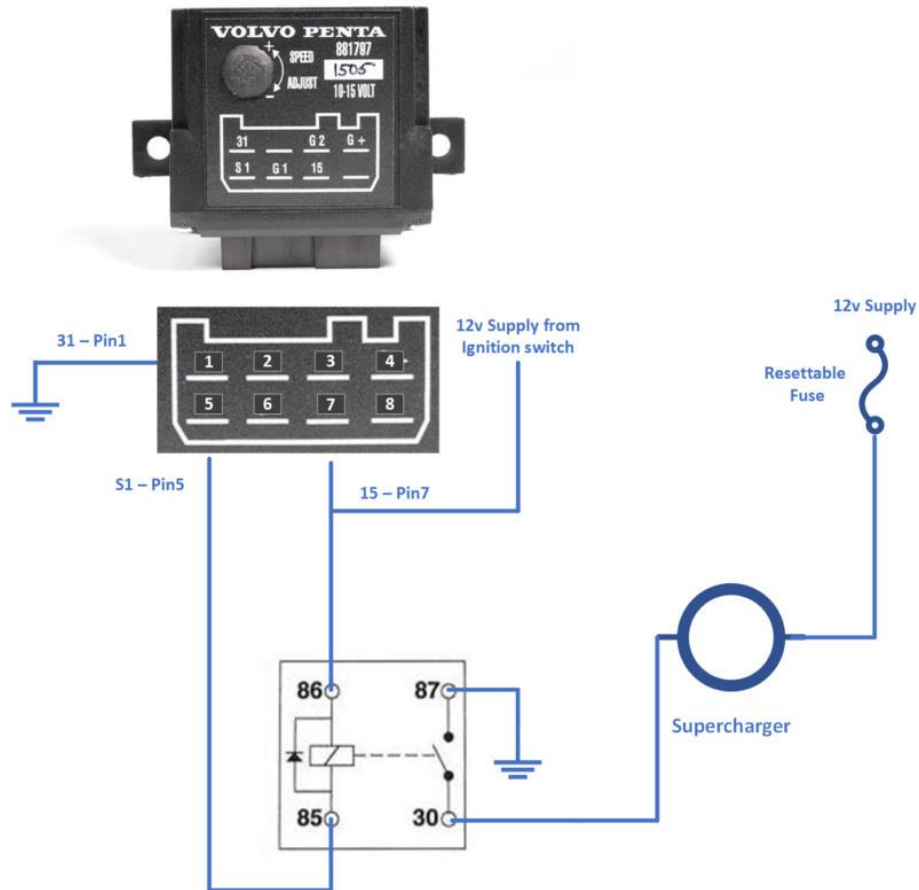
Consider fitting a relay in between the supercharger and the Volvo speed relay. This will protect the speed relay from damage when the clutch coil fails.

Ensure the relay has a suppression diode.

The diode should be installed in the relay with the stripe on the diode body facing towards terminal 86 (reverse biased) and it is important that +12V is connected this terminal.

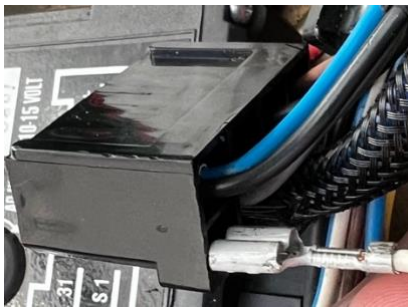
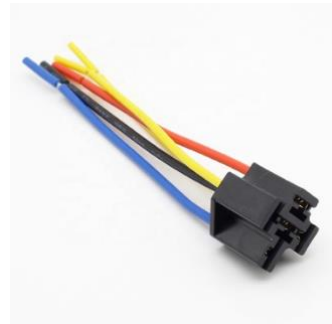
Locate cable S1 / Pin 5 on the Volvo connector block. Do not cut this cable. Remove the connector from the connector housing using a [connector pin removal tool](#).

<<< Volvo connector

New relay socket >>>

On the new relay socket remove the existing cable for Pin 30 using a pin removal tool and insert the cable removed from S1/Pin 5 into the new relay socket at Pin 30.

On the new relay socket locate pin 85.

Using another relay socket as a donor remove the same colour cable using a pin removal tool. Cut to length and join this spare cable together with the cable on pin 85. The 'new' connector obtained from the donor relay socket will then plug into the now empty position S1/Pin5 on the Volvo connector block.

On the new relay socket locate pin 87. This cable should be spliced onto cable 31/Pin 1.  
On the new relay socket locate pin 86. This cable should be spliced onto cable 15/Pin 7.

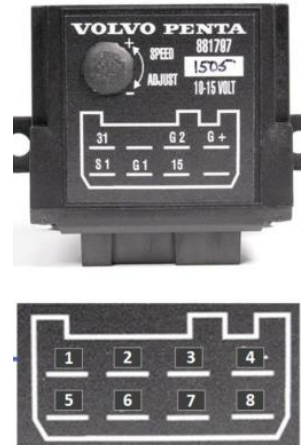
Connector	Case Identifier	Info
P1	31	GND
P2	-	n/c
P3	G2	Signal from position sensor
P4	G+	Supply to position sensor
P5	S1	Supercharger
P6	G1	Engine Speed Sensor
P7	15	Ignition Switch (+12v)
P8	-	n/c

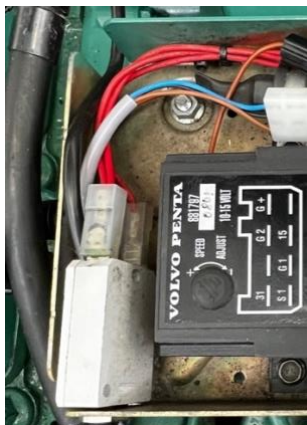
The circuit breaker / trip is the white item shown below. It will trip at 10A.

If it is tripping repeatedly then it is likely there is a fault with the supercharger coils.

Check the trip is correctly wired and has not been bypassed by a previous owner.

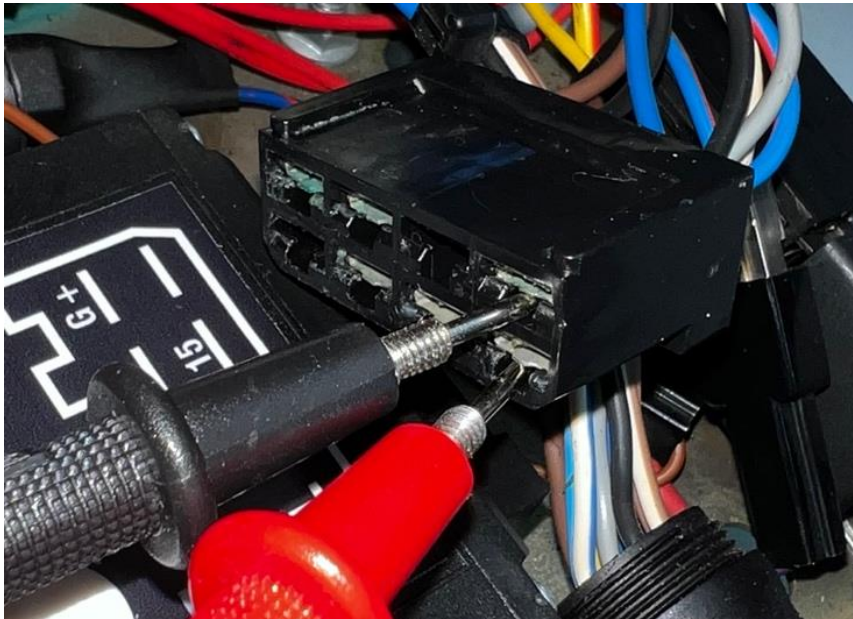
Using a multimeter set to DC volts measure the voltage between pin 1 and pin 5 on the connector (31 & S1). The reading should be at least 12v.

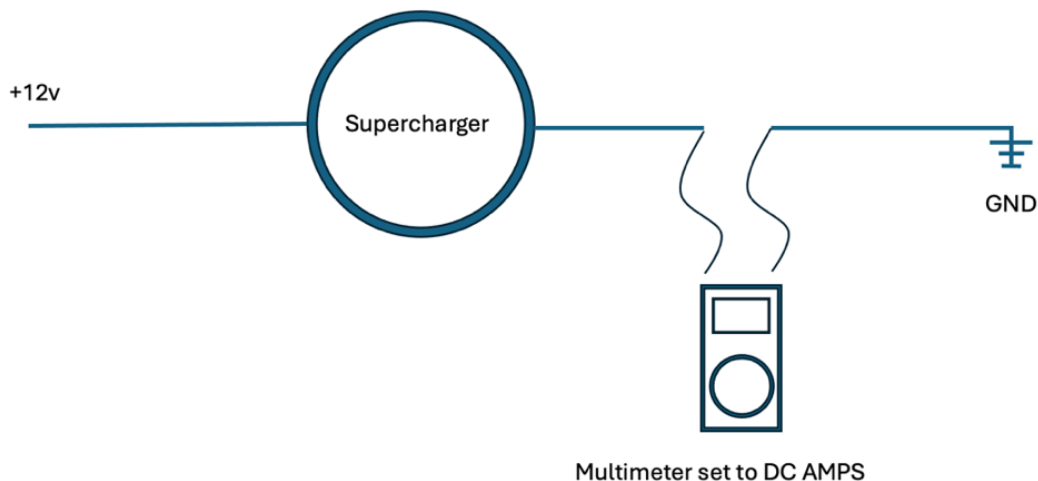
Measure the current between pin 1 and pin 5 on the connector. The reading should be circa 3.75 Amps. The clutch will make an audible clunk as the measurement is read.

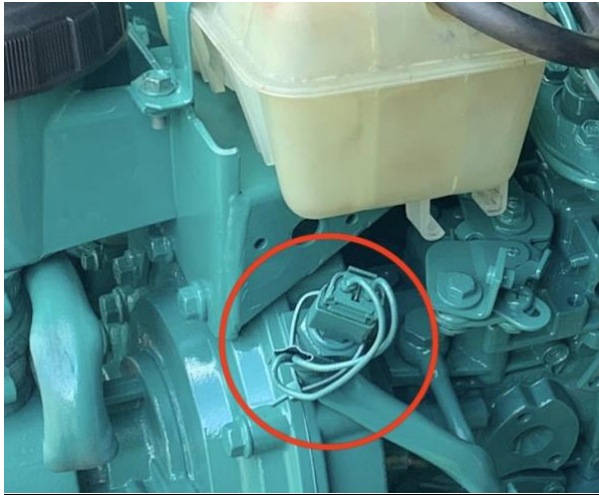
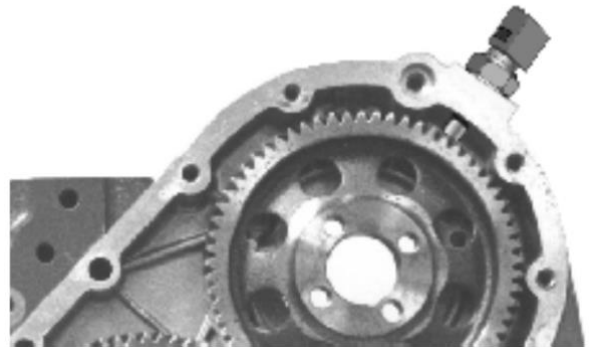
This item is located on the camshaft cover.

The speed relay uses this component to determine the engine speed. If it is disconnected, faulty or has a bad connection, the supercharger will not engage.

Inductive sensor (cog counter). Internal resistance  $1050 \Omega \pm 100 \Omega$ .

With the connector removed measure the resistance with a multimeter set to Ohms.  
Expected reading  $1050 \Omega \pm 100 \Omega$

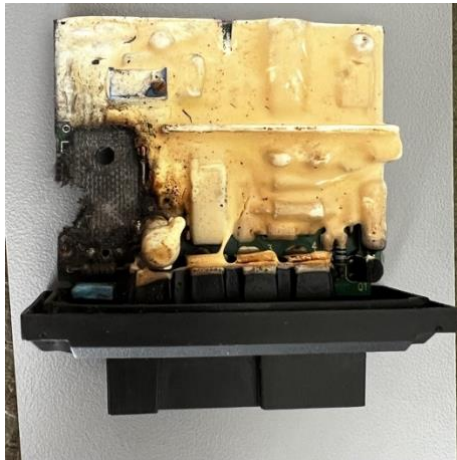
Unfortunately for this owner the speed relay was beyond repair. The heat had damaged 6 components, and the main board had started to disintegrate.

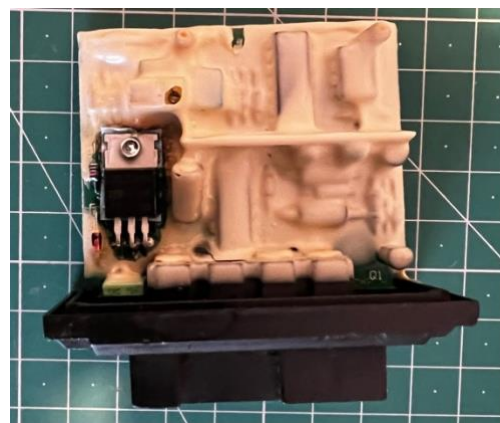
A different board and a successful repair.

This board had heat damage, but no track damage. Whilst cosmetically it does not look perfect, it is a good repair with a new transistor riveted in place.

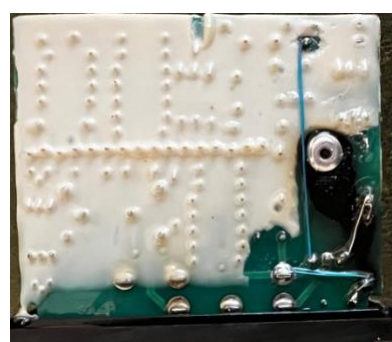
Another board with track and component damage.

Successfully repaired with the repair covered in a conformal coating to protect it from moisture and corrosion.
